VILLAGE OF BRATENAHL
VILLAGE CENTER
FEASIBILITY STUDY

2022 Bratenahl Condition Assessments

Bratenahl Center – Facade Observations & Recommendations

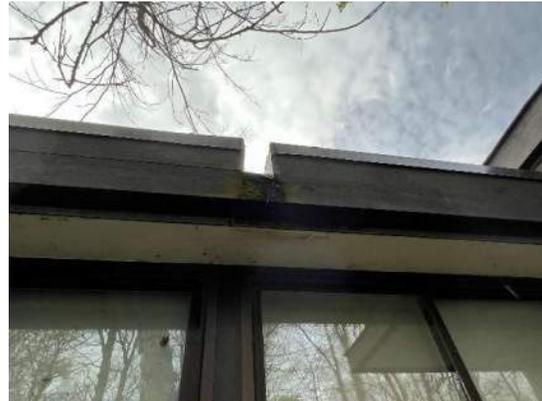
2. Low-Sloped Membrane Roof: The footprint of the building consists of four rotated rectangular sections, with hipped roofs, with a central connection. The roof of the central section consists of a low-sloped roof membrane. The original design drawings indicate a built-up roof with gravel ballast. We were unable to review the roof membrane, but from satellite photographs it appears to consist of an SBS modified bitumen roof membrane. A scupper is located on the northwest elevation for drainage directly off the roof; a drip edge or downspout are not provided.

We recommend review of the low-sloped membrane roof for replacement. It is our understanding that leaks are occurring into the interior of the building within the low-sloped roof.

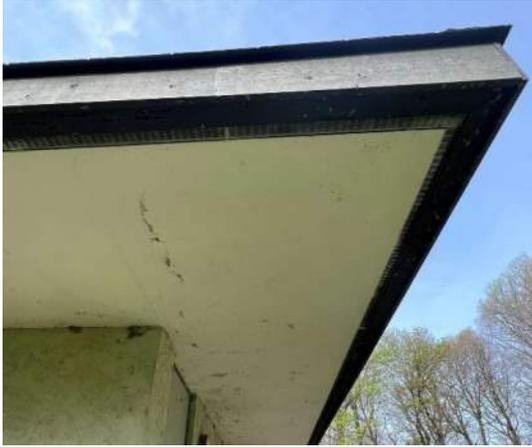
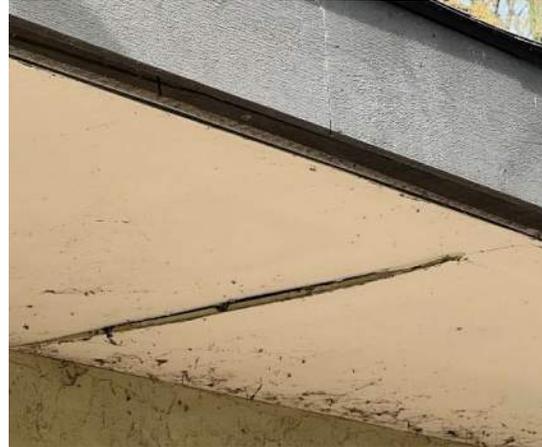
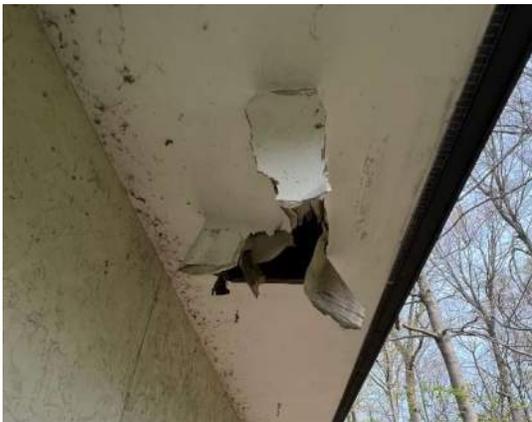
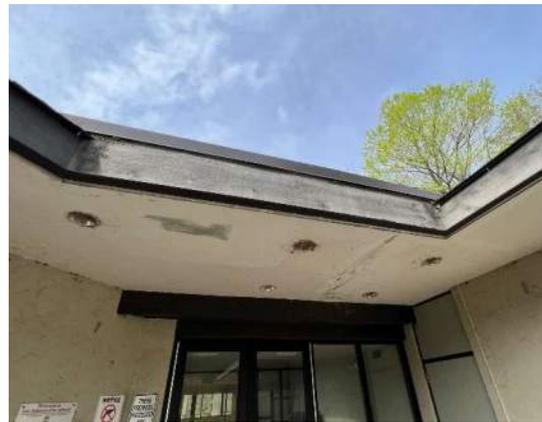
4. Soffit: The soffit around the perimeter of the hipped roofs consists of painted exterior gypsum sheathing. Cracking and displacement/sagging was observed between adjacent panels, particularly at the corners of the building. Blistering and peeling of the paint, moisture damage, as well as holes within the soffit sheathing, were observed at isolated locations due to leaks/moisture.

We recommend removal and replacement of the soffit, potentially with a new sheet metal or composite soffit system, or with new exterior sheathing with a waterproof coating. If budget constraints do not allow replacement of the soffit, we recommend replacement of damaged portions and cleaning and painting of the existing soffit to extend its service life.

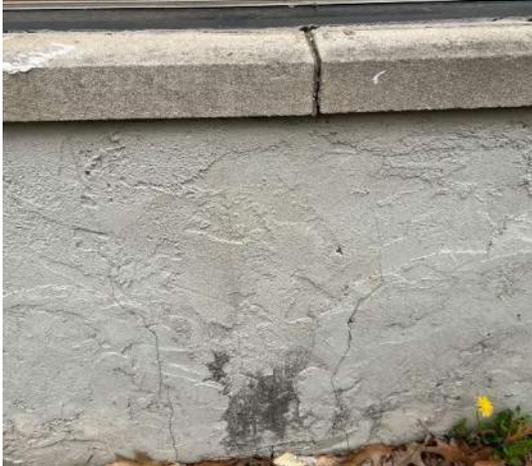
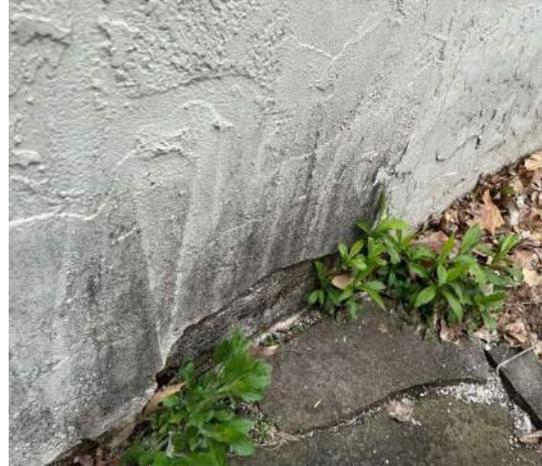
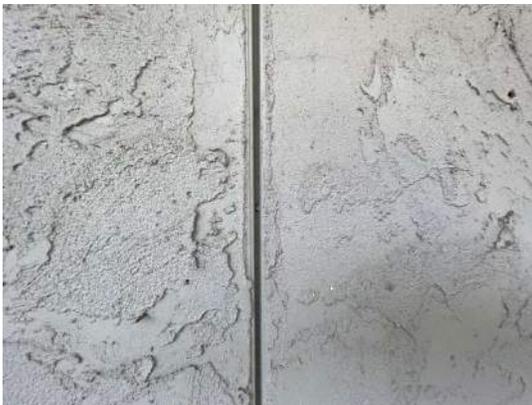
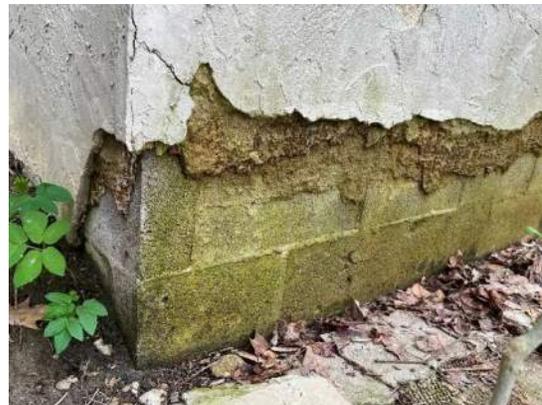
The stucco is applied the full height of the building; cracks, delaminations, and spalls were observed within the stucco, particularly at the base of the walls where moisture due to rain and snow could wick up the wall. The accumulation of moisture resulted in both freeze-thaw deterioration of the stucco and corrosion of its embedded metal lath. (Freeze-thaw deterioration is cracking and spalling caused by cyclic freezing and thawing. Water that is absorbed in the exterior wall material freezes, expands, breaks down the material, and then thaws leaving voids within the material.)

Spalls revealed that the stucco is approximately 1-inch thick. Within the spalled area, we observed evidence of very few fasteners for the metal lath to the concrete masonry (approximately three fasteners in a 50 to 60 square foot area). Within the spalled material, the lath, which was located within the center of the thickness of the stucco, was observed to be corroded. Previous patch repairs were performed at isolated locations; shrinkage cracks were observed within the patches.

The exterior stucco walls perform as a barrier system. (A barrier wall system is intended to prevent moisture penetration, as compared to a drainage wall system that would allow water to penetrate but would direct it back out of the exterior.) Repair and waterproofing of the stucco will be required as ongoing maintenance. We recommend the following within the exterior stucco:

- Removal of loose material and patching the stucco at cracks, delaminations, and spalls.
- Installation of additional reveals/control joints within the stucco.
- Removal of the stucco at the base of the walls for installation of new sheet metal flashing/weep screed. (Industry standards recommend maintaining the base of the stucco 4-inches minimum above grade, requiring installation of a waterproof membrane at the base of the concrete masonry backup.)
- Cleaning of the stucco and coating with a breathable elastomeric coating.
- Installation of silicone joint sealant within the reveals/control joints. We recommend use of silicone joint sealant, which has an anticipated service life of 20 years if properly installed, versus the 5 to 7-year anticipated life of urethane.

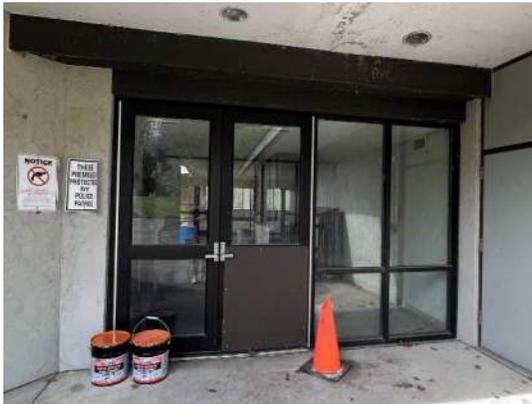
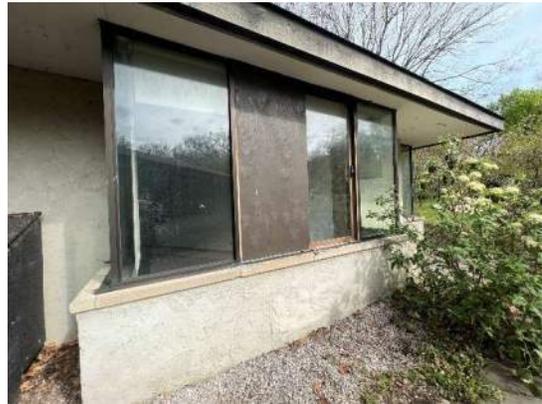
- a. Broken Glass: Broken panes of glass, which have been infilled with plywood, were observed at isolated windows and storefronts.

We recommend replacement of the broken panes of glass or replacement of the window units.

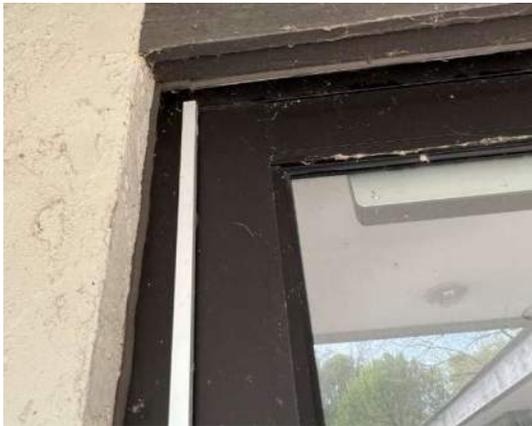
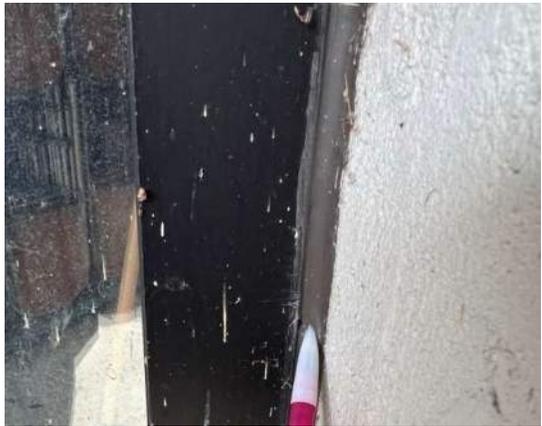
- b. Perimeter Joint Sealant: The joint sealant at the perimeter of the windows and storefronts, as well as at miscellaneous wall penetrations, was observed to consist of urethane joint sealant that is thin in profile, has hardened, crazed, and lost bond at isolated locations.

We recommend removal of the existing joint sealant at the perimeter joints, and replacement with silicone joint sealant.

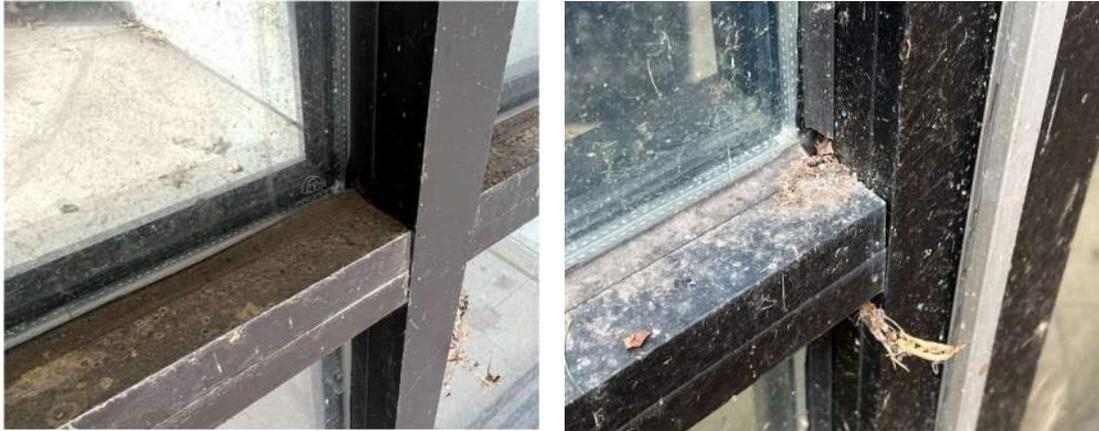
- c. Glass-to-Metal Wet Sealant: The gaskets within the windows and storefronts, providing the seal at the perimeter of the glazing, have hardened, and have begun to shorten.

We recommend installation of silicone glass-to-metal wet sealant at the perimeter of the glazing to minimize moisture penetration into the storefront window system.

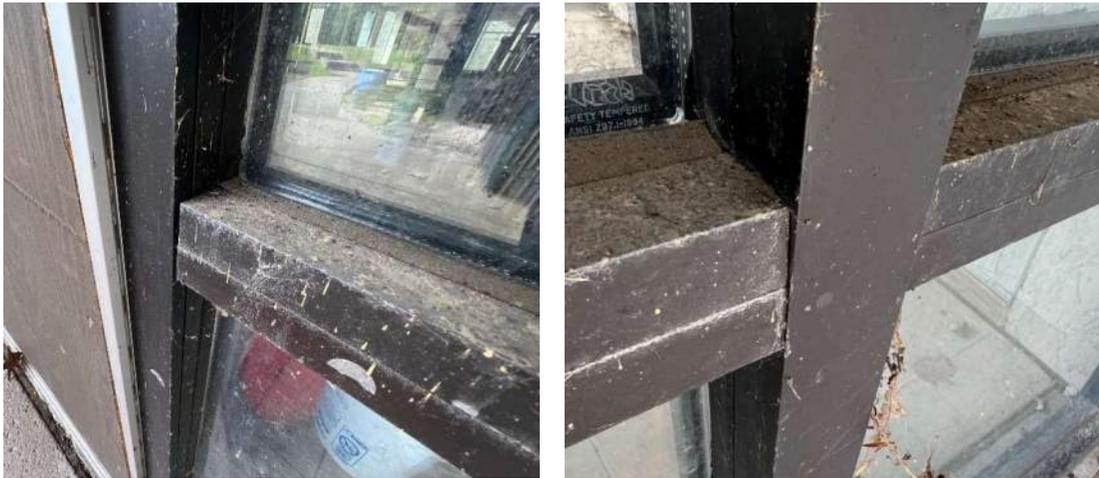
- d. Preformed Silicone Seals: Gaps were noted at intersections of the frame between the horizontal and vertical frame members within the storefront windows.

We recommend installation of preformed silicone seals at the joints within the frames to minimize moisture penetration into the system.

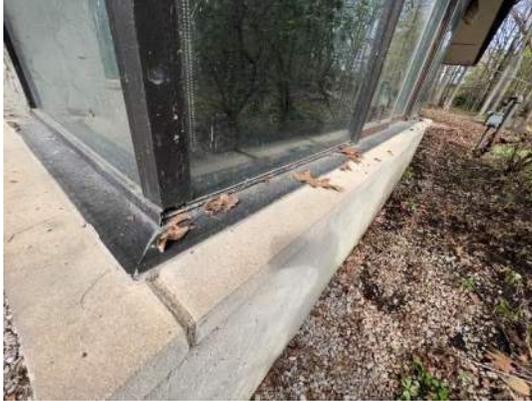
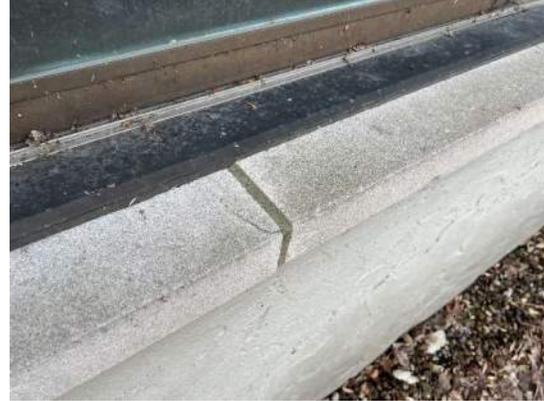
- e. Cast Stone Sills: The windowsills consist of cast stone. The cast stone is in overall good condition, with cracks at isolated locations. The mortar within the head (vertical) and bed (horizontal) joints was observed to have weathered and to have cracked and lost bond at isolated locations. We did not observe evidence of subsill flashing.

We recommend the following waterproofing repairs within the cast stone sills:

- Removal of loose material and patching the cracks within the cast stone.
 - Repointing the mortar head and bed joints. We recommend raking back the head joints to allow for the installation of backer rod and silicone joint sealant.

- Cleaning the cast stone and application of a clear water repellent sealer, to minimize moisture penetration into the cast stone and freeze-thaw deterioration.

- If the Owner elects to remove and replace the windows, we recommend removal and reinstallation of the cast stone windowsills to allow for installation of sheet metal subsill flashing.

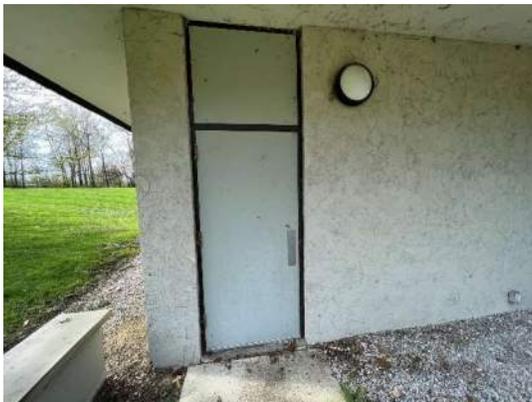
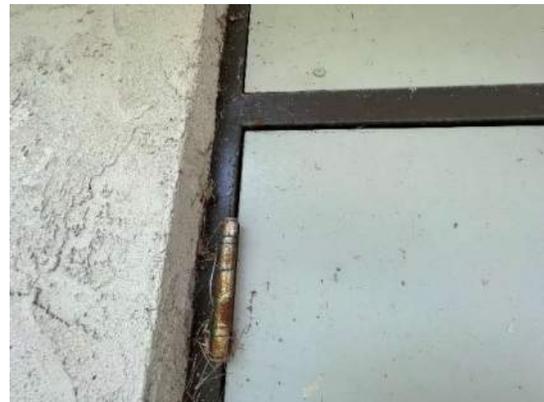
- f. Metal Doors: The doors consist of painted metal doors and frames. The frames, which extend to the soffit, are infilled with sheet metal panels installed as transoms over the doors and as wall panels at additional infilled door locations. The metal doors, frames, and metal panels are in overall good condition, with outward displacement of the metal panels observed at isolated locations. The paint has weathered and has cracked, blistered, and peeled at isolated locations. We observed surface corrosion of the exposed metal, as well as of the exposed door hinges.

The door frames were installed tight to the stucco walls. The urethane joint sealant at the perimeter of the frames was observed to be thin in profile, to have hardened, and to be typically concealed by paint.

We recommend cleaning and painting the metal doors, frames, and sheet metal infill panels, as well as removal and replacement of the joint sealant with silicone at the perimeter of the frames.

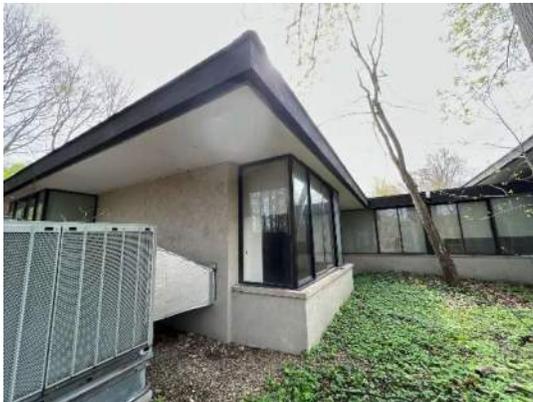
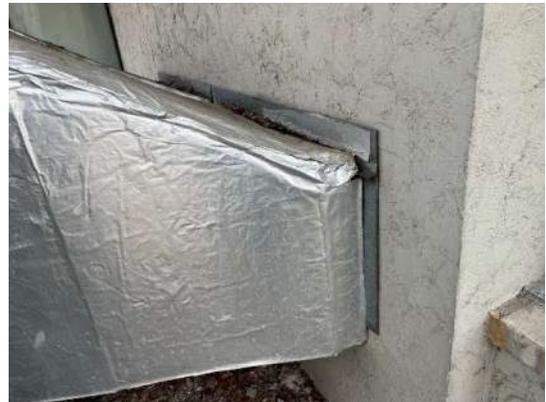
- a. MEP Penetrations: Ductwork, from adjacent exterior mechanical units, penetrates the exterior stucco walls on the north and northwest elevations of the building. We did not observe flashing at the penetration into the exterior wall.

We recommend installation of sheet metal counter-flashing at the penetrations of the mechanical ductwork into the exterior stucco walls, as well as installation of silicone joint sealant at the joint above the counter-flashing.

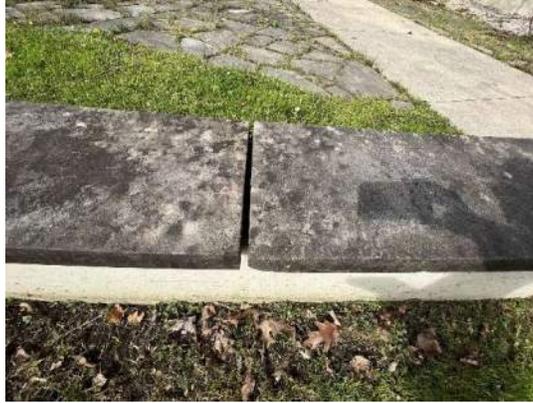
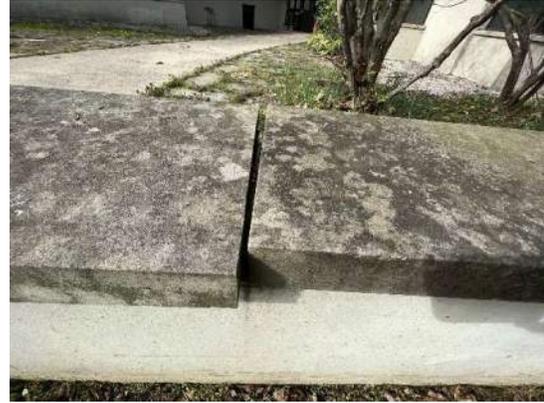
- b. Exterior Barrier Walls: Exterior barrier walls are located at the main entry, one each side of the sidewalk. The walls are constructed of concrete masonry, coated with exterior stucco, with cast stone copings. The mortar joints within the copings were observed to have cracked, lost bond, contain voids, or to be missing at various locations, and isolated coping units have displaced, providing direct paths for moisture penetration into the barrier wall. Through-wall flashing was not observed below the copings.

We recommend the following repairs within the exterior barrier walls:

- Removal and reinstallation of the cast stone copings to allow for installation of sheet metal through-wall flashing. We recommend reinstallation of the copings in full mortar head and bed joints, with head joints raked back to allow for the installation of backer rod and silicone joint sealant.

- Removal of loose material and patching the stucco at cracks, delaminations, and spalls.
- Installation of reveals/control joints within the stucco.
- Removal of the stucco at the base of the barrier walls for installation of new sheet metal flashing/weep screed. (Industry standards recommend maintaining the base of the stucco 4-inches minimum above grade, requiring installation of a waterproof membrane at the base of the concrete masonry backup.)

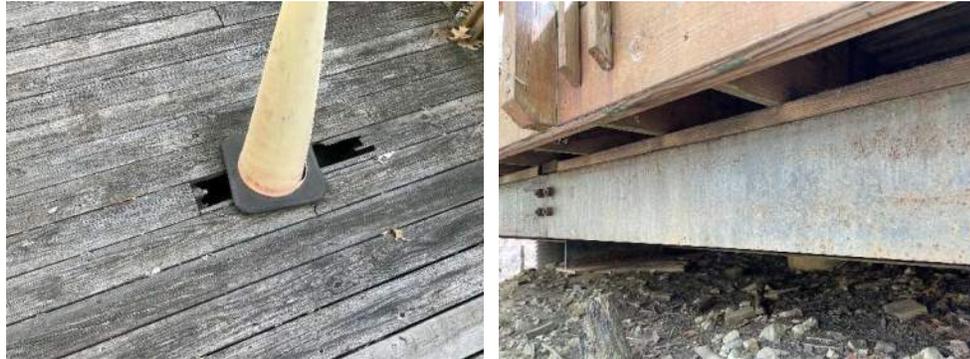
- e. The southwest side of the building has an exterior deck framed with wood joists over steel girders on drilled pier foundations. The deck floorboards were observed to be weathers, rotted at some locations, and missing at one location.

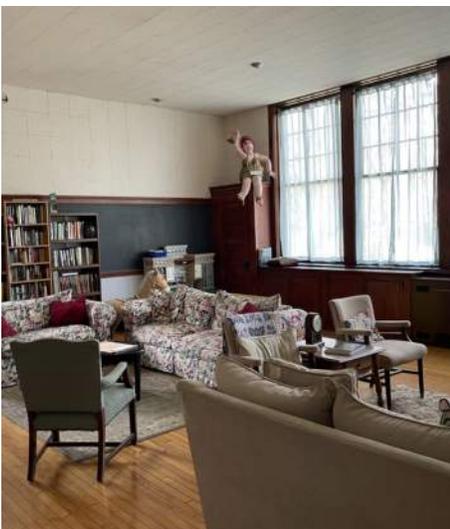
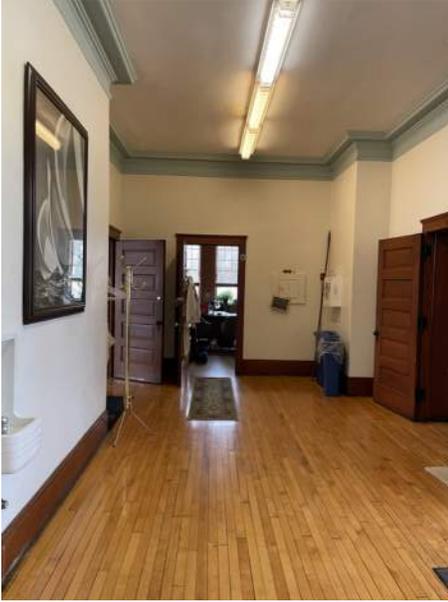
1. Several Door handles are non-compliant knob type and should be switched to a type not requiring tight grasping, pinching, or twisting of the wrist.
2. The internal stairs of the building do not meet standards. The width is

- not adequate and handrails at internal stairs do not provide the proper extensions at top and bottom of stairs
3. No ADA drinking fountains were observed.
 4. Most of the building's restrooms do not appear to meet ADA requirements for clearances, turning radius requirements and grab bars.
 5. Compliant signage is also required.
 6. Push and pull clearances for doors and reach ranges should also be further analyzed.

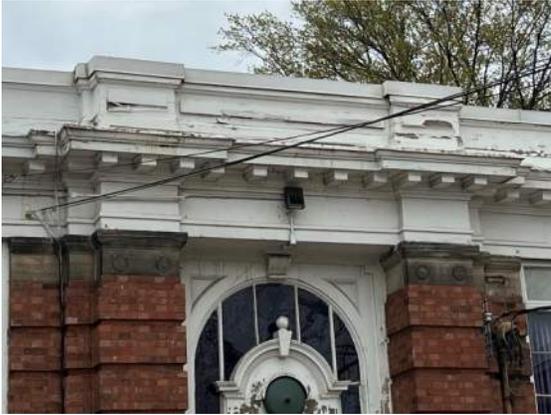
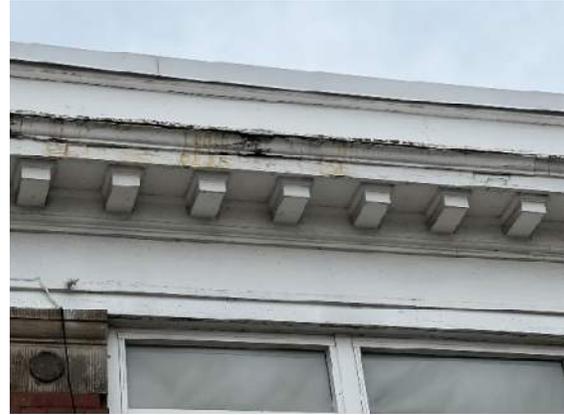
2. Cornice: A decorative cornice, as well as trim above and below the cornice, consists of painted wood at the top of the wall around the perimeter of the original building. The cornice projects out the face of the wall 12-inches with a decorative dentil below. (A dentil, which consists of rectangular blocks that are closely spaced, are typically installed directly below the projecting cornice to form a decorative band.) The paint was observed to have cracked, blistered, and peeled within the cornice and trim, exposing bare wood. Moisture accumulation has resulted in deterioration of the wood at isolated locations.

We recommend removal and replacement of the isolated portions of deteriorated and rotted wood, application of an epoxy hardener where it is soft, and cleaning and painting the wood cornice to extend its service life.

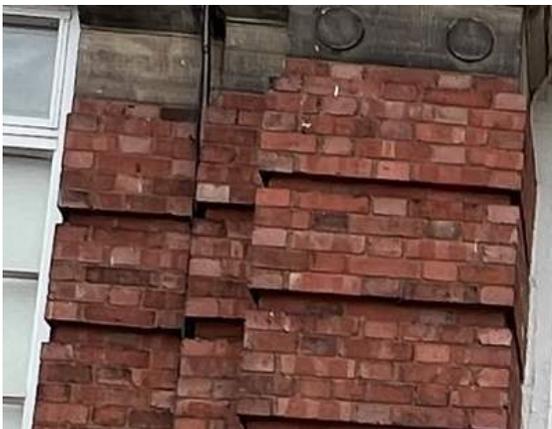
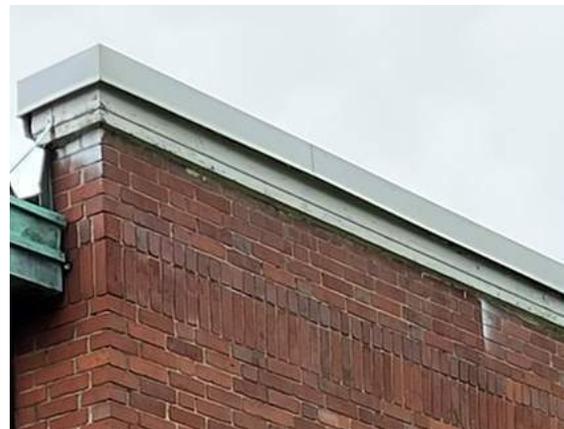
The multi-wythe masonry walls perform as a barrier system. (A barrier wall system is intended to prevent moisture penetration, as compared to a modern cavity/drainage wall system that allows water to penetrate but directs it back out of the exterior.) Efflorescence was observed on the exterior face of the brick masonry at isolated locations, particularly at the top of the walls, indicating moisture retention within the wall. (Efflorescence is the deposit of water-soluble salts, inherent in both the brick and mortar, on the surface due to evaporation of moisture within the masonry.) Additionally, vines were observed growing on the exterior brick masonry at isolated locations. The vines retain moisture against the exterior walls.

We recommend removal of any vines, as well as cleaning the brick masonry, and applying a clear water repellent sealer after completion of masonry repairs to minimize moisture penetration and freeze-thaw deterioration of the brick and to extend its service life. (Freeze-thaw deterioration is cracking and spalling caused by cyclic freezing and thawing. Water that is absorbed in the exterior wall material freezes, expands, breaks down the material, and then thaws leaving voids within the material.)

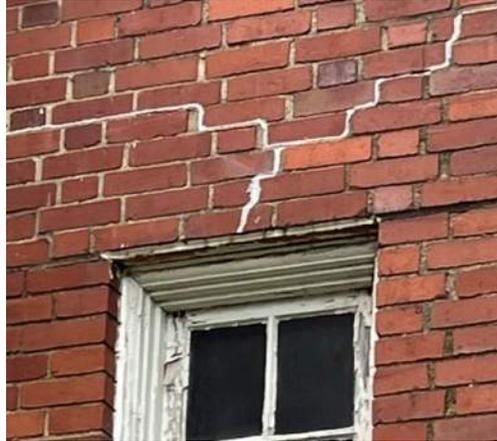
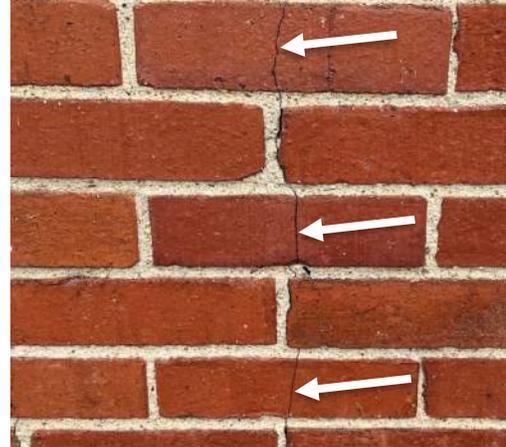
- a. Cracks & Spalls: The brick masonry was typically observed to be in overall good condition with moisture accumulation and deterioration at isolated locations. Cracking and displacement of the brick were observed at isolated locations, particularly due to corrosion of embedded steel or moisture expansion of the brick masonry. (When the clay material of the brick absorbs moisture, it expands. When it dries, the clay shrinks, but does not shrink entirely back to its original size. Over time, the brick continues to grow. In modern construction, brick expansion joints are installed to accommodate the moisture expansion. However, in historic multi-wythe masonry, brick expansion joints were not provided, and vertical cracks can result from moisture expansion.)

We recommend removal and replacement of brick masonry at the isolated areas of distress to minimize moisture penetration into the exterior walls and freeze-thaw deterioration of the masonry.

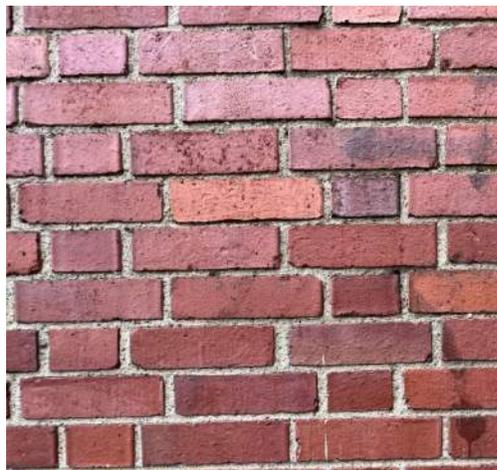
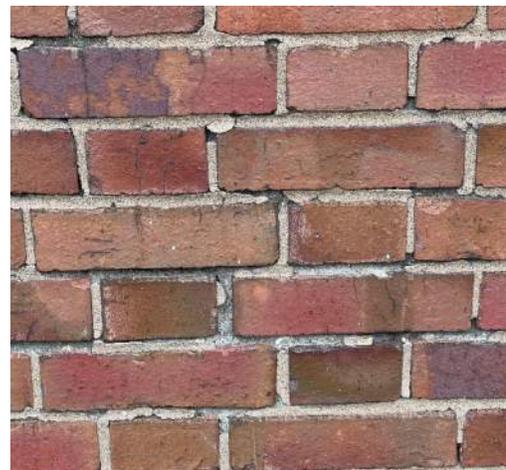
We observed evidence of previous mortar repointing at isolated areas. The repointed mortar is thin in profile and has cracked, lost bond, and contains voids revealing moisture staining and biological growth within the joint.

We recommend repointing weathered and deteriorated mortar joints to reduce water penetration into the exterior walls and potential subsequent freeze-thaw deterioration of the masonry. (Repointing is the process of the removal and replacement of mortar to a partial depth.) We recommend removal of the mortar to a minimum depth of ¾-inch and replacement with new mortar in ¼-inch deep lifts.

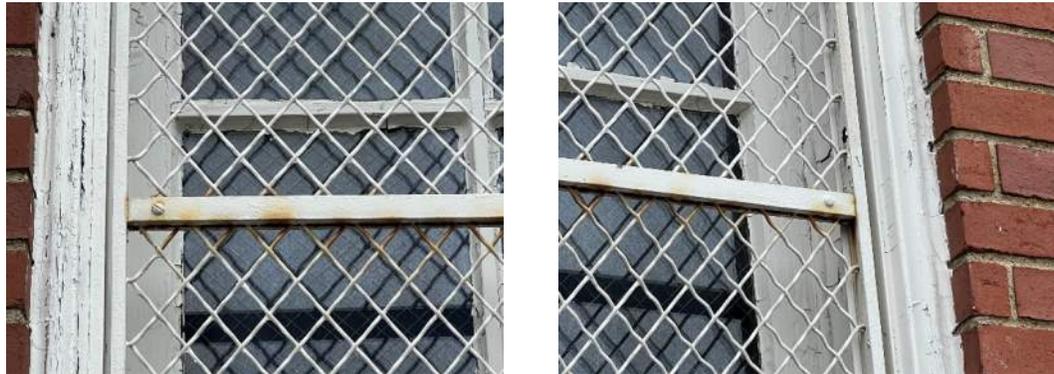
- b. Metal Grates: Painted steel grates are installed at three of the windows on the west elevation of the gym. The paint was observed to have cracked and peeled, and surface corrosion of the steel was observed.

We recommend removal and disposal of the metal grates during replacement or restoration of the windows. If the grates are desired for security or protection of the glass, we recommend replacement and installation of new at the additional west elevation windows. If budget constraints do not permit replacement, we recommend cleaning and painting the metal grates to extend their service life.

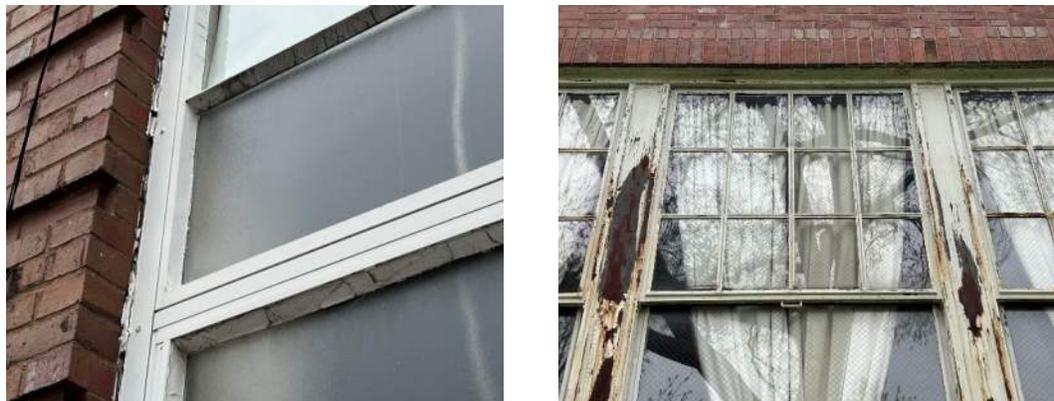
The paint on the frames of the metal windows within the addition has cracked, blistered, and peeled, and surface corrosion of the steel was observed. The perimeter joint sealant, which consists of urethane, has hardened, cracked, and lost bond to at isolated locations.

We recommend removal and replacement of the metal framed windows with new thermally broken windows that would improve the energy efficiency of the building. If budget constraints do not allow replacement, we recommend cleaning and painting the metal frames, removal, and replacement of the glazing putty with silicone wet sealant, as well as removal and replacement of the perimeter joint sealant with silicone.

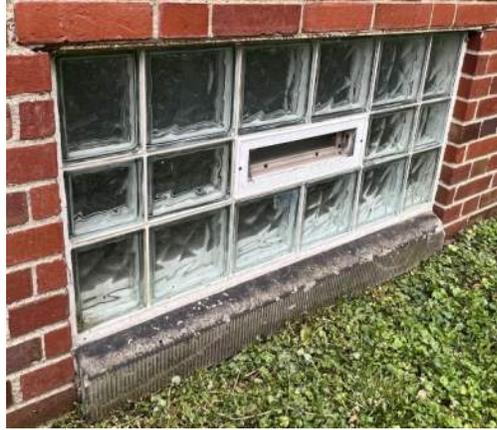
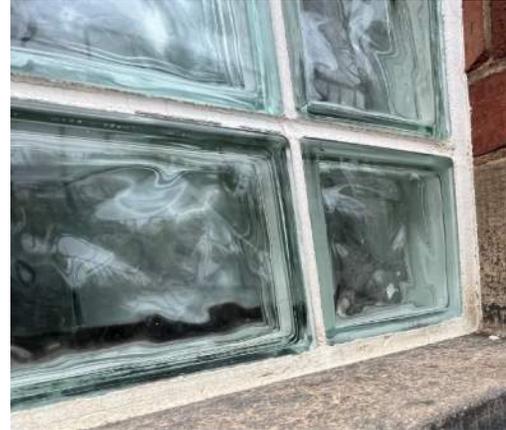
- d. Glass Block: Glass block has been installed within various basement windows within the original building and the addition. The glass block was observed to be in overall good condition; however, shrinkage cracks were noted within the mortar. Joint sealant is installed at the perimeter of the glass block windows. The urethane sealant was observed to have hardened, cracked, and to have lost bond at isolated locations.

We recommend repointing the mortar at isolated locations of deterioration within the glass block, as well as removal and replacement of the perimeter joint sealant with silicone.

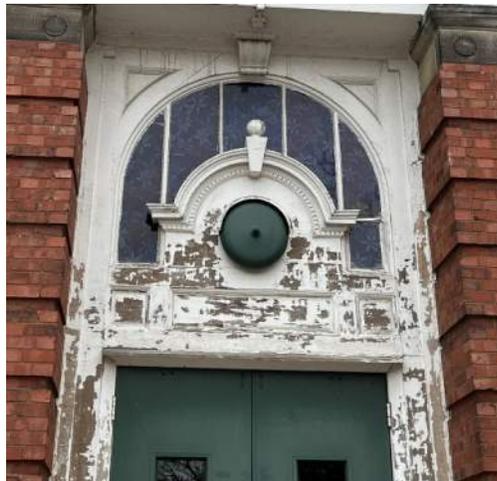
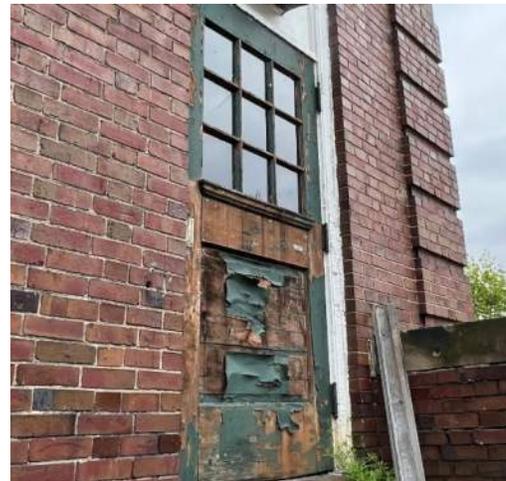
- e. Wood Doors: The doors within the original building and the addition consist of painted wood doors and frames. The paint was observed to have cracked, blistered, and peeled exposing bare wood. The perimeter joint sealant was observed to be urethane that has hardened, cracked, and lost bond at isolated locations.

To extend the service life of the existing doors, we recommend cleaning and painting the wood doors and frames, and removal and replacement of the perimeter joint sealant with silicone joint sealant. Alternatively, removal and replacement of the doors with new energy efficient doors could be performed.

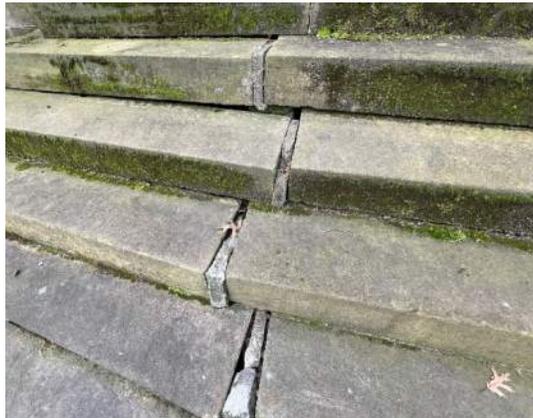
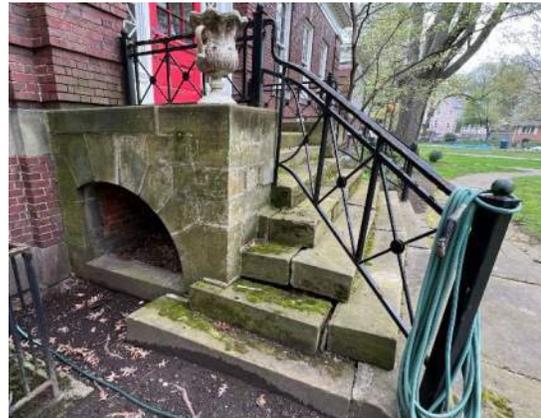
- a. Main Entry Stair: Stone stairs lead to the main entry doors at the west façade. The mortar head and bed joints within the stone treads were observed to have cracked, lost bond and to contain voids at isolated locations; settlement of the treads at the center of the stair has resulted in opening of the head joints. Stone barrier walls are located on each side of the stair. The mortar joints within the barrier walls were observed to have cracked, lost bond, and to contain voids at isolated locations. Moisture accumulation has caused staining and development of biological growth throughout the treads and barrier walls. The railings consist of painted wrought iron with base plates anchored to the stone. We observed blistering and peeling of the paint, and surface corrosion, at isolated locations, particularly at the base of the posts.

We recommend the following repairs within the main entry stairs:

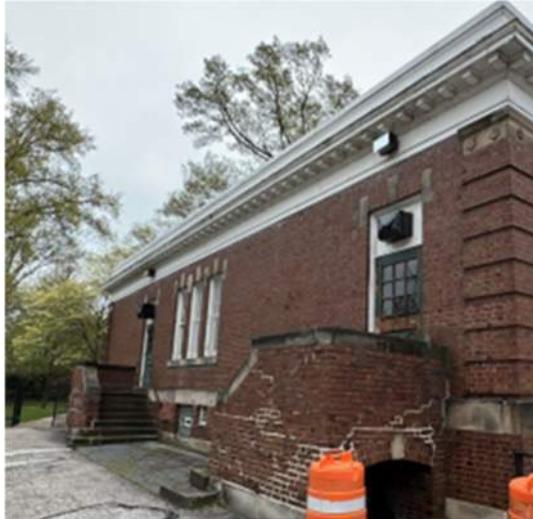
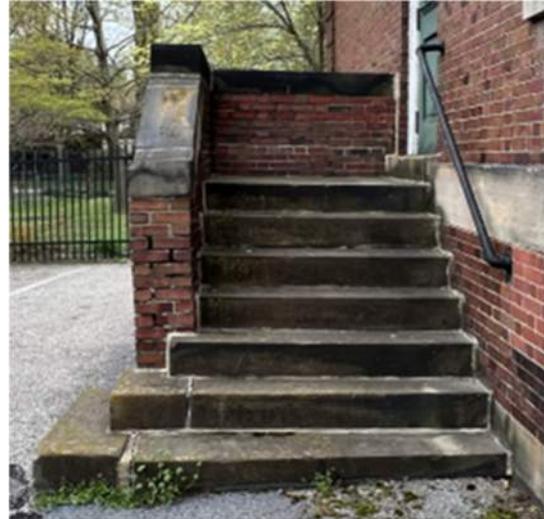
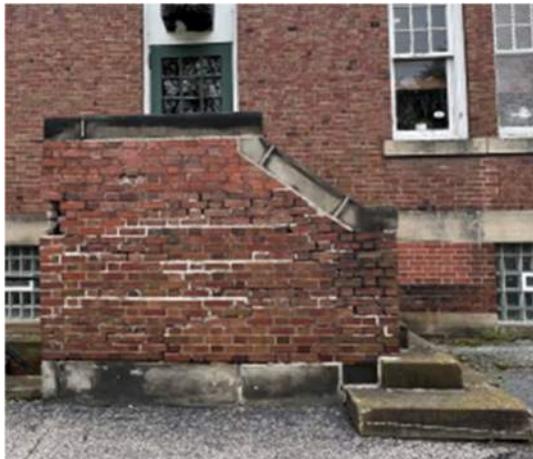
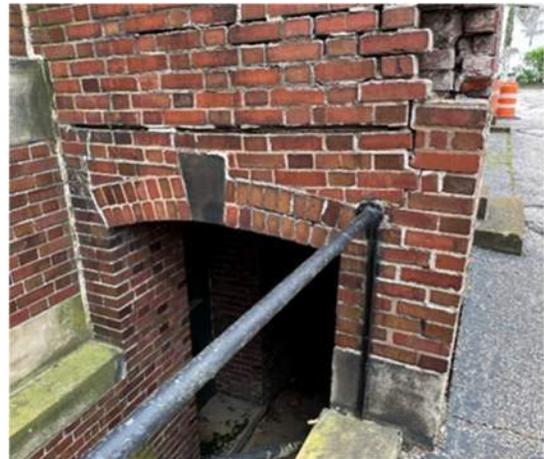
The mortar within the coping head and bed joints have cracked, providing a direct path for moisture to penetrate the barrier walls. Accumulation of moisture has resulted in cracking, spalling, and displacement of the brick masonry at both stairs.

We recommend removal and reconstruction of the west exterior stairs and masonry barrier walls with installation of through-wall flashing below the copings to minimize moisture penetration into the masonry.

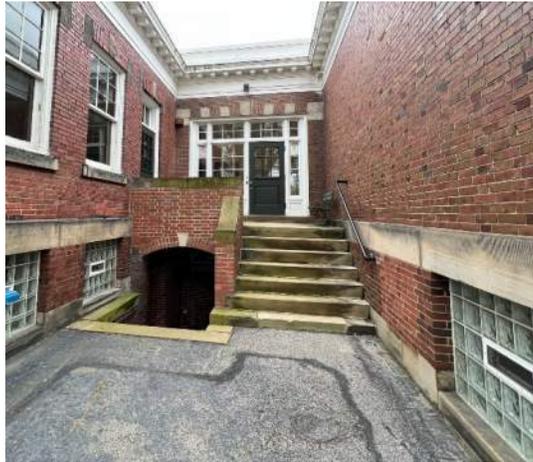
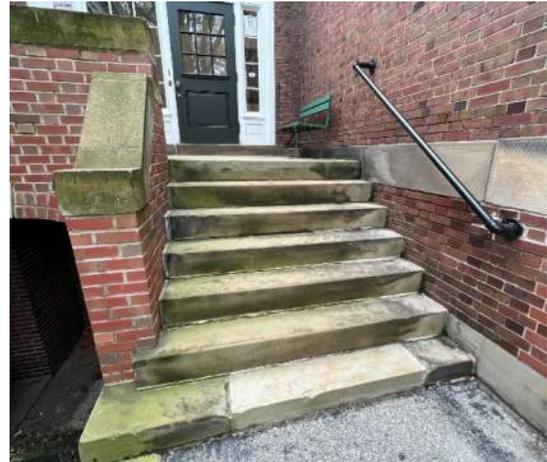
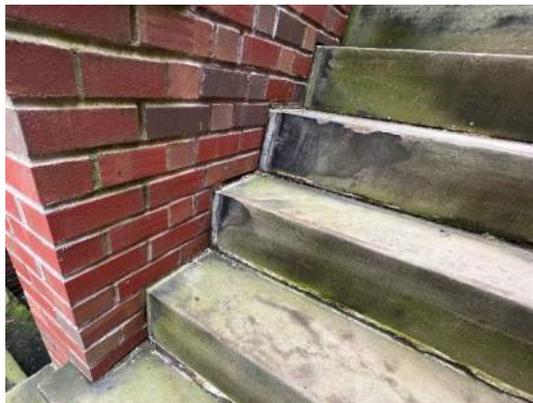
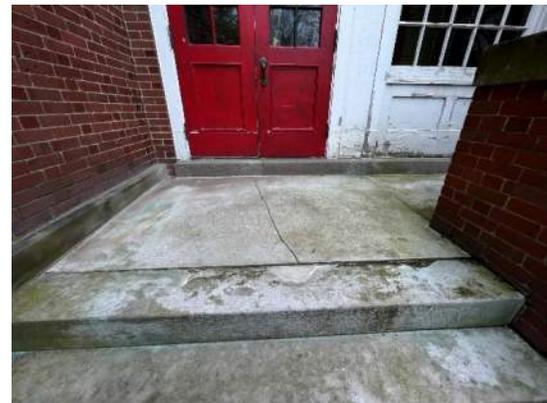
- c. Exterior Stone Stairs: Two additional stone stairs leading to the 1st Floor are located on the north elevation of the original building. The stair consists of stone treads and landing with a perimeter multi-wythe brick masonry barrier wall capped with sandstone copings. Moisture accumulation, cracks, cracks, and spalls were evident within the stone. The mortar joints within the stone treads were observed to have cracked, lost bond and to contain voids at isolated locations. The handrails consist of painted steel pipe rails anchored to the exterior masonry walls of the building.

We recommend the following repairs at the exterior stone stairs:

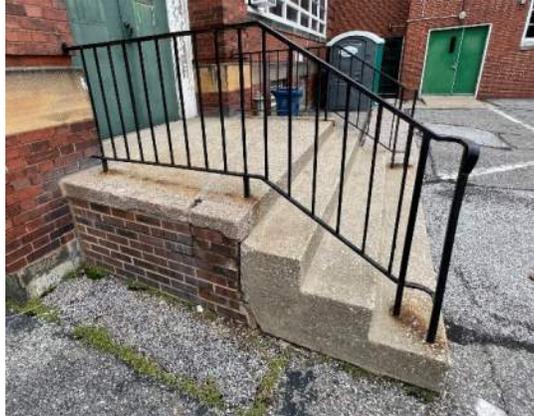
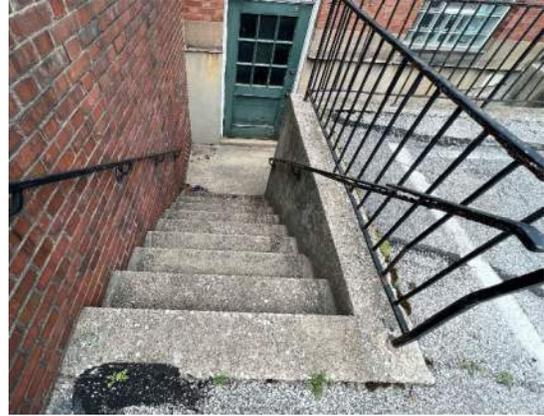
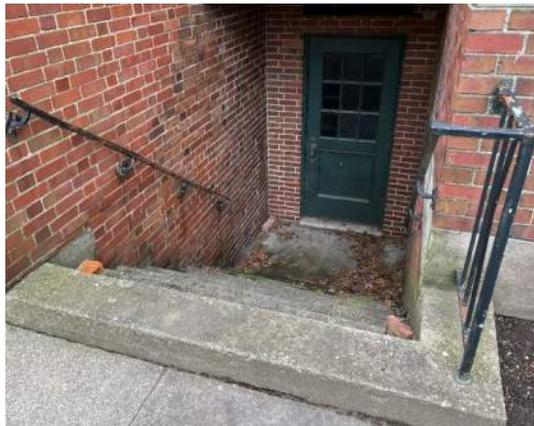
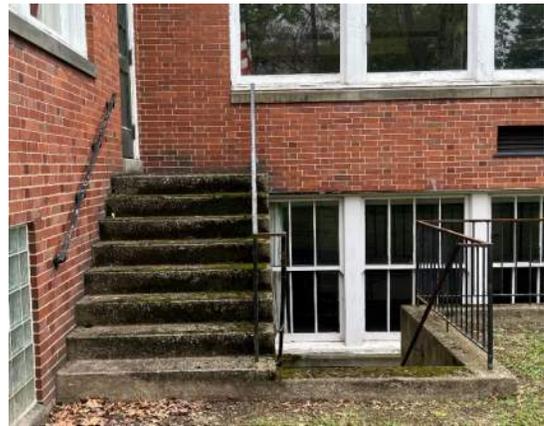
- d. Cast-in-Place Concrete Stairs: Exterior cast-in-place concrete stairs providing access to the 1st Floor are located on the south elevation of the original building and the north elevation of the addition. Additional cast-in-place concrete stairs provide access to the basement on the north and west elevations of the original building and the north elevation of the addition. Staining and biological growth are evident within the cast-in-place concrete due to moisture accumulation as well as corrosion of the embedded wrought iron railings. Cracks and spalls we observed at isolated locations due to freeze-thaw deterioration as well as corrosion of the embedded railings. Cracking, peeling, and blistering of the paint has also resulted in surface of the wrought iron at isolated locations.

We recommend the following within the exterior cast-in-place concrete stairs:

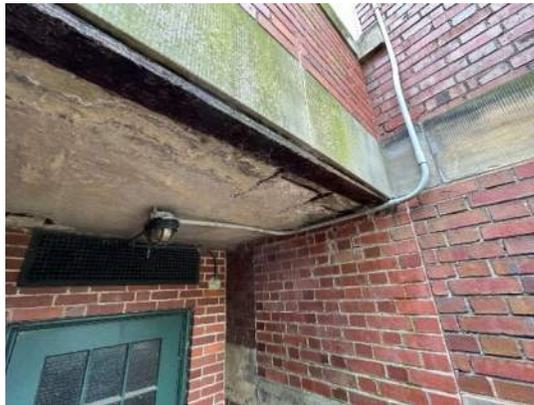
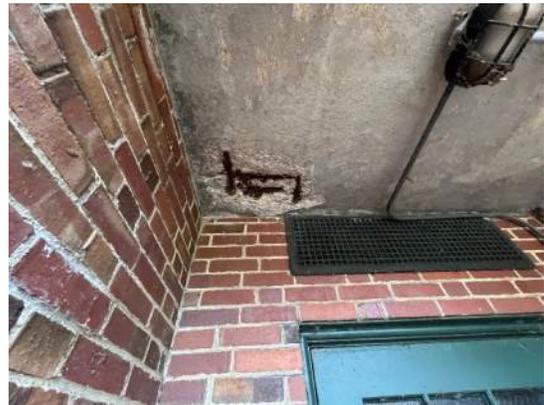
- e. Exposed Concrete: The underside of the structural slab at the secondary stone stairs is exposed. Cracks, delaminations, and spalls were observed within the concrete due to corrosion of the embedded steel reinforcement.

We recommend removing loose material, sawcutting the perimeter of the repair areas, cleaning and coating the embedded steel with a corrosion inhibitor and performing concrete patch repairs at the isolated locations of deterioration. If a uniform appearance is desired, we recommend applying a breathable stain to the ceiling of the walkway/arcade so as not to trap moisture within the concrete.

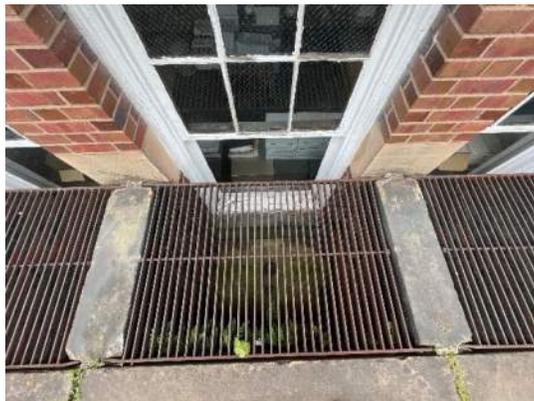
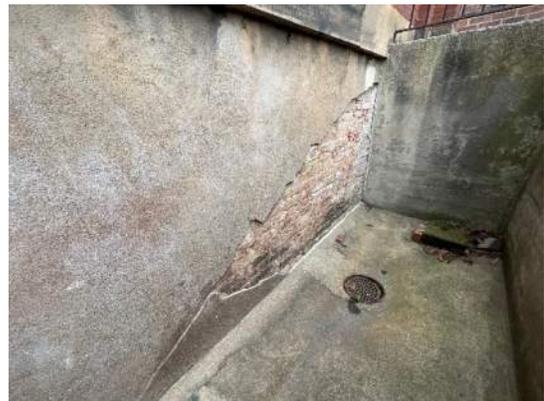
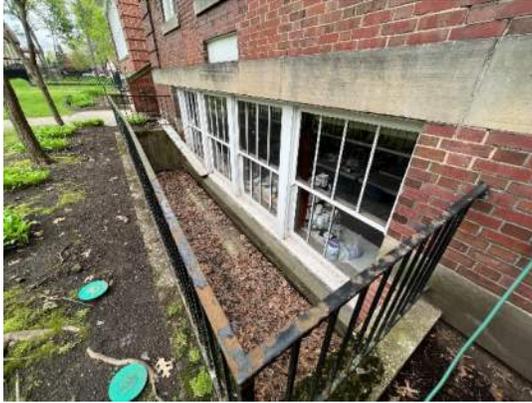
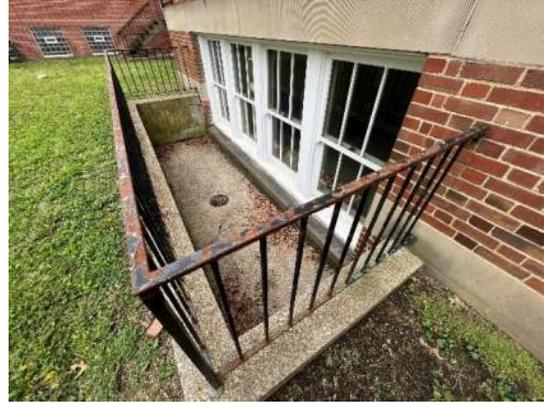
The floor of the window wells consists of a continuous cast-in-place concrete slab-on-grade. The top of the slab was observed to be located one brick course below the basement sandstone sills. Joint sealant is not installed at the perimeter cove joint. A single drain was typically observed within the window wells.

We recommend the following within the window wells:

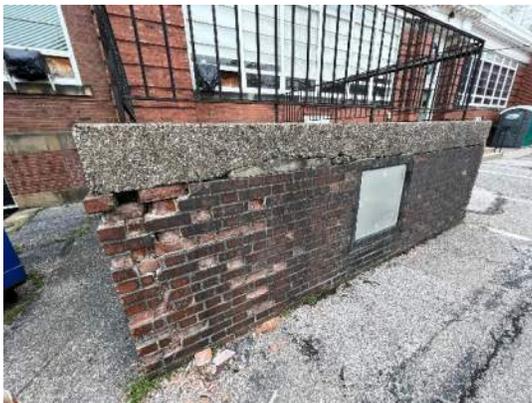
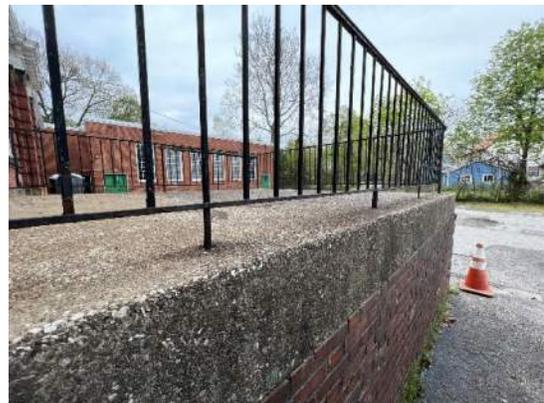
Moisture penetration and accumulation has resulted in freeze-thaw cracking and spalling of the brick masonry and mortar below the slab.

We recommend the following within the exterior platform:

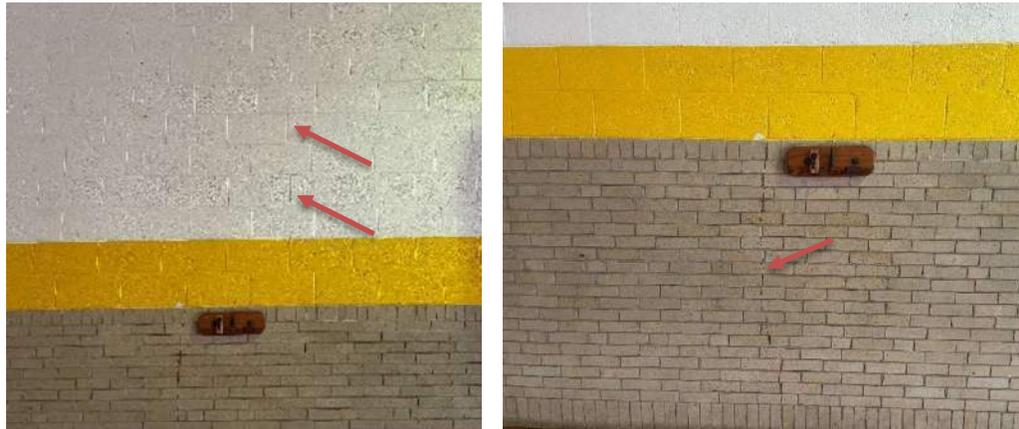
- a. Vertical Cracks were observed in the CMU and Brick masonry Gym walls at isolated locations. The vertical cracks were observed on the interior of the structure.

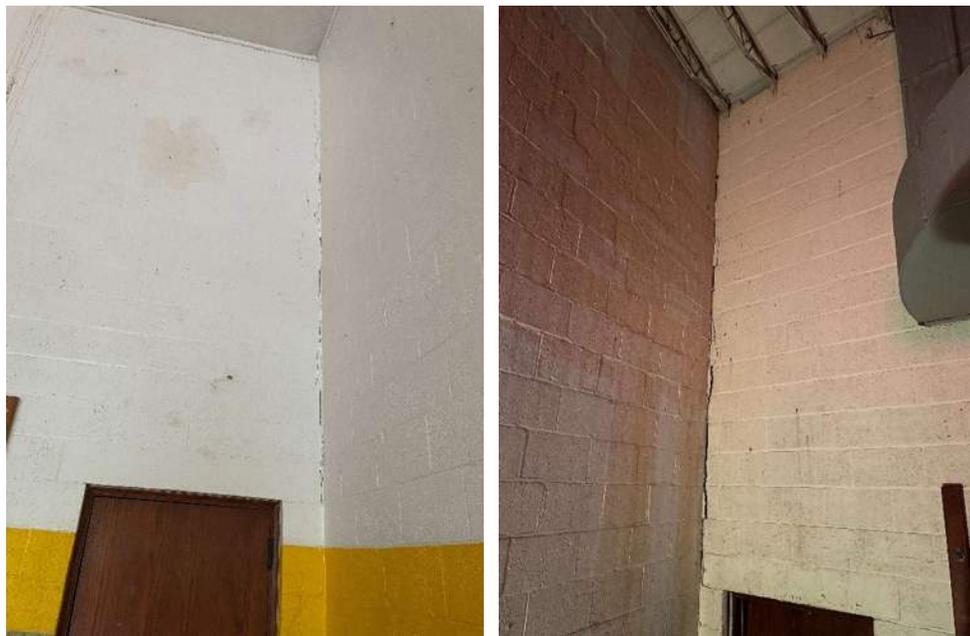
- c. An interior CMU wall separates the gym and stage areas. At the intersection of the interior wall and the west exterior wall a wide crack is present on both sides.
