VILLAGE OF BRATENAH  
VILLAGE CENTER  
FEASIBILITY STUDY

## 2022 Bratenahl Condition Assessments

### Bratenahl Center – Facade Observations & Recommendations

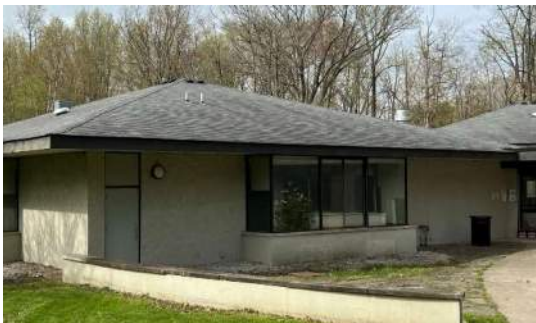
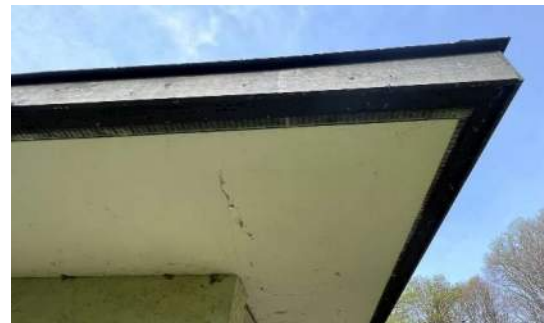
1. Asphalt Shingled Roofs: The roof consists of high-sloped hipped asphalt shingled roofs that were observed to be in overall fair condition. The shingles extend approximately 2-inches past the edge of the roof; we did not observe a drip edge, gutters, or downspouts. A sheet metal diverter is installed at the base of the roof over the main entrance to direct the water to the adjacent hipped roofs to drain off their edges. The roofs are vented with 2-inch-wide continuous soffit vents as the intake, and two box vents at the top of each hip as the exhaust.

We recommend removal and replacement of the asphalt shingle roof. During replacement, we recommend installation of a drip edge to facilitate shedding of water off the fascia and, although it will alter the aesthetics of the building, potential installation of gutters and downspouts to drain the water. Additionally, we recommend performing calculations to confirm that the roof ventilation is sufficient.

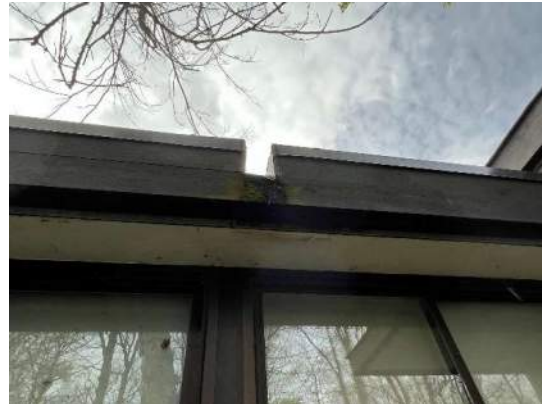
2. Low-Sloped Membrane Roof: The footprint of the building consists of four rotated rectangular sections, with hipped roofs, with a central connection. The roof of the central section consists of a low-sloped roof membrane. The original design drawings indicate a built-up roof with gravel ballast. We were unable to review the roof membrane, but from satellite photographs it appears to consist of an SBS modified bitumen roof membrane. A scupper is located on the northwest elevation for drainage directly off the roof; a drip edge or downspout are not provided.

We recommend review of the low-sloped membrane roof for replacement. It is our understanding that leaks are occurring into the interior of the building within the low-sloped roof.

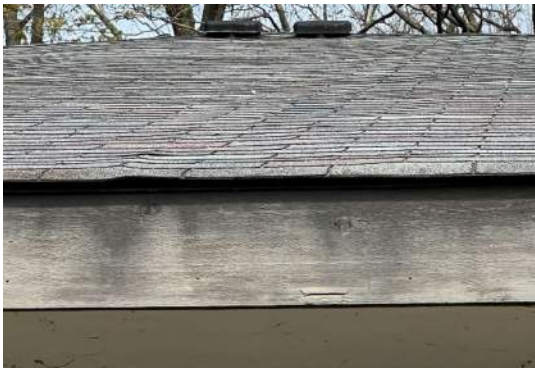
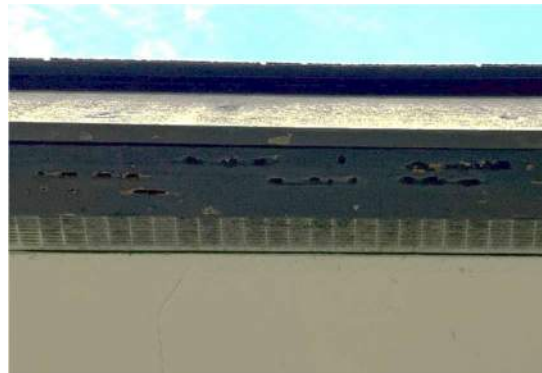
3. Wood Fascia: A 1x12 stained wood fascia is located at the base of the roof around the perimeter of the building at both the hipped roofs and the central low-sloped roof. The fascia was observed to have weathered and the stain has cracked, blistered, and peeled at isolated locations. Additionally, bugs have burrowed holes within the wood fascia at isolated locations around the perimeter of the building.

We recommend removal and replacement of any isolated portions of deteriorated and damaged wood, application of an epoxy hardener where it is soft, and cleaning and staining the wood fascia to extend its service life.

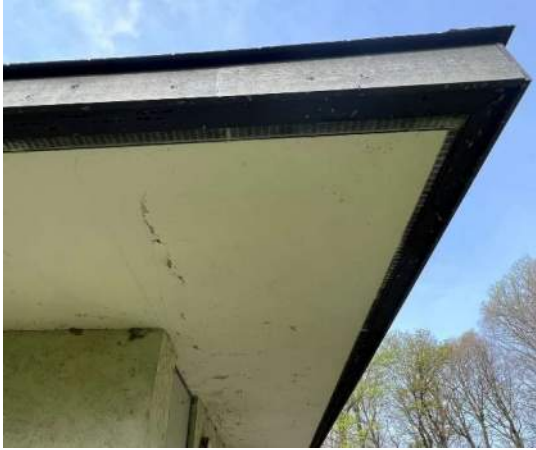
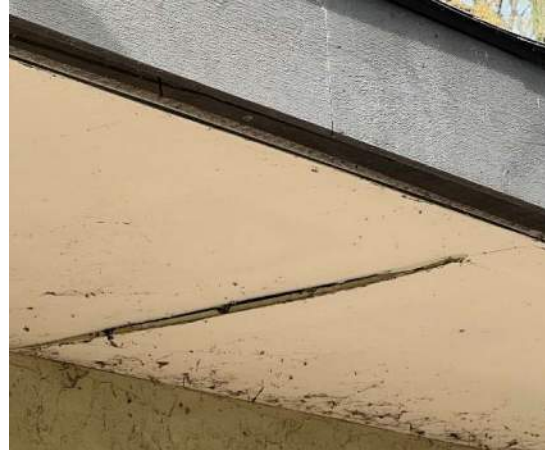
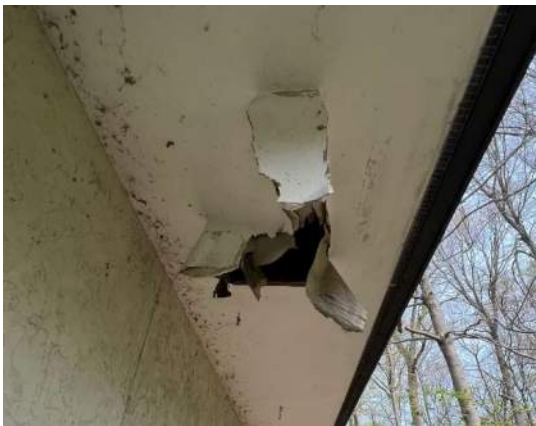
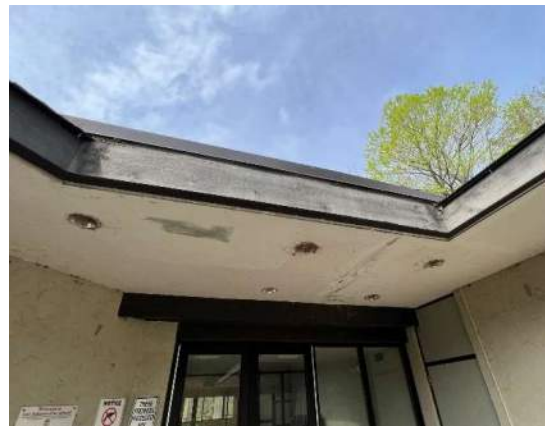
4. Soffit: The soffit around the perimeter of the hipped roofs consists of painted exterior gypsum sheathing. Cracking and displacement/sagging was observed between adjacent panels, particularly at the corners of the building. Blistering and peeling of the paint, moisture damage, as well as holes within the soffit sheathing, were observed at isolated locations due to leaks/moisture.

We recommend removal and replacement of the soffit, potentially with a new sheet metal or composite soffit system, or with new exterior sheathing with a waterproof coating. If budget constraints do not allow replacement of the soffit, we recommend replacement of damaged portions and cleaning and painting of the existing soffit to extend its service life.

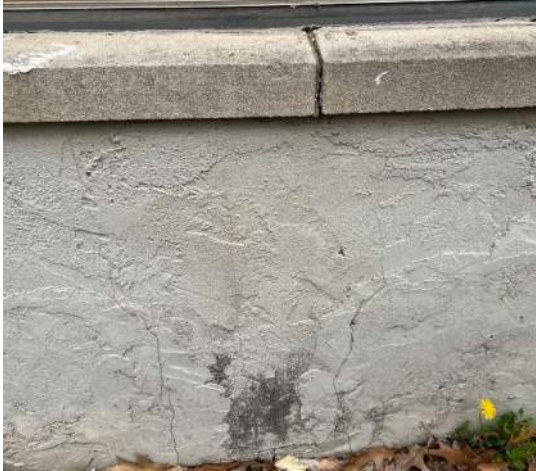
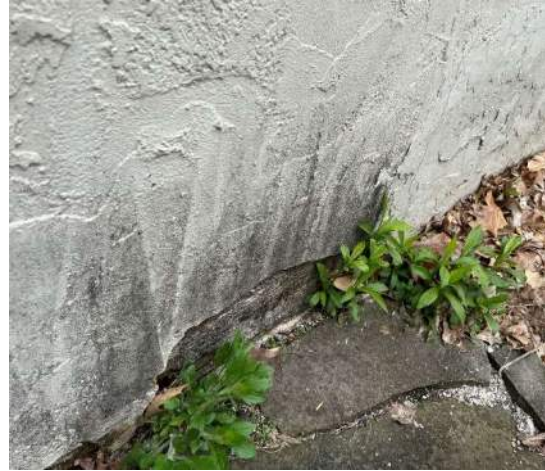
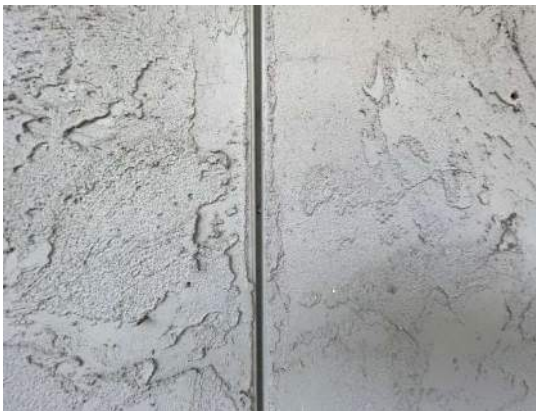
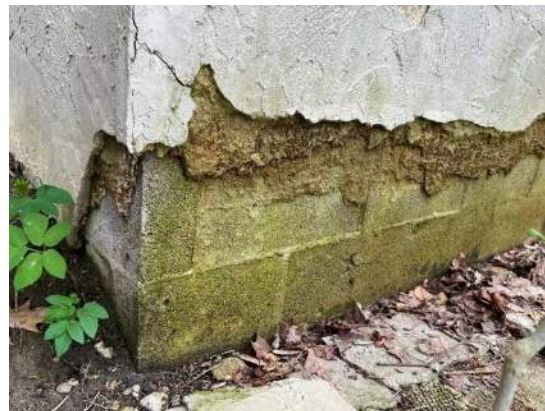
5. Exterior Stucco: The exterior walls consist of exterior stucco applied to the load-bearing concrete masonry walls. Reveals/control joints, intended to “control” shrinkage cracking of the cementitious coating, are provided in the stucco within longer lengths of walls, spaced approximately 8-feet on center. However, vertical cracks were observed within the stucco at isolated locations.

The stucco is applied the full height of the building; cracks, delaminations, and spalls were observed within the stucco, particularly at the base of the walls where moisture due to rain and snow could wick up the wall. The accumulation of moisture resulted in both freeze-thaw deterioration of the stucco and corrosion of its embedded metal lath. (Freeze-thaw deterioration is cracking and spalling caused by cyclic freezing and thawing. Water that is absorbed in the exterior wall material freezes, expands, breaks down the material, and then thaws leaving voids within the material.)

Spalls revealed that the stucco is approximately 1-inch thick. Within the spalled area, we observed evidence of very few fasteners for the metal lath to the concrete masonry (approximately three fasteners in a 50 to 60 square foot area). Within the spalled material, the lath, which was located within the center of the thickness of the stucco, was observed to be corroded. Previous patch repairs were performed at isolated locations; shrinkage cracks were observed within the patches.

The exterior stucco walls perform as a barrier system. (A barrier wall system is intended to prevent moisture penetration, as compared to a drainage wall system that would allow water to penetrate but would direct it back out of the exterior.) Repair and waterproofing of the stucco will be required as ongoing maintenance. We recommend the following within the exterior stucco:

- Removal of loose material and patching the stucco at cracks, delaminations, and spalls.
- Installation of additional reveals/control joints within the stucco.
- Removal of the stucco at the base of the walls for installation of new sheet metal flashing/weep screed. (Industry standards recommend maintaining the base of the stucco 4-inches minimum above grade, requiring installation of a waterproof membrane at the base of the concrete masonry backup.)
- Cleaning of the stucco and coating with a breathable elastomeric coating.
- Installation of silicone joint sealant within the reveals/control joints. We recommend use of silicone joint sealant, which has an anticipated service life of 20 years if properly installed, versus the 5 to 7-year anticipated life of urethane.

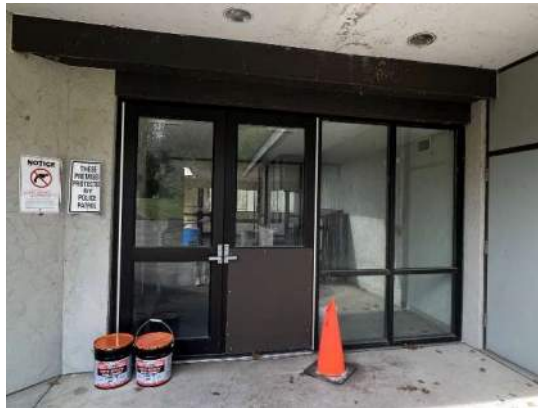
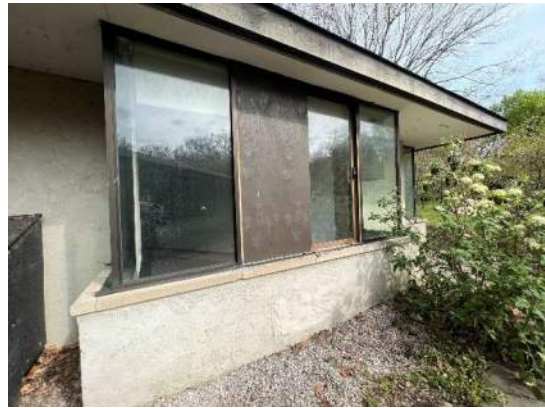
a. Broken Glass: Broken panes of glass, which have been infilled with plywood, were observed at isolated windows and storefronts.

We recommend replacement of the broken panes of glass or replacement of the window units.

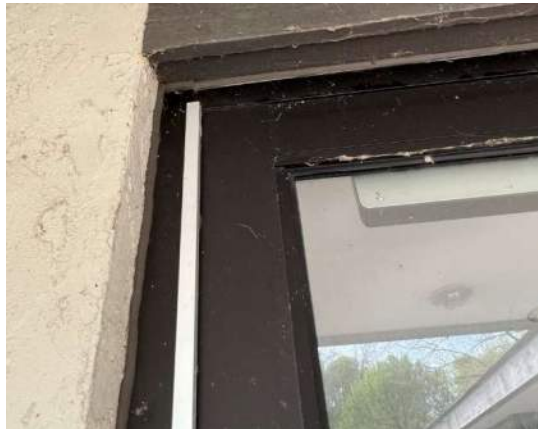
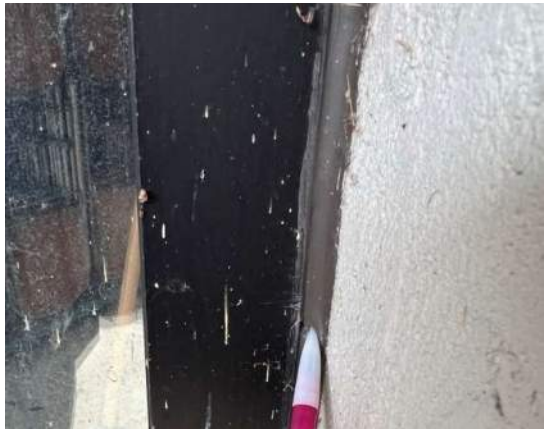
b. Perimeter Joint Sealant: The joint sealant at the perimeter of the windows and storefronts, as well as at miscellaneous wall penetrations, was observed to consist of urethane joint sealant that is thin in profile, has hardened, crazed, and lost bond at isolated locations.

We recommend removal of the existing joint sealant at the perimeter joints, and replacement with silicone joint sealant.

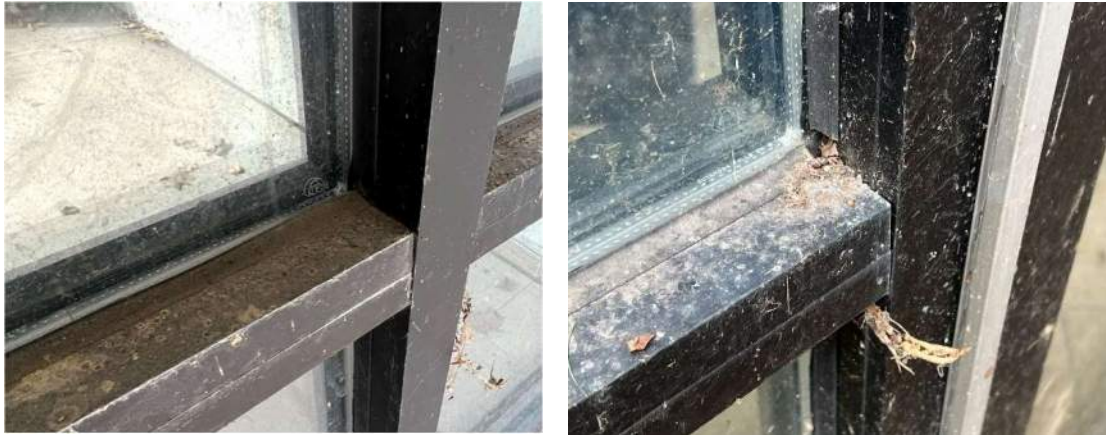
- c. Glass-to-Metal Wet Sealant: The gaskets within the windows and storefronts, providing the seal at the perimeter of the glazing, have hardened, and have begun to shorten.

We recommend installation of silicone glass-to-metal wet sealant at the perimeter of the glazing to minimize moisture penetration into the storefront window system.

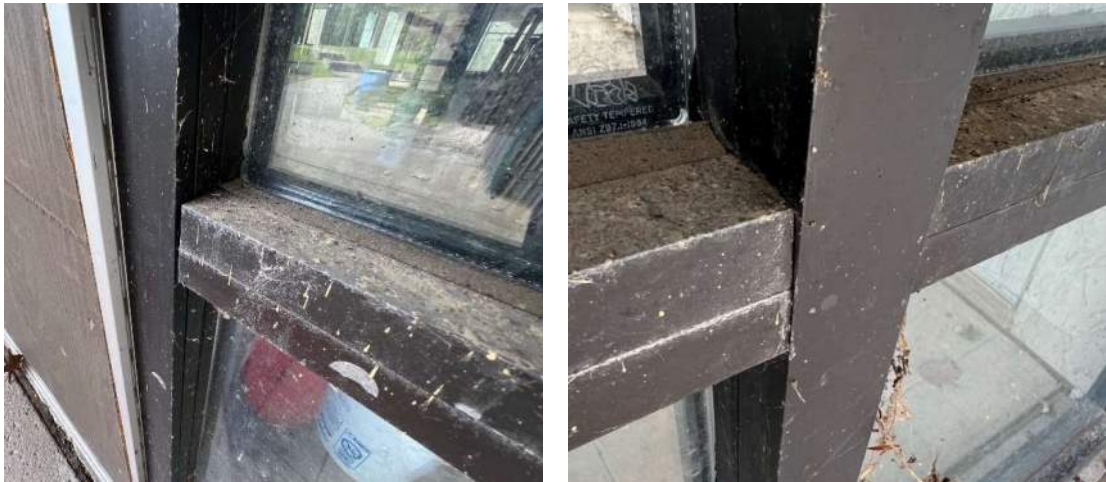
- d. Preformed Silicone Seals: Gaps were noted at intersections of the frame between the horizontal and vertical frame members within the storefront windows.

We recommend installation of preformed silicone seals at the joints within the frames to minimize moisture penetration into the system.

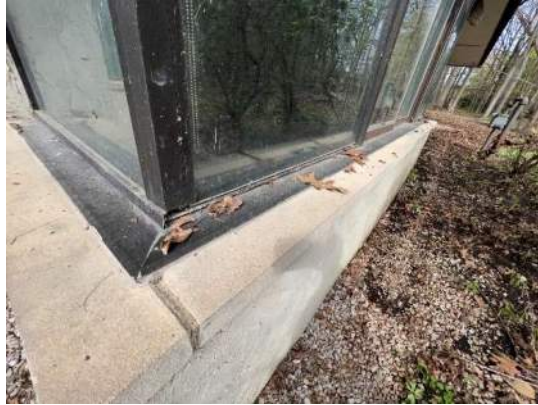
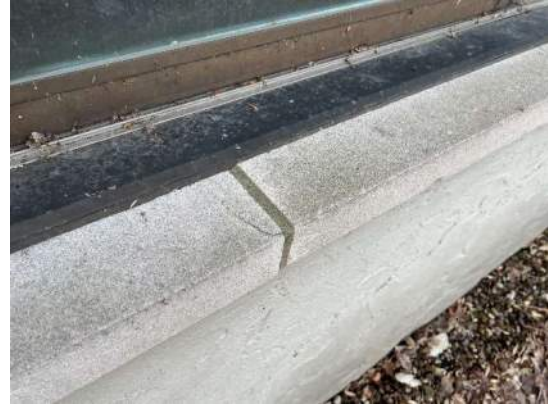
- e. Cast Stone Sills: The windowsills consist of cast stone. The cast stone is in overall good condition, with cracks at isolated locations. The mortar within the head (vertical) and bed (horizontal) joints was observed to have weathered and to have cracked and lost bond at isolated locations. We did not observe evidence of subsill flashing.

We recommend the following waterproofing repairs within the cast stone sills:

- Removal of loose material and patching the cracks within the cast stone.
  - Repointing the mortar head and bed joints. We recommend raking back the head joints to allow for the installation of backer rod and silicone joint sealant.

- Cleaning the cast stone and application of a clear water repellent sealer, to minimize moisture penetration into the cast stone and freeze-thaw deterioration.

- If the Owner elects to remove and replace the windows, we recommend removal and reinstallation of the cast stone windowsills to allow for installation of sheet metal subsill flashing.

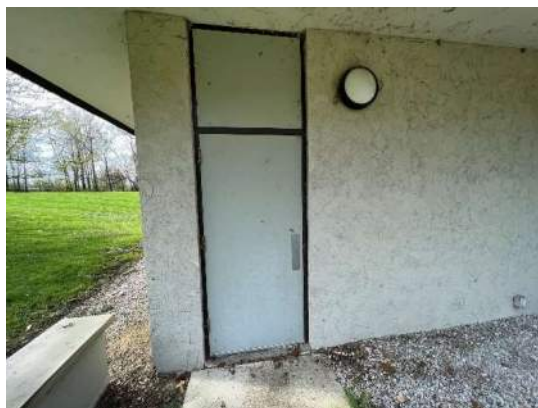
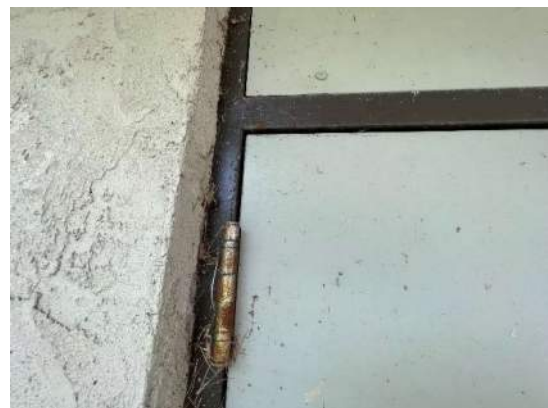
- f. Metal Doors: The doors consist of painted metal doors and frames. The frames, which extend to the soffit, are infilled with sheet metal panels installed as transoms over the doors and as wall panels at additional infilled door locations. The metal doors, frames, and metal panels are in overall good condition, with outward displacement of the metal panels observed at isolated locations. The paint has weathered and has cracked, blistered, and peeled at isolated locations. We observed surface corrosion of the exposed metal, as well as of the exposed door hinges.

The door frames were installed tight to the stucco walls. The urethane joint sealant at the perimeter of the frames was observed to be thin in profile, to have hardened, and to be typically concealed by paint.

We recommend cleaning and painting the metal doors, frames, and sheet metal infill panels, as well as removal and replacement of the joint sealant with silicone at the perimeter of the frames.

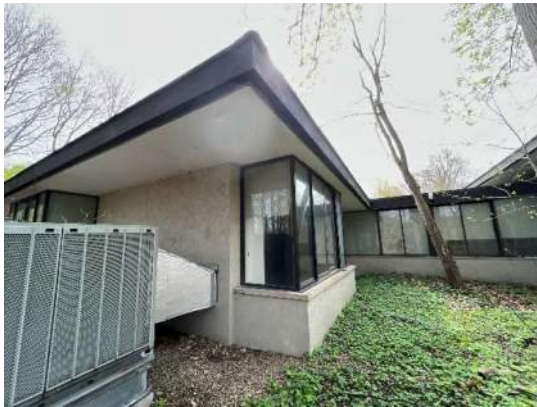
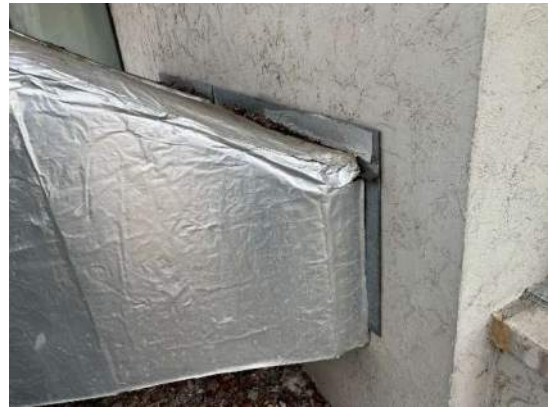
- a. MEP Penetrations: Ductwork, from adjacent exterior mechanical units, penetrates the exterior stucco walls on the north and northwest elevations of the building. We did not observe flashing at the penetration into the exterior wall.

We recommend installation of sheet metal counter-flashing at the penetrations of the mechanical ductwork into the exterior stucco walls, as well as installation of silicone joint sealant at the joint above the counter-flashing.

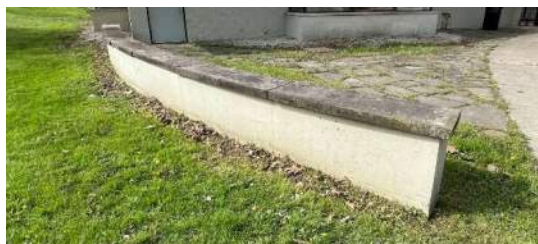
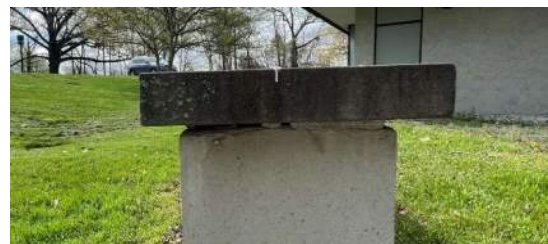
- b. Exterior Barrier Walls: Exterior barrier walls are located at the main entry, one each side of the sidewalk. The walls are constructed of concrete masonry, coated with exterior stucco, with cast stone copings. The mortar joints within the copings were observed to have cracked, lost bond, contain voids, or to be missing at various locations, and isolated coping units have displaced, providing direct paths for moisture penetration into the barrier wall. Through-wall flashing was not observed below the copings.

We recommend the following repairs within the exterior barrier walls:

- Removal and reinstallation of the cast stone copings to allow for installation of sheet metal through-wall flashing. We recommend reinstallation of the copings in full mortar head and bed joints, with head joints raked back to allow for the installation of backer rod and silicone joint sealant.

- Removal of loose material and patching the stucco at cracks, delaminations, and spalls.
- Installation of reveals/control joints within the stucco.
- Removal of the stucco at the base of the barrier walls for installation of new sheet metal flashing/weep screed. (Industry standards recommend maintaining the base of the stucco 4-inches minimum above grade, requiring installation of a waterproof membrane at the base of the concrete masonry backup.)

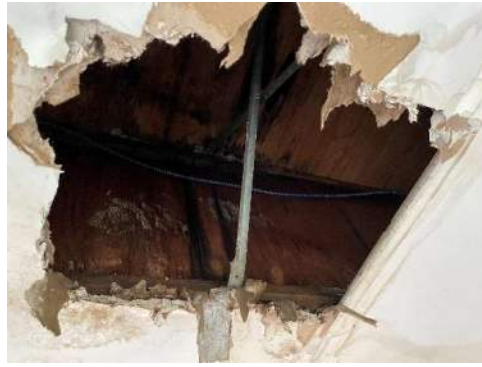
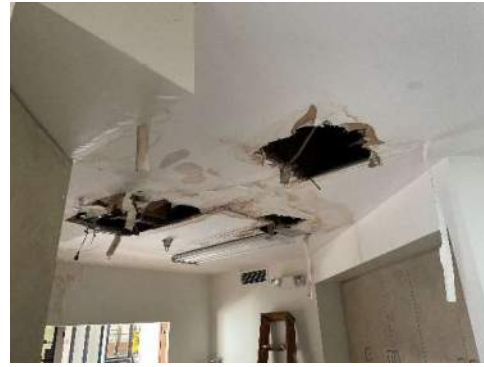
- a. Extensive roof leaks exist at the flat roof above the entrance lobby and kitchen area. The roof structure in this area was observed to be wood I-joists. The moisture from the roof leaks has saturated the wood. Wood I-joists typically have plywood webs. Moisture can decrease the strength of the webs.

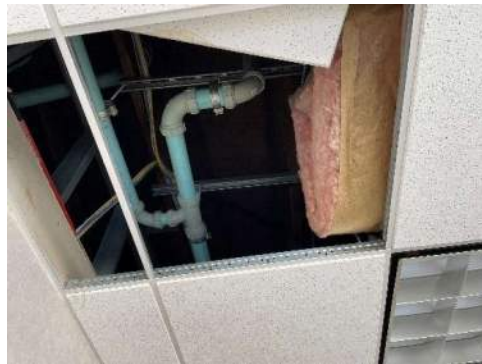
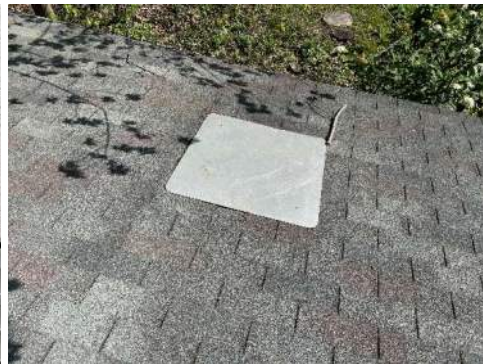
- b. Several roof leaks were observed throughout the areas of the building with wood trusses and plywood roof sheathing. Roof sheathing observed to be moisture stained.

- b. Damaged roof sheathing should be replaced. This will keep the wood trusses in good condition and maintain the stability of the trusses. In conjunction with review of the structure for an increased risk category the roof sheathing thickness should be increased as required to support increased seismic loading.

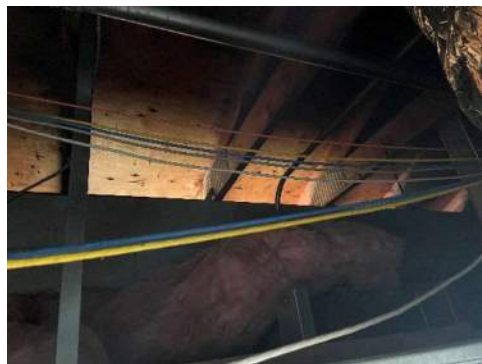
- d. At one location on the north side of the building a hole through the roof sheathing was observed. The hole in the roof sheathing is above the perimeter soffit.

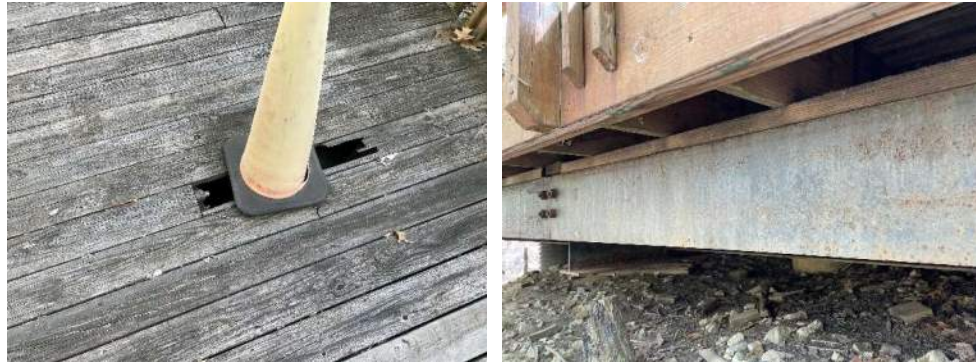
- e. The southwest side of the building has an exterior deck framed with wood joists over steel girders on drilled pier foundations. The deck floorboards were observed to be weathers, rotted at some locations, and missing at one location.

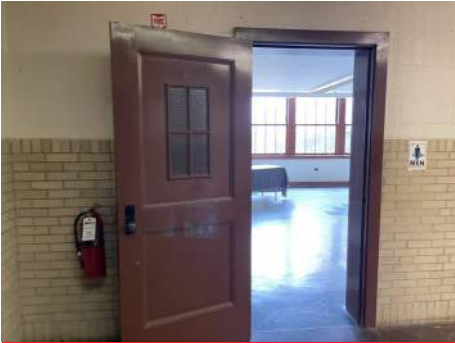
The existing stairs are non-code compliant. Thus, both the basement and Level 1 are not provided with adequate emergency egress at this time.

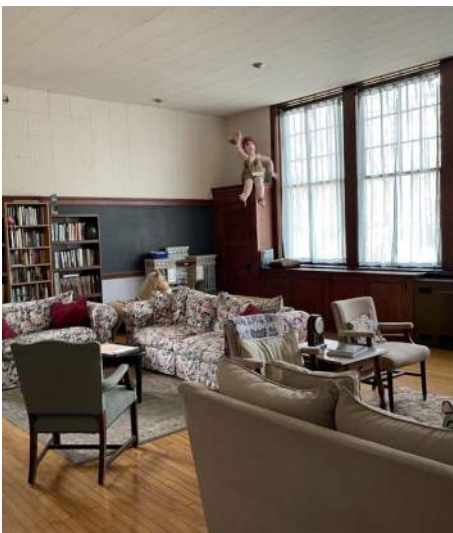
An adequate number of accessible parking spots are located on the site for the current amount of spaces required. However, if additional parking spaces were added additional accessible parking spots would be required. There is currently no accessible access to the first floor or basement of the building. All entrances from the public way require the traversing of stairs up from grade level to first floor level or down to the basement.

Internal circulation for the building includes multiple level changes, all traversed via non-accessible stairs.

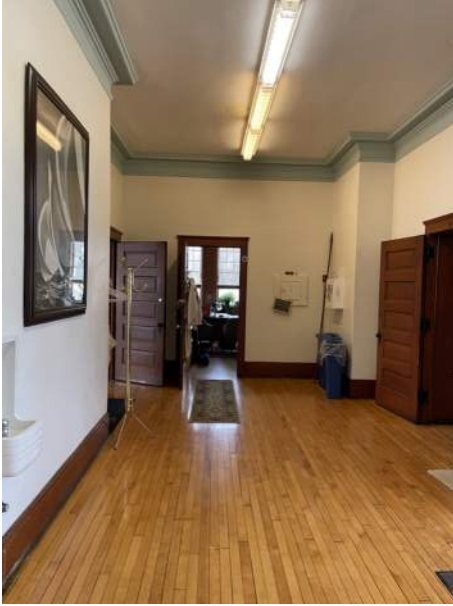
1. Several Door handles are non-compliant knob type and should be switched to a type not requiring tight grasping, pinching, or twisting of the wrist.
2. The internal stairs of the building do not meet standards. The width is not adequate and handrails at internal stairs do not provide the proper extensions at top and bottom of stairs
3. No ADA drinking fountains were observed.
4. Most of the building’s restrooms do not appear to meet ADA requirements for clearances, turning radius requirements and grab bars.

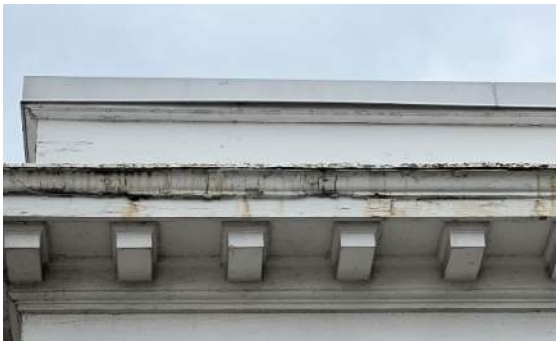
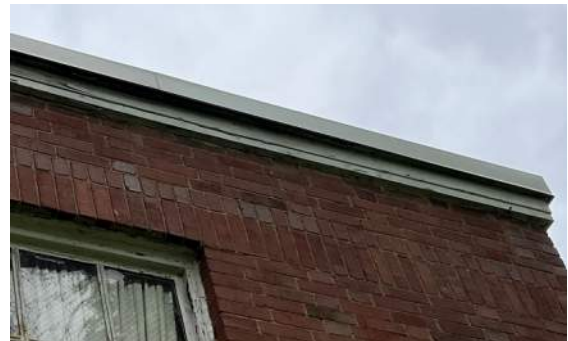
1. Sheet Metal Copings: Sheet metal copings cap the top of the exterior walls around the perimeter of the building. A drip edge is provided within the coping to facilitate shedding of water way from the vertical face of the wall. Concealed splices are provided between adjacent sections of sheet metal within the coping. It appears that the cleats that secure the coping to the exterior wall are widely spaced as the vertical face of the coping was observed to displace inward and outward.

We recommend removal and replacement of the sheet metal copings. The copings should be secured to the exterior wall with cleats that are 4-inches wide, minimum, and spaced 12-inches on center, maximum, or are continuous around the perimeter of the roof.

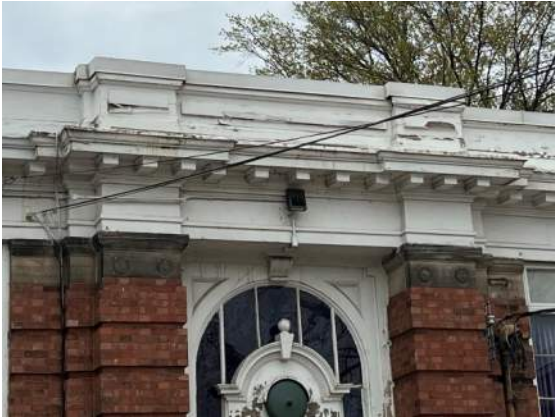
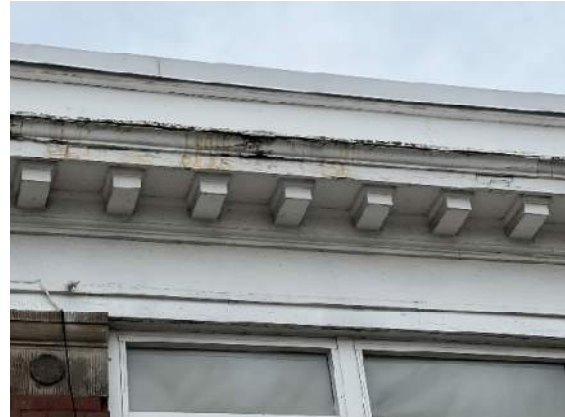
2. Cornice: A decorative cornice, as well as trim above and below the cornice, consists of painted wood at the top of the wall around the perimeter of the original building. The cornice projects out the face of the wall 12-inches with a decorative dentil below. (A dentil, which consists of rectangular blocks that are closely spaced, are typically installed directly below the projecting cornice to form a decorative band.) The paint was observed to have cracked, blistered, and peeled within the cornice and trim, exposing bare wood. Moisture accumulation has resulted in deterioration of the wood at isolated locations.

We recommend removal and replacement of the isolated portions of deteriorated and rotted wood, application of an epoxy hardener where it is soft, and cleaning and painting the wood cornice to extend its service life.

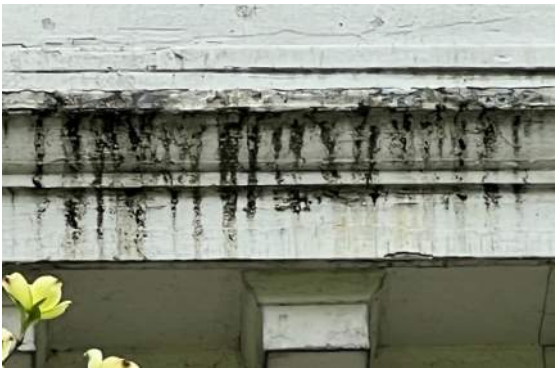
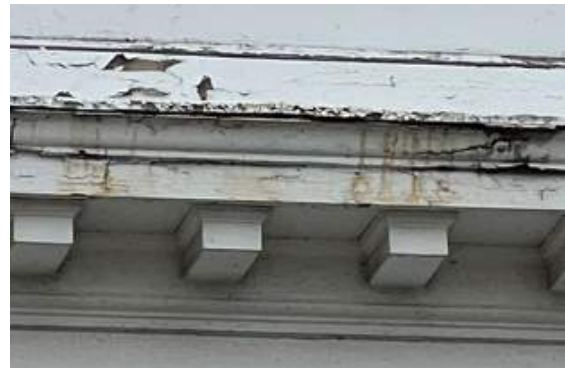
3. Cornice Cap: The top of the projecting cornice is capped by sheet metal. The sheet metal is bent downward at the edge of the cornice; however, we did not observe a drip edge. We observed blistered and peeling paint, moisture staining, and deterioration of the wood directly below the cap. The sheet metal was previously coated/painted; however, the coating is blistered and peeling. We observed surface corrosion of the metal as well as corrosion stains on the wood below.

We recommend removal and replacement of the existing cornice cap with new sheet metal with a baked Kynar coating that matches the color of the cornice. Industry standards recommend providing a hemmed drip edge, bent 1/2-inch away from the face of the wall, to facilitate shedding of water away from the wall.

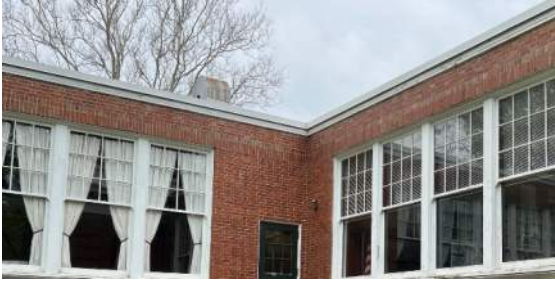
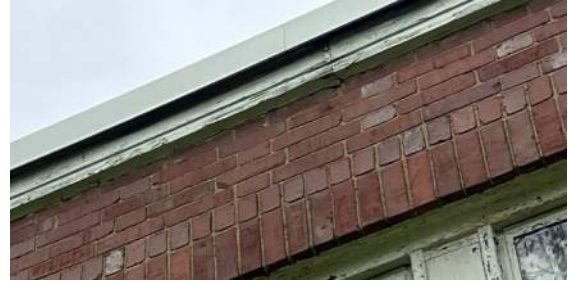
4. Wood Fascia: A painted wood fascia is located at the top of the wall around the perimeter of the east addition. The paint was observed to have cracked, blistered, and peeled at isolated locations.

We recommend removal and replacement of any isolated portions of deteriorated and rotted wood, application of an epoxy hardener where it is soft, and cleaning and painting the wood fascia to extend its service life.

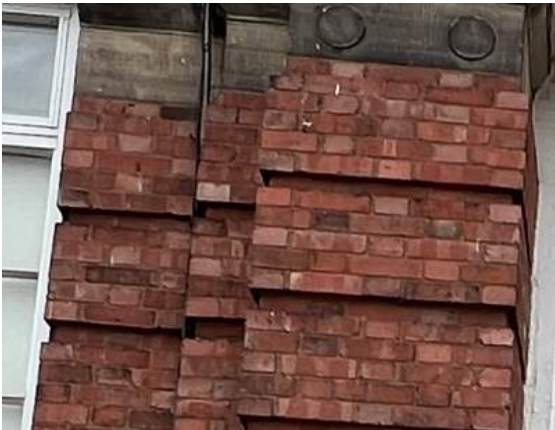
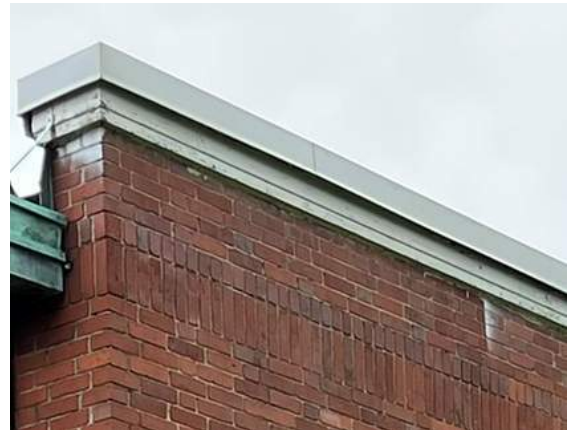
The multi-wythe masonry walls perform as a barrier system. (A barrier wall system is intended to prevent moisture penetration, as compared to a modern cavity/drainage wall system that allows water to penetrate but directs it back out of the exterior.) Efflorescence was observed on the exterior face of the brick masonry at isolated locations, particularly at the top of the walls, indicating moisture retention within the wall. (Efflorescence is the deposit of water-soluble salts, inherent in both the brick and mortar, on the surface due to evaporation of moisture within the masonry.) Additionally, vines were observed growing on the exterior brick masonry at isolated locations. The vines retain moisture against the exterior walls.

We recommend removal of any vines, as well as cleaning the brick masonry, and applying a clear water repellent sealer after completion of masonry repairs to minimize moisture penetration and freeze-thaw deterioration of the brick and to extend its service life. (Freeze-thaw deterioration is cracking and spalling caused by cyclic freezing and thawing. Water that is absorbed in the exterior wall material freezes, expands, breaks down the material, and then thaws leaving voids within the material.)

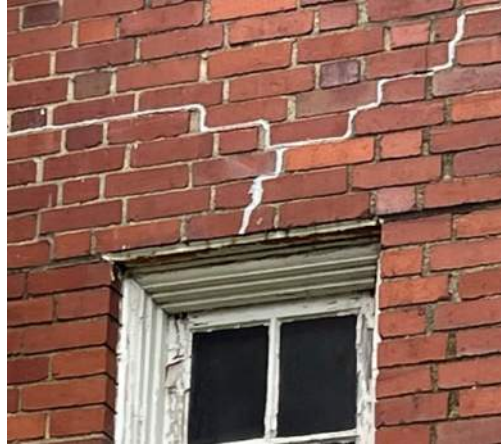
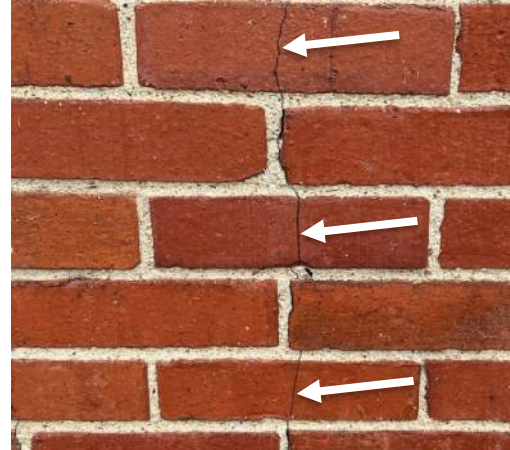
- a. Cracks & Spalls: The brick masonry was typically observed to be in overall good condition with moisture accumulation and deterioration at isolated locations. Cracking and displacement of the brick were observed at isolated locations, particularly due to corrosion of embedded steel or moisture expansion of the brick masonry. (When the clay material of the brick absorbs moisture, it expands. When it dries, the clay shrinks, but does not shrink entirely back to its original size. Over time, the brick continues to grow. In modern construction, brick expansion joints are installed to accommodate the moisture expansion. However, in historic multi-wythe masonry, brick expansion joints were not provided, and vertical cracks can result from moisture expansion.)

We recommend removal and replacement of brick masonry at the isolated areas of distress to minimize moisture penetration into the exterior walls and freeze-thaw deterioration of the masonry.

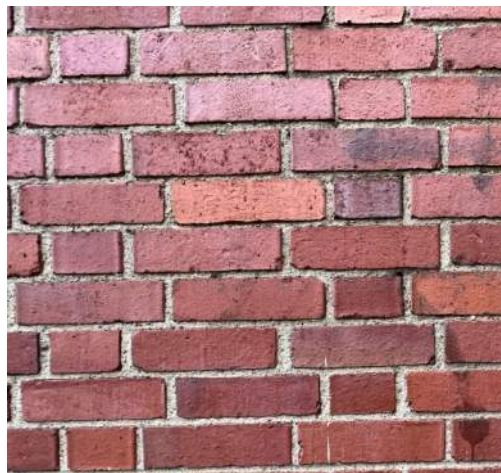
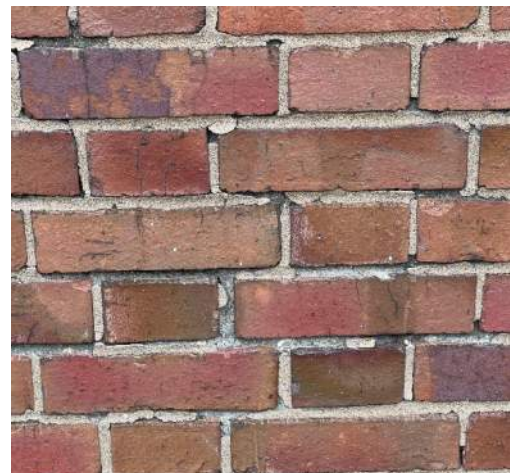
We observed evidence of previous mortar repointing at isolated areas. The repointed mortar is thin in profile and has cracked, lost bond, and contains voids revealing moisture staining and biological growth within the joint.

We recommend repointing weathered and deteriorated mortar joints to reduce water penetration into the exterior walls and potential subsequent freeze-thaw deterioration of the masonry. (Repointing is the process of the removal and replacement of mortar to a partial depth.) We recommend removal of the mortar to a minimum depth of ¾-inch and replacement with new mortar in ¼-inch deep lifts.

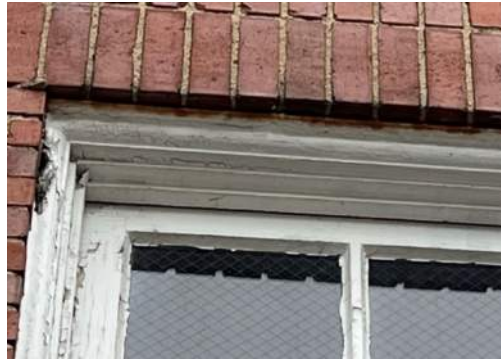
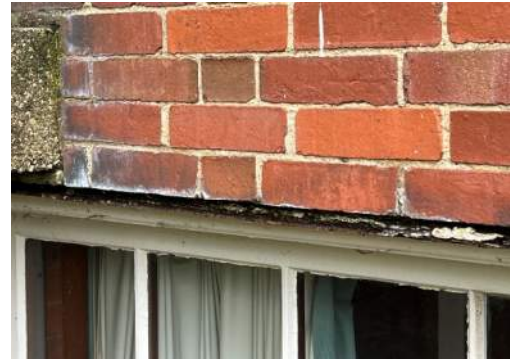
- c. Lintels: Painted steel lintels are installed over masonry openings (windows, doors, and louvers) to support the masonry above. Due to the age of the building and the addition, through-wall flashing was not installed at the lintels. Surface corrosion of the steel was typically observed while evidence of the development of pack rust was observed at isolated locations.

We recommend removal and replacement of the steel lintels that have developed pack rust, experienced section loss, or have severely deflected, with new with new galvanized steel lintels. In conjunction with the lintel replacement, we recommend installation of new stainless-steel sheet metal through-wall flashing to protect the embedded steel.

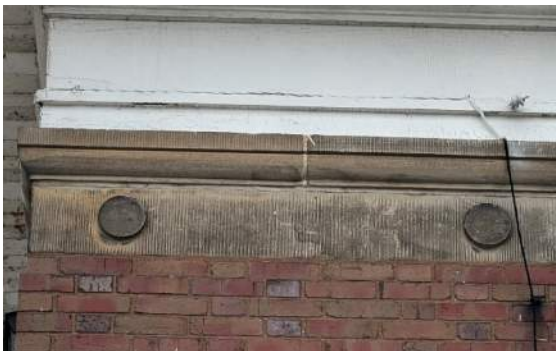
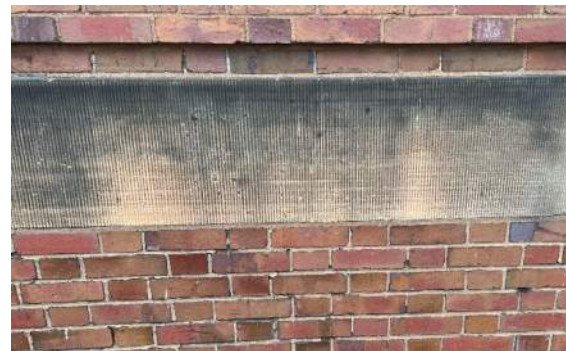
6. Sandstone: Sandstone is installed within the exterior masonry walls as accent bands at the top, as a water table, and at the base of the exterior walls of the original building, as pilaster caps within the gymnasium, as well as at windowsills throughout the building. Moisture and atmospheric staining were observed at throughout the sandstone. Biological growth was observed at isolated locations due to moisture accumulation within the stone.

We recommend cleaning the stone masonry and applying a clear water repellent sealer after completion of masonry repairs to minimize moisture penetration and freeze-thaw deterioration of the sandstone and to extend its service life.

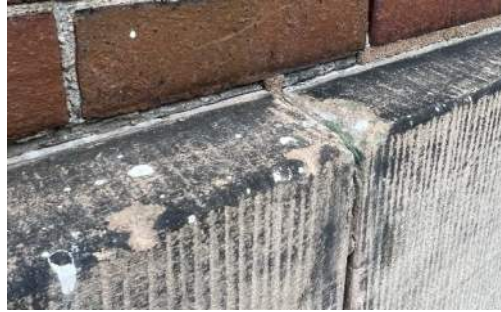
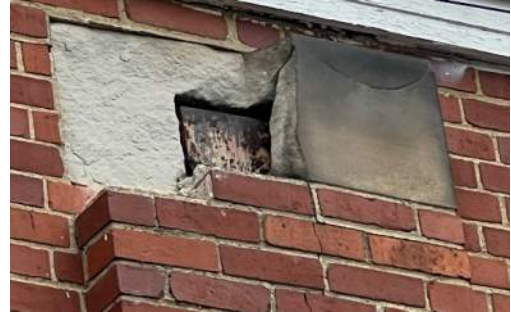
- a. Cracks, Delaminations & Spalls: Hairline cracks, delaminations, and spalls were observed within the sandstone at isolated locations, particularly within areas of moisture accumulation. (A delamination is a separation within the stone. When a delaminated portion breaks away, it is a spall.)

We recommend routing the cracks, removal of loose material at delaminations and spalls, and patching the stone with a stone repair mortar to minimize the penetration of moisture and continued freeze-thaw deterioration of the masonry. We recommend removal and replacement of stone units that have significantly lost section.

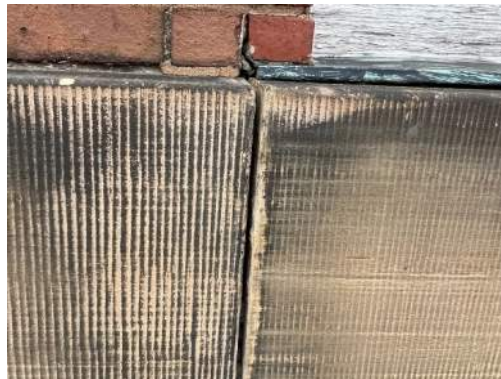
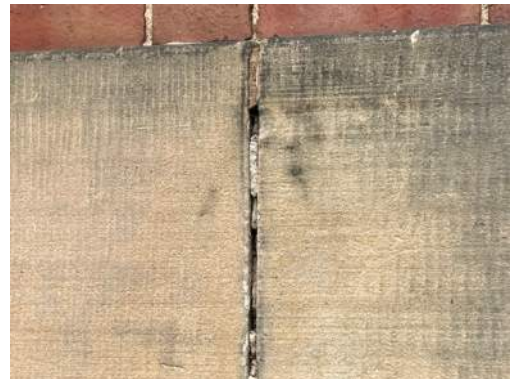
- b. Mortar: The mortar within the stone masonry was observed to be in overall poor condition. The mortar, which was struck flush with the face of the stone, is friable and has typically cracked, lost bond, or is missing at various locations.

We recommend repointing the mortar 100 percent within the sandstone to minimize moisture penetration and freeze-thaw deterioration of the stone.

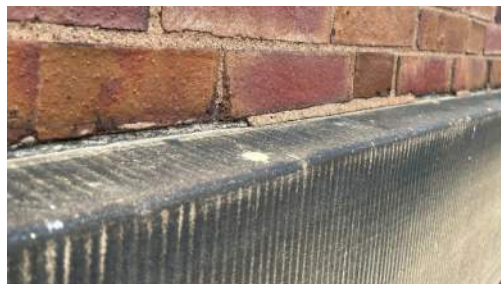
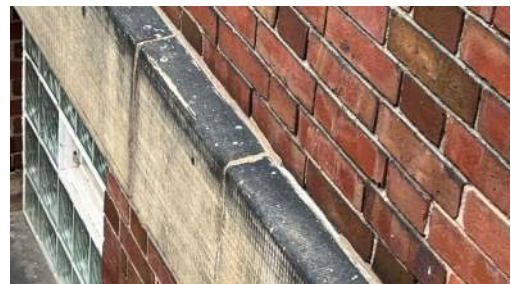
- c. Projecting Stone Water Table: The stone masonry projects out from the exterior face of the wall at the water table. The mortar bed joint between the exterior wall and the top of the projecting masonry, which is susceptible to moisture accumulation and freeze-thaw deterioration, has been previously repointed. However, the repointed mortar was observed to have cracked, lost bond, and to be missing at isolated locations.

We recommend, after repointing the mortar bed joint between the stone masonry and the projecting stone, the installation of a cove joint of silicone sealant to minimize moisture penetration into the joint. We recommend installing silicone joint sealant, which has a 20-year anticipated service life, versus 5 to 7 years for urethane.

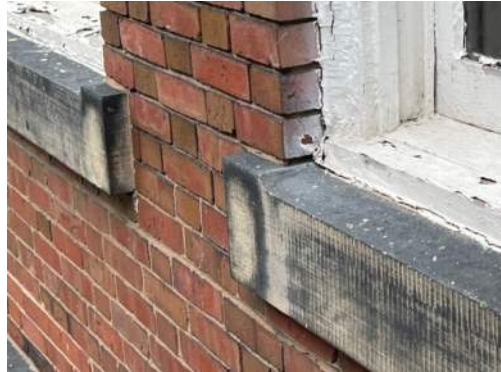
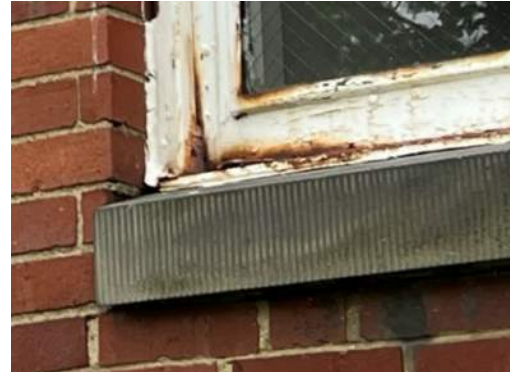
- d. Stone Sills: The windowsills throughout the building are sandstone. The bed joint at sills that extend into the brick jambs, and the mortar head joints at the ends of sills of equal width to the masonry openings, are susceptible to moisture penetration and freeze-thaw deterioration.

We recommend, after repointing the mortar bed joints between the stone masonry and the projecting stone sills as well as the vertical/head joints between the sills and the adjacent brick jambs, the installation of a cove joint of silicone sealant to minimize moisture penetration into the joint.

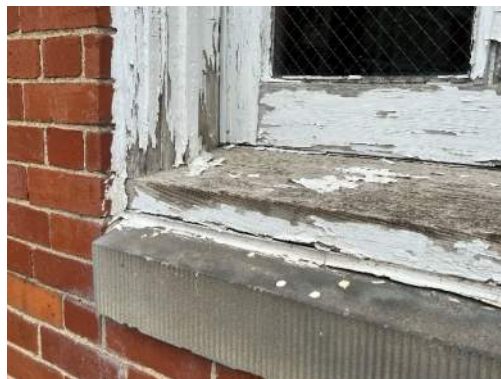
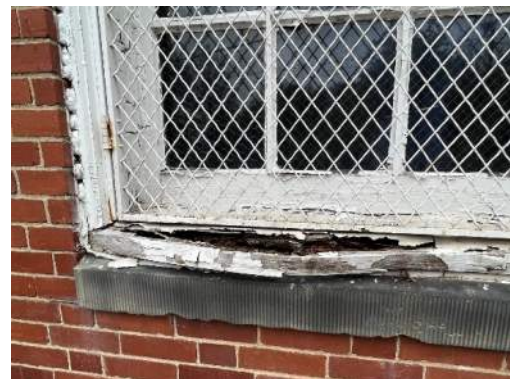
- a. Wood Framed Windows: The windows within the Bratenahl Community Center typically consist of the original painted wood windows. The paint was observed to have cracked, blistered, and peeled, exposing bare wood. The perimeter joint sealant, which consists of urethane, has hardened, cracked, and lost bond to at isolated locations.

We recommend removal and replacement of the wood framed windows with new thermally broken windows that would improve the energy efficiency of the building. If budget constraints do not allow replacement, we recommend the following. At exposed portions of the wood window frames, we recommend repair of any damaged wood, or application of an epoxy hardener where it is soft, and cleaning and painting the window frames. We recommend removal and replacement of the perimeter joint sealant with silicone.

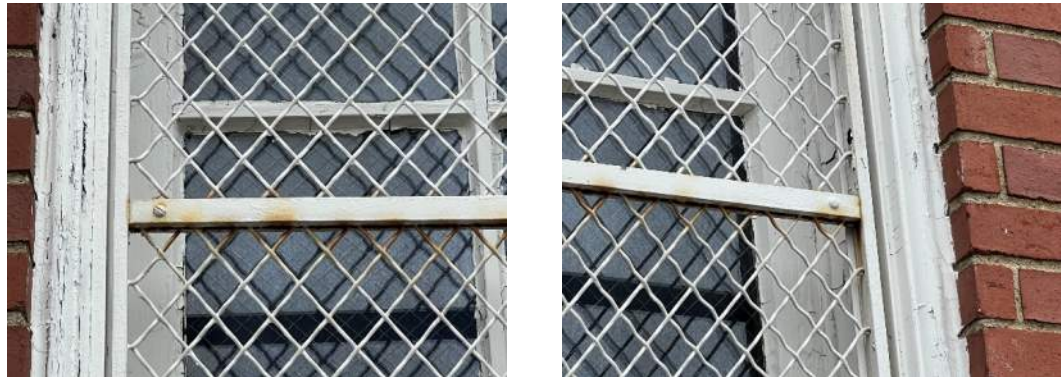
- b. Metal Grates: Painted steel grates are installed at three of the windows on the west elevation of the gym. The paint was observed to have cracked and peeled, and surface corrosion of the steel was observed.

We recommend removal and disposal of the metal grates during replacement or restoration of the windows. If the grates are desired for security or protection of the glass, we recommend replacement and installation of new at the additional west elevation windows. If budget constraints do not permit replacement, we recommend cleaning and painting the metal grates to extend their service life.

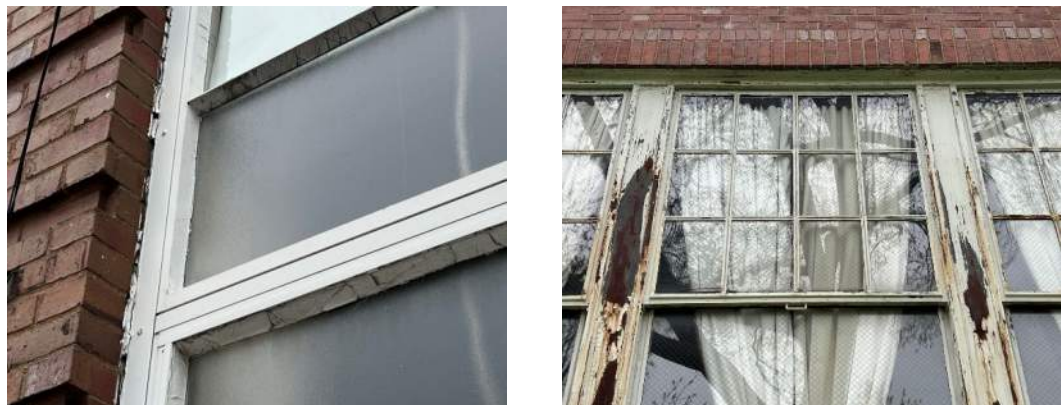
The paint on the frames of the metal windows within the addition has cracked, blistered, and peeled, and surface corrosion of the steel was observed. The perimeter joint sealant, which consists of urethane, has hardened, cracked, and lost bond to at isolated locations.

We recommend removal and replacement of the metal framed windows with new thermally broken windows that would improve the energy efficiency of the building. If budget constraints do not allow replacement, we recommend cleaning and painting the metal frames, removal, and replacement of the glazing putty with silicone wet sealant, as well as removal and replacement of the perimeter joint sealant with silicone.

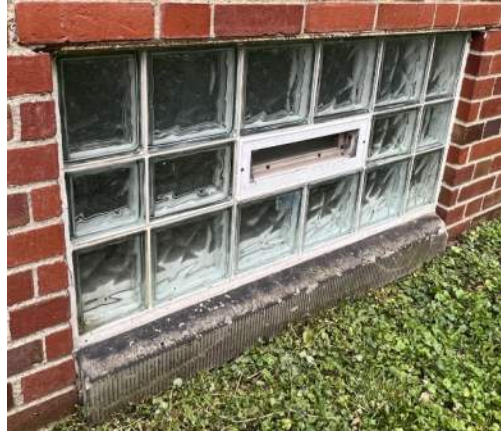
- d. Glass Block: Glass block has been installed within various basement windows within the original building and the addition. The glass block was observed to be in overall good condition; however, shrinkage cracks were noted within the mortar. Joint sealant is installed at the perimeter of the glass block windows. The urethane sealant was observed to have hardened, cracked, and to have lost bond at isolated locations.

We recommend repointing the mortar at isolated locations of deterioration within the glass block, as well as removal and replacement of the perimeter joint sealant with silicone.
