VILLAGE OF BRATENAH  
VILLAGE CENTER  
FEASIBILITY STUDY

## 2022 Bratenahl Condition Assessments

### Bratenahl Center – Facade Observations & Recommendations

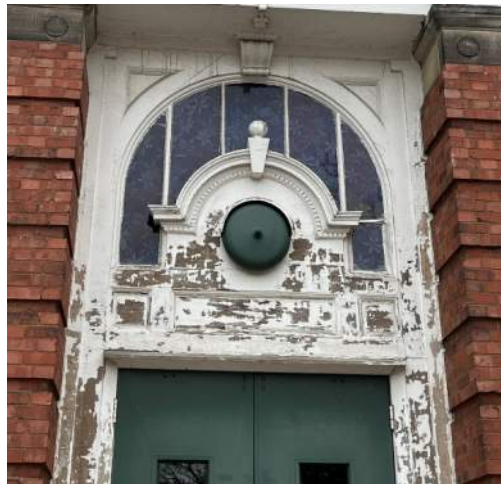
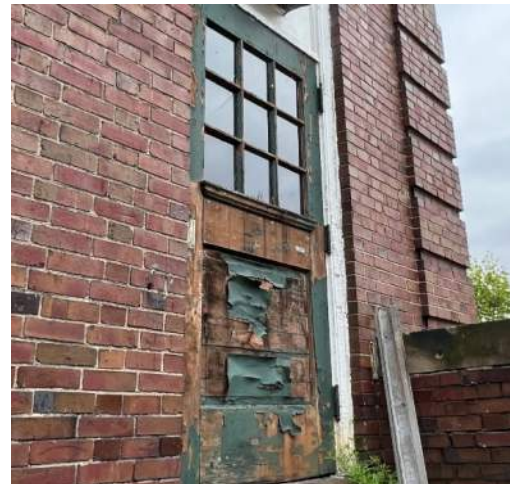
- e. Wood Doors: The doors within the original building and the addition consist of painted wood doors and frames. The paint was observed to have cracked, blistered, and peeled exposing bare wood. The perimeter joint sealant was observed to be urethane that has hardened, cracked, and lost bond at isolated locations.

To extend the service life of the existing doors, we recommend cleaning and painting the wood doors and frames, and removal and replacement of the perimeter joint sealant with silicone joint sealant. Alternatively, removal and replacement of the doors with new energy efficient doors could be performed.

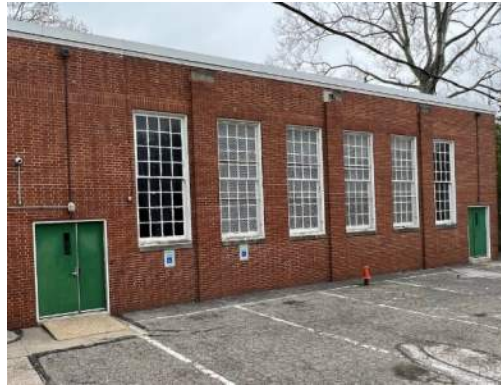
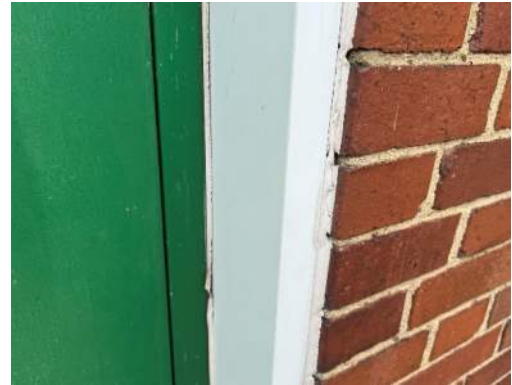
- f. Metal Doors: The doors on the west elevation of the gym consist of painted metal doors and frames. The metal doors are in overall good condition; however, the paint has weathered. It appears that metal trim was installed over an existing frame. Joint sealant is installed at the metal-to-metal joint at the perimeter of the frame and at the metal-to-brick joint at the perimeter of the trim. The urethane was observed to have hardened, cracked, and to have lost bond at isolated locations.

We recommend cleaning and painting the metal doors, as well as removal and replacement of the joint sealant with silicone at the perimeter of the frames and the perimeter of the trim.

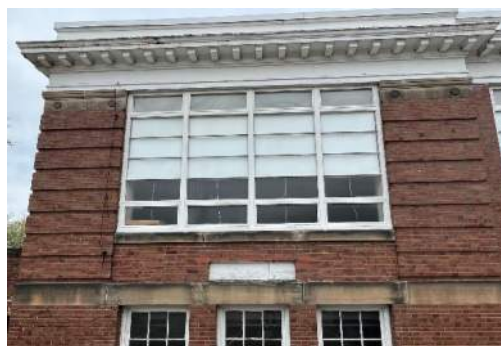
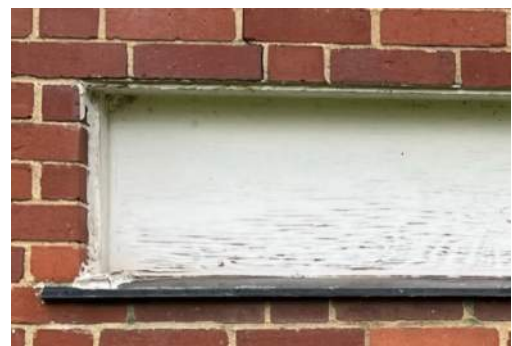
- g. Plywood Infill: Painted plywood infill was observed at locations of former louvers or vents within the exterior walls. The paint was observed to have weathered, cracked, blistered, and peeled, exposing bare wood. Joint sealant is installed at the perimeter of the wood infill; however, the urethane was observed to be thin in profile and to have hardened and cracked.

The sill within the former louver/vent openings consists of copper sheet metal. The sheet metal is hemmed (turned under) but lacks a drip edge to break the capillary action of water draining off its surface. The copper extends out the face of the wall within the brick masonry; however, at louver/vent openings located directly over the water table, the outer edge of the sheet metal is located on top of the stone.

We recommend removal of the plywood infill and copper sheet metal sills and infill with clay brick masonry. If budget constraints do not permit infill with new brick, we recommend cleaning and painting the infill, replacement of the perimeter sealant with silicone, as well as installation of silicone joint sealant below the copper sheet metal to the brick or along the edge of the copper to the sandstone water table.

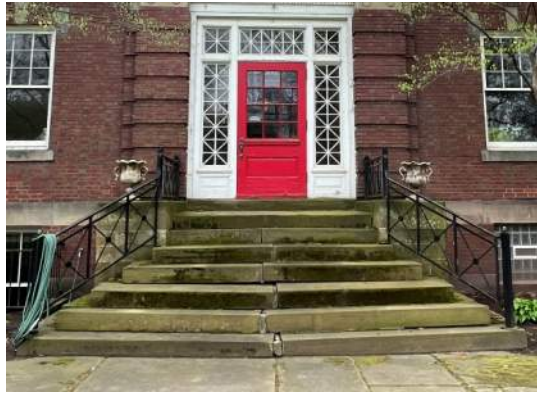
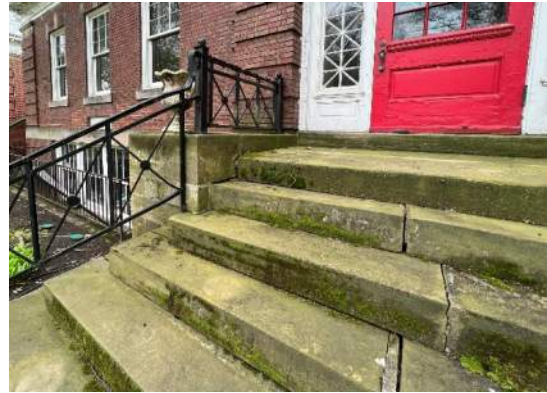
- a. Main Entry Stair: Stone stairs lead to the main entry doors at the west façade. The mortar head and bed joints within the stone treads were observed to have cracked, lost bond and to contain voids at isolated locations; settlement of the treads at the center of the stair has resulted in opening of the head joints. Stone barrier walls are located on each side of the stair. The mortar joints within the barrier walls were observed to have cracked, lost bond, and to contain voids at isolated locations. Moisture accumulation has caused staining and development of biological growth throughout the treads and barrier walls. The railings consist of painted wrought iron with base plates anchored to the stone. We observed blistering and peeling of the paint, and surface corrosion, at isolated locations, particularly at the base of the posts.

We recommend the following repairs within the main entry stairs:

- Removal and resetting of the stone treads, with repair of the underlying structure as required.
- Stone patching at cracks and spalls within the stone with a repair mortar.
- Reinstallation of the treads with full mortar head and bed joints, with head joints raked back to allow for the installation of backer rod and silicone joint sealant.
- Installation of cove joint sealant at the stair treads and landings, with silicone. (Cove joints are the joints at the intersection of horizontal and vertical elements.)
- Mortar repointing within the stone barrier walls.
- Cleaning of the stone and application of clear water repellent.
- Cleaning and painting wrought iron railings and installation of cove joint sealant at the perimeter of the railing post base plates.

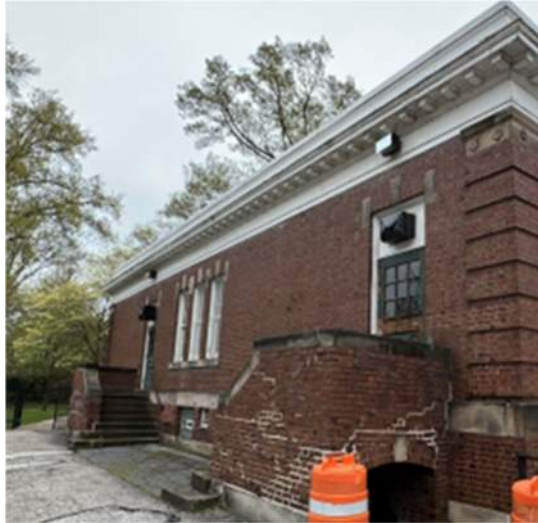
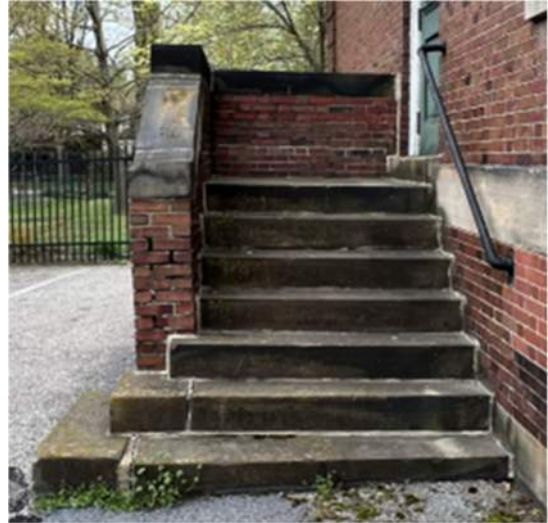
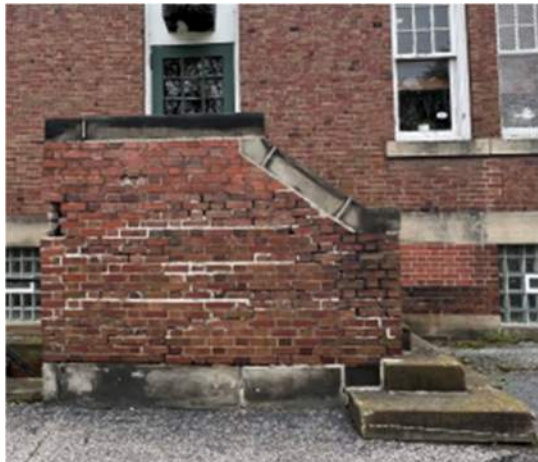
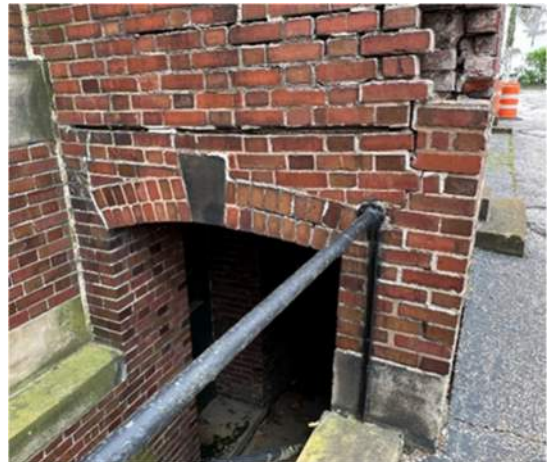
The mortar within the coping head and bed joints have cracked, providing a direct path for moisture to penetrate the barrier walls. Accumulation of moisture has resulted in cracking, spalling, and displacement of the brick masonry at both stairs.

We recommend removal and reconstruction of the west exterior stairs and masonry barrier walls with installation of through-wall flashing below the copings to minimize moisture penetration into the masonry.

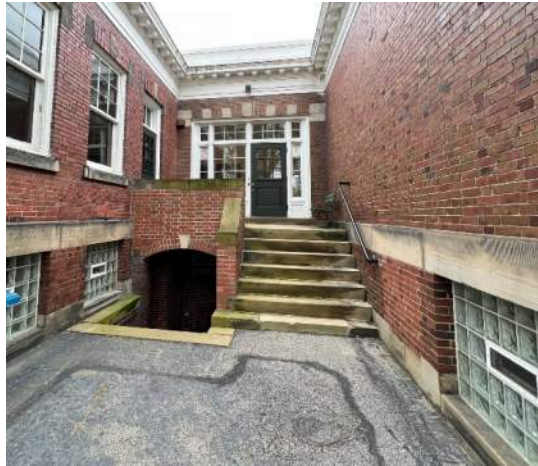
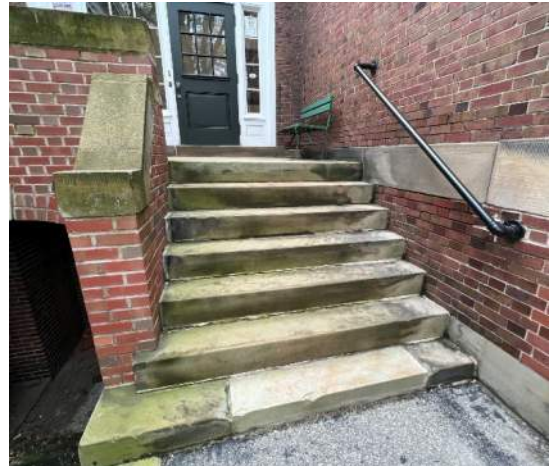
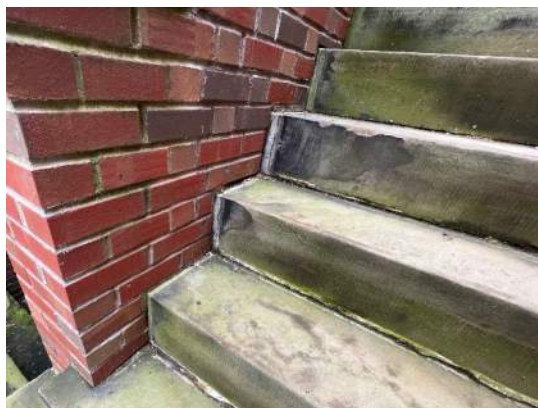
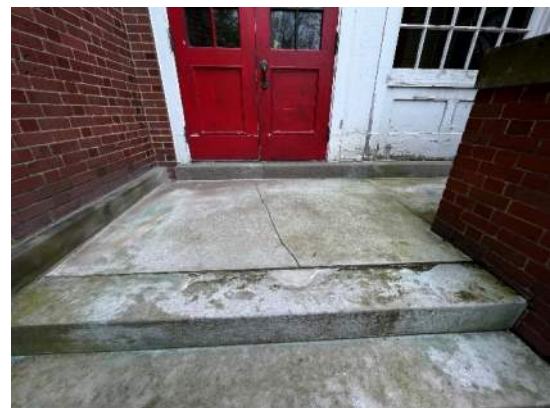
- c. Exterior Stone Stairs: Two additional stone stairs leading to the 1<sup>st</sup> Floor are located on the north elevation of the original building. The stair consists of stone treads and landing with a perimeter multi-wythe brick masonry barrier wall capped with sandstone copings. Moisture accumulation, cracks, cracks, and spalls were evident within the stone. The mortar joints within the stone treads were observed to have cracked, lost bond and to contain voids at isolated locations. The handrails consist of painted steel pipe rails anchored to the exterior masonry walls of the building.

We recommend the following repairs at the exterior stone stairs:

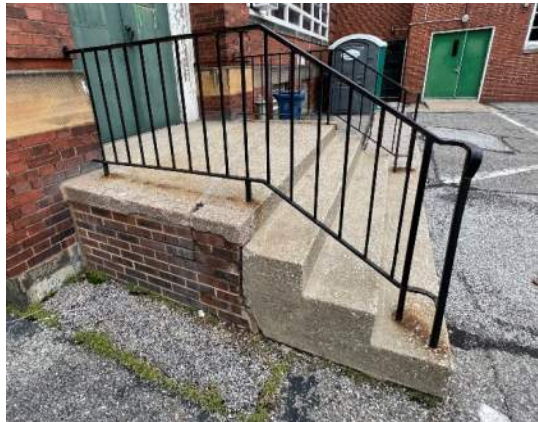
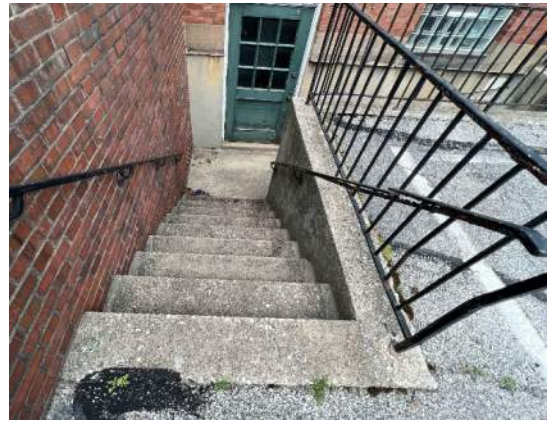
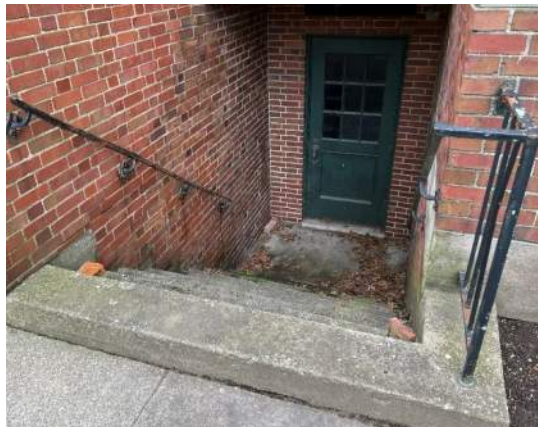
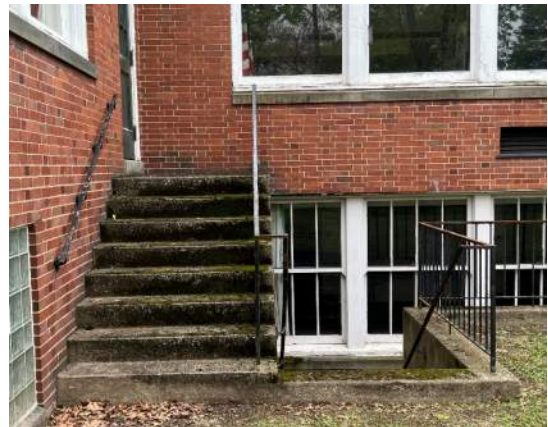
- d. Cast-in-Place Concrete Stairs: Exterior cast-in-place concrete stairs providing access to the 1<sup>st</sup> Floor are located on the south elevation of the original building and the north elevation of the addition. Additional cast-in-place concrete stairs provide access to the basement on the north and west elevations of the original building and the north elevation of the addition. Staining and biological growth are evident within the cast-in-place concrete due to moisture accumulation as well as corrosion of the embedded wrought iron railings. Cracks and spalls we observed at isolated locations due to freeze-thaw deterioration as well as corrosion of the embedded railings. Cracking, peeling, and blistering of the paint has also resulted in surface of the wrought iron at isolated locations.

We recommend the following within the exterior cast-in-place concrete stairs:

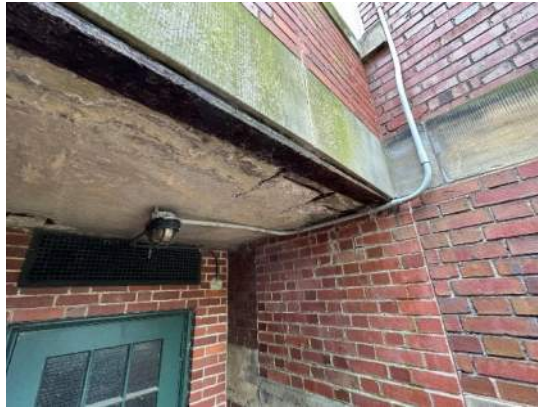
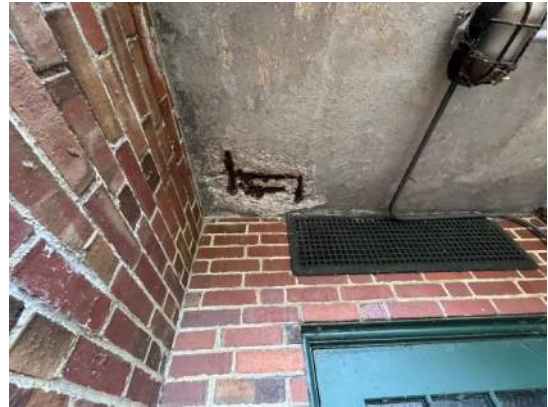
- e. Exposed Concrete: The underside of the structural slab at the secondary stone stairs is exposed. Cracks, delaminations, and spalls were observed within the concrete due to corrosion of the embedded steel reinforcement.

We recommend removing loose material, sawcutting the perimeter of the repair areas, cleaning and coating the embedded steel with a corrosion inhibitor and performing concrete patch repairs at the isolated locations of deterioration. If a uniform appearance is desired, we recommend applying a breathable stain to the ceiling of the walkway/arcade so as not to trap moisture within the concrete.

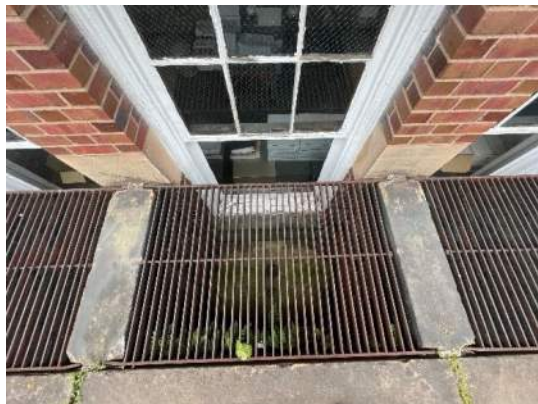
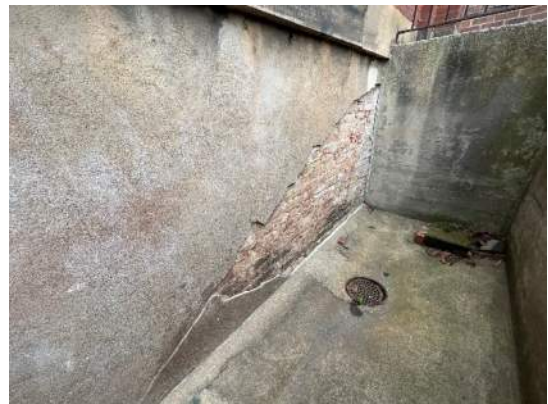
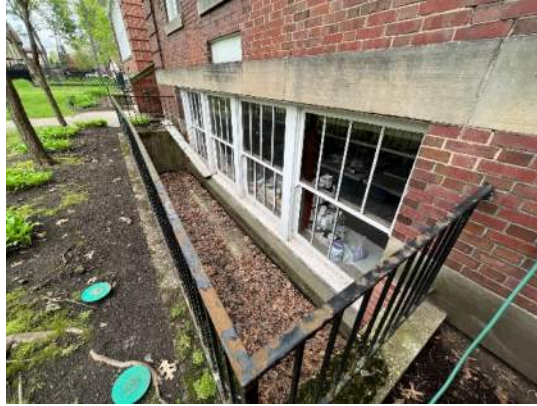
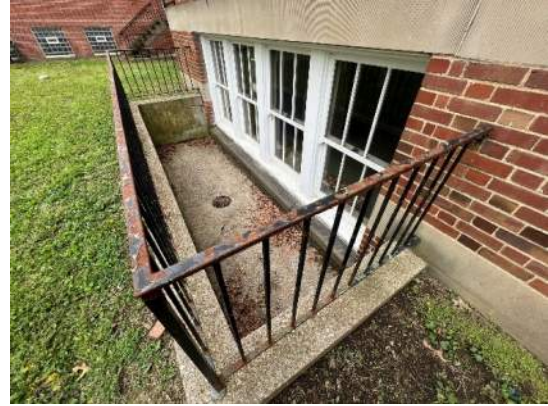
- f. Window Wells: Window wells are located on the north, south, and east elevations of the original building at the basement windows. The perimeter walls of the south elevation window wells are constructed of clay brick masonry with sandstone copings; the top of the stone is level with the surrounding pavement and metal grates span between perpendicular window well walls. A cementitious parge coat was applied to the window well at the base of the south elevation concrete stair. Cracks, delaminations and spalls were observed within the parge coat due to freeze-thaw deterioration.

The perimeter walls of the north and east elevation window wells consist of cast-in-place concrete with painted wrought iron railings embedded into the top of the concrete. We observed cracking, blistering, and peeling of the paint, as well as surface corrosion of the wrought iron.

The floor of the window wells consists of a continuous cast-in-place concrete slab-on-grade. The top of the slab was observed to be located one brick course below the basement sandstone sills. Joint sealant is not installed at the perimeter cove joint. A single drain was typically observed within the window wells.

We recommend the following within the window wells:

- Mortar repointing within the masonry window well walls. We recommend raking back the mortar at the sandstone copings to allow for installation of backer rod and joint sealant.
- Removal and replacement of the cracked, delaminated, spalled, and missing parge coat.
- Installation of cove joint sealant at the perimeter of the window wells.
- Cleaning and application of clear water repellent to the masonry and cast-in-place concrete.
- Cleaning and painting of the metal grates.
- Cleaning and painting the wrought iron railings and installation of cove joint sealant at the embedded railing posts.
- Removal of any debris within the window well, and cleaning the drains, as ongoing maintenance.

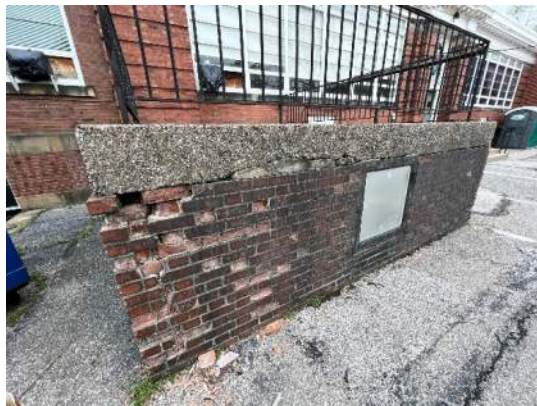
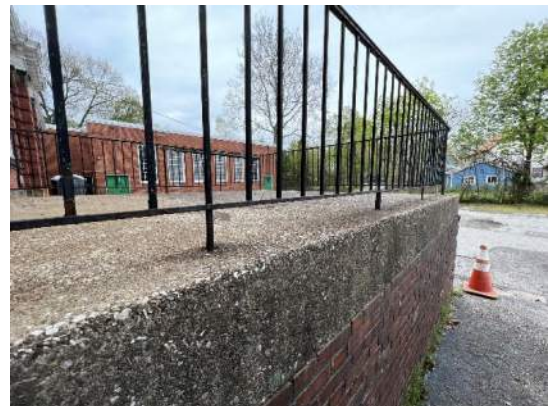
Moisture penetration and accumulation has resulted in freeze-thaw cracking and spalling of the brick masonry and mortar below the slab.

We recommend the following within the exterior platform:

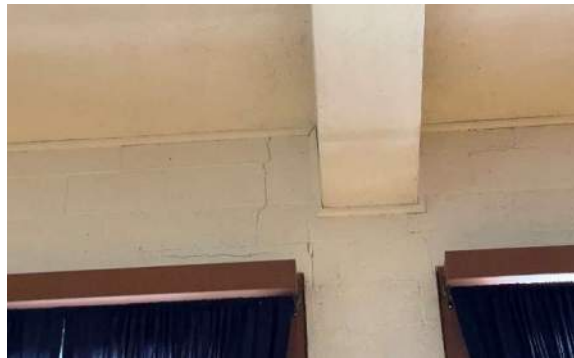
- b. Distress was observed at the roof structure bearing at one location on the north exterior wall of the gym.

- a. When renovating this building, an evaluation of the lateral system will be required if the risk category changes. If the building area is modified or the structural system is significantly altered, new seismic load resisting systems may be needed to meet the requirements of the current codes.
- b. Continued exposure to moisture in both wood framed areas and CMU areas will lead to deterioration and possible structural instability. Locations of moisture damage to the finishes should be opened during a renovation and review for any needed repairs. Exterior basement walls with moisture staining should be properly waterproofed and any needed repairs performed.
- c. The gym and stage masonry walls are recommended to be repaired.

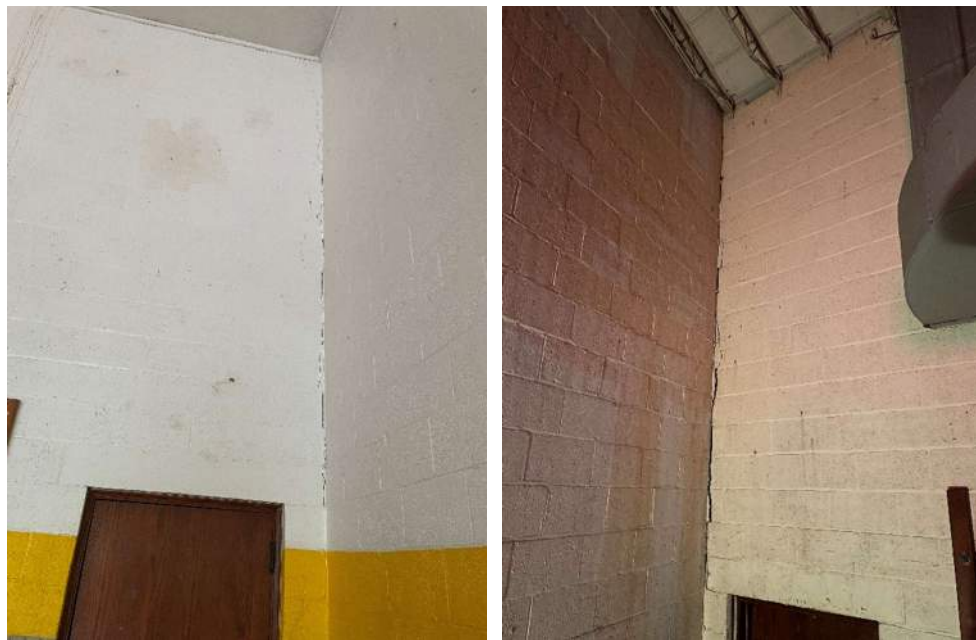
- c. An interior CMU wall separates the gym and stage areas. At the intersection of the interior wall and the west exterior wall a wide crack is present on both sides.

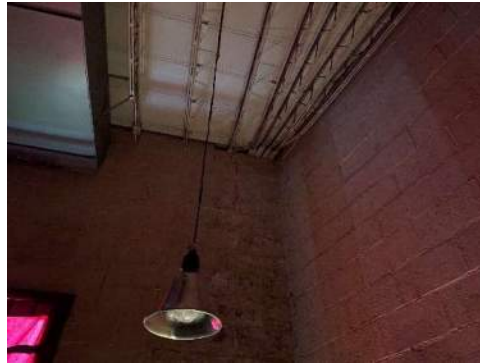
- d. In the southwest corner of the stage/gym building, moisture staining is present.

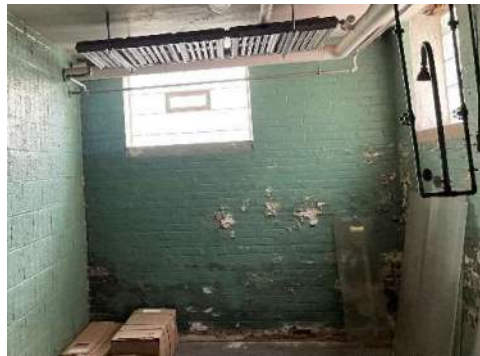
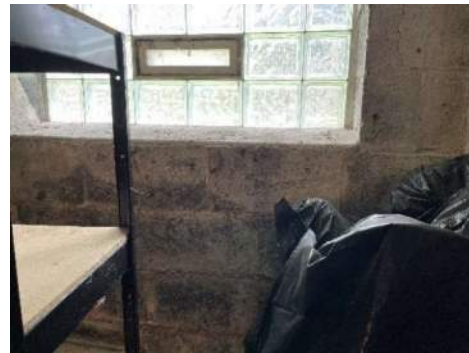
- e. Typically, the interior side of the basement walls was observed to be moisture stained showing high vapor drive into the building.

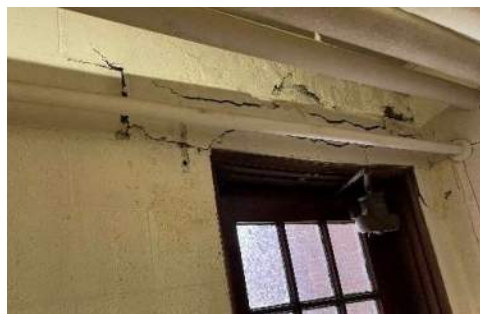
- f. At the exterior door on adjacent to the current men's locker room on the east side of the building to an area well, the concrete lintel is spalled.

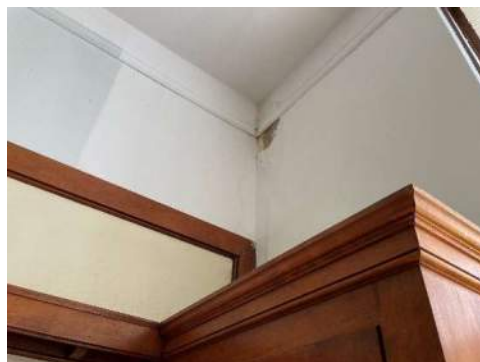
- g. Moisture damage was observed at the southeast corner of the Bratenahl room on the exterior wall.

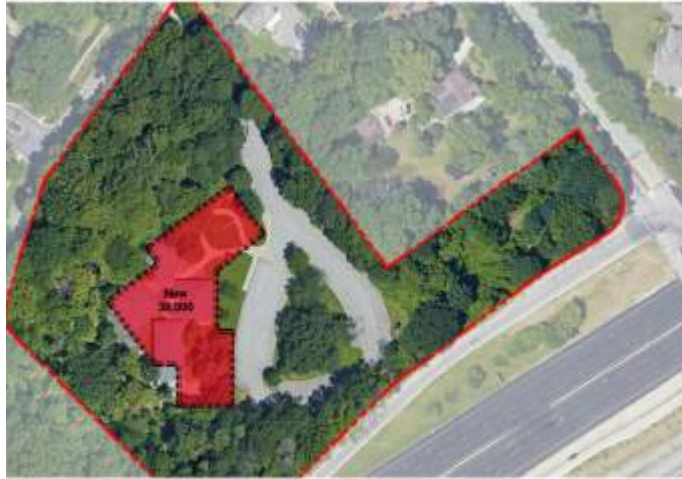
Concept 1A - Campus Center (1 Site)

All services located at Bratenahl Center - New Construction

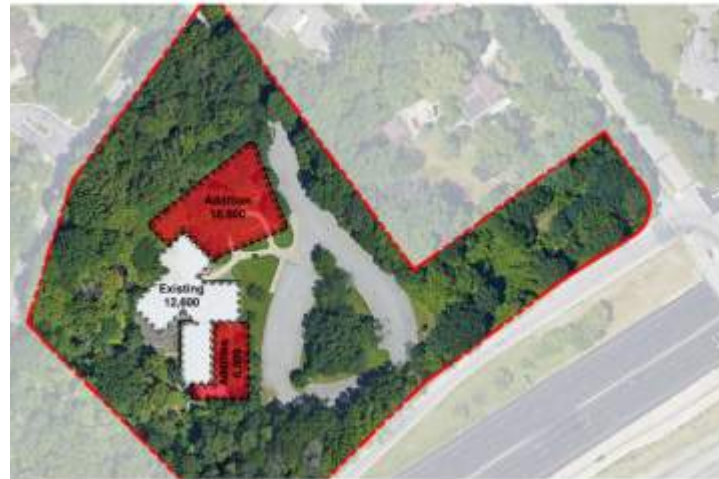
Concept 1A.1 - Campus Center (1 Site)

All services located at Bratenahl Center - Renovation + Addition

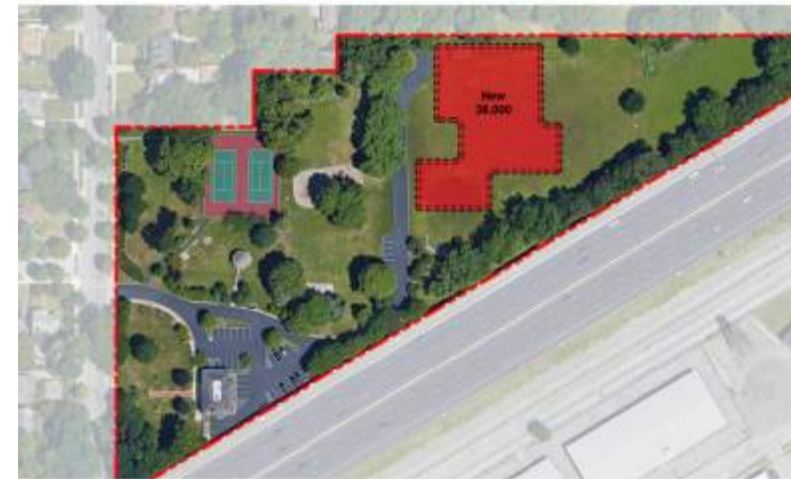
Concept 1B - Campus Center (1 Site)

All services located at Village Hall Site - New Construction

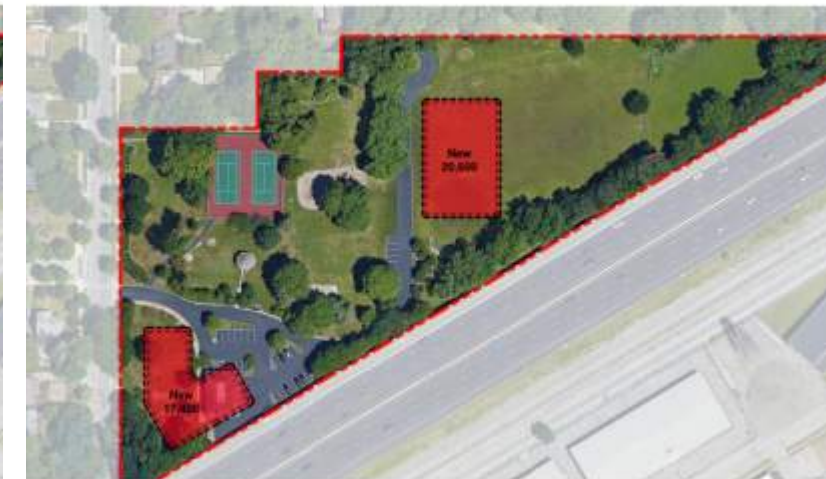
Concept 1B.1 - Campus Center (1 Site)

All services located at Village Hall Site - New Construction, 2 Buildings

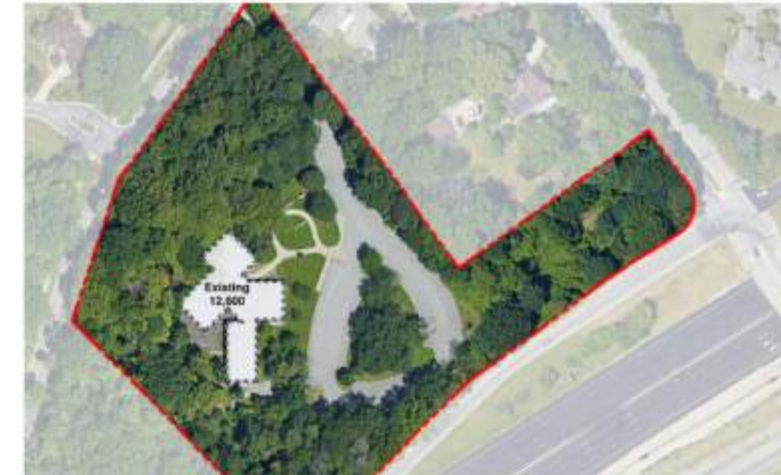
Concept 2A - Separate Facilities (3 Sites)

Rec to remain at Community Center

Police at Village Hall - New Construction

Village Admin at Bratenahl Center - Renovation

All services located at Community Center - New Construction

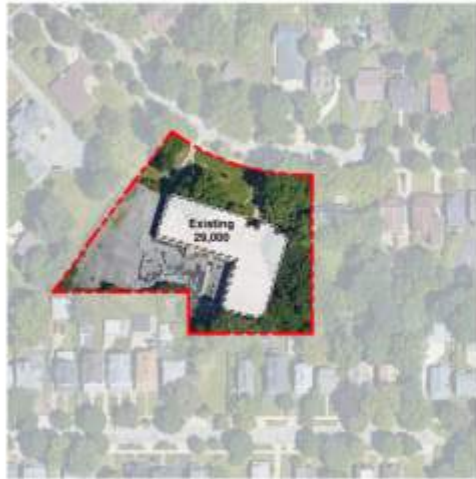
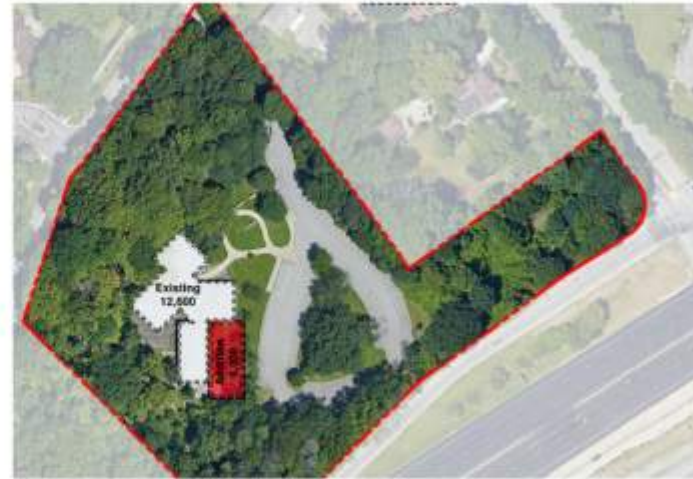
Concept 3A - Hybrid (2 Sites)

Rec to remain at Community Center

Village Admin and Police at Bratenahl Center - Renovation + Addition

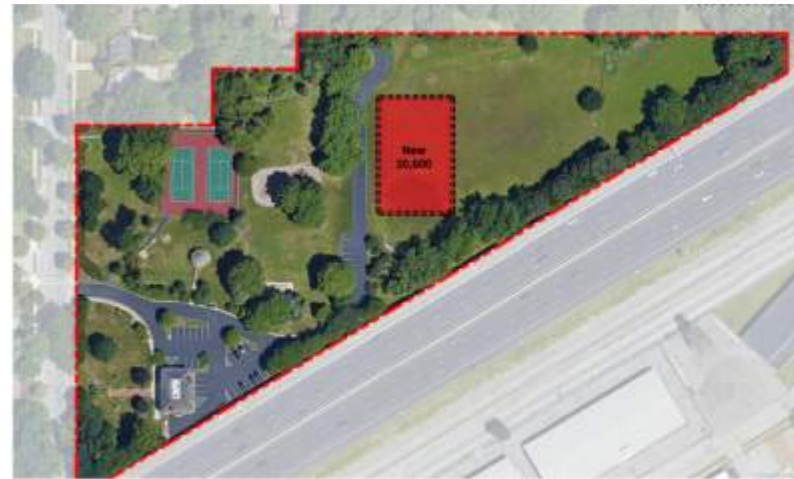
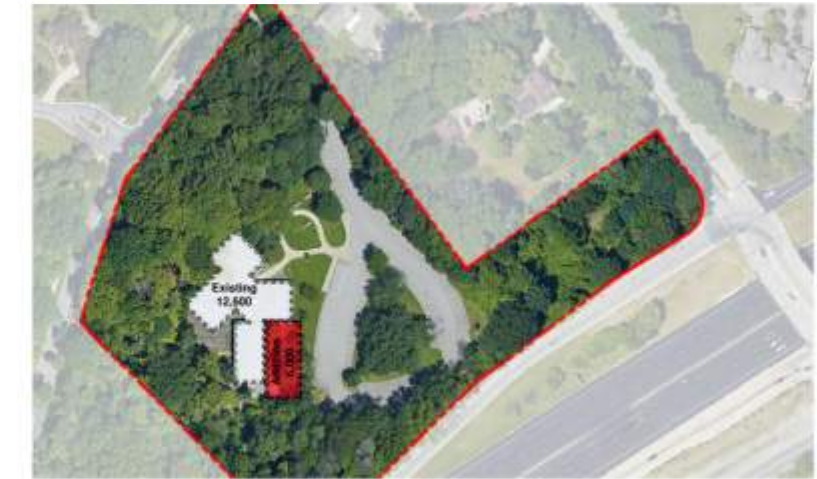
Concept 3B - Hybrid (2 Sites)

Rec at Village Hall Site - New Construction

Village Admin and Police at Bratenahl Center - Renovation + Addition

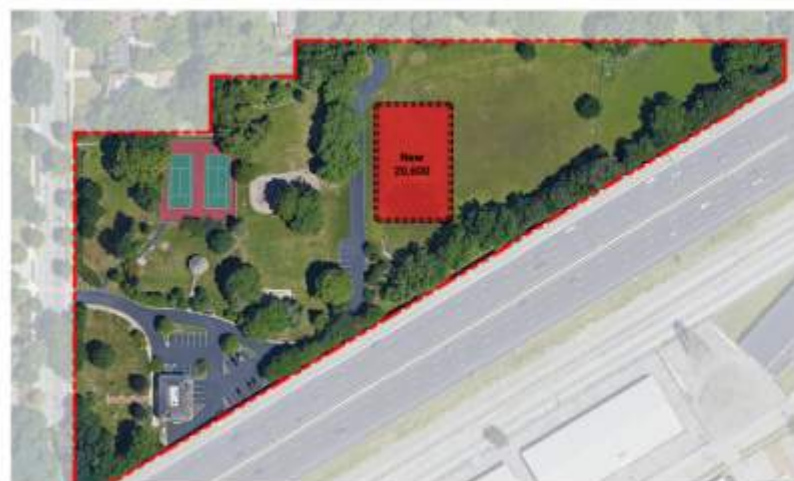
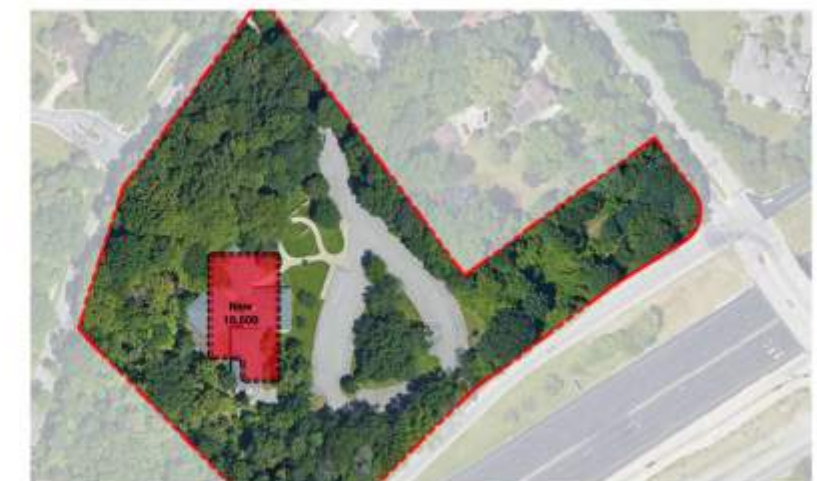
Concept 3B.1 - Hybrid (2 Sites)

Rec at Village Hall Site - New Construction

Village Admin and Police at Bratenahl Center - Renovation + Addition

Concept 3B	Rec at Village Park, Police/Admin at Bratenahl Center - Addition	Positive (+1)	Neutral (0)	Positive (+1)	Positive (+1)	Neutral (0)	Neutral (0)	Positive (+1)	Positive (+1)		Neutral (0)	Neutral (0)		Positive (+1)	Neutral (0)	6
Concept 3B.1	Rec at Village Park, Police/Admin at Bratenahl Center - New Construction	Positive (+1)	Neutral (0)	Positive (+1)	Positive (+1)	Neutral (0)	Positive (+1)	Positive (+1)	Positive (+1)		Negative (-1)	Positive (+1)		Positive (+1)	Positive (+1)	8
Concept 3C	Rec at Bratenahl Center, Police/Admin at Village Hall	Neutral (0)	Neutral (0)	Negative (-1)	Neutral (0)	Neutral (0)	Neutral (0)	Negative (-1)	Neutral (0)		Negative (-1)	Neutral (0)		Positive (+1)	Neutral (0)	-2
Concept 3D	Rec at Community Center, Police/Admin at Village Hall - New Construction	Neutral (0)	Neutral (0)	Neutral (0)	Neutral (0)	Neutral (0)	Positive (+1)	Neutral (0)	Neutral (0)		Positive (+1)	Neutral (0)		Positive (+1)	Neutral (0)	3

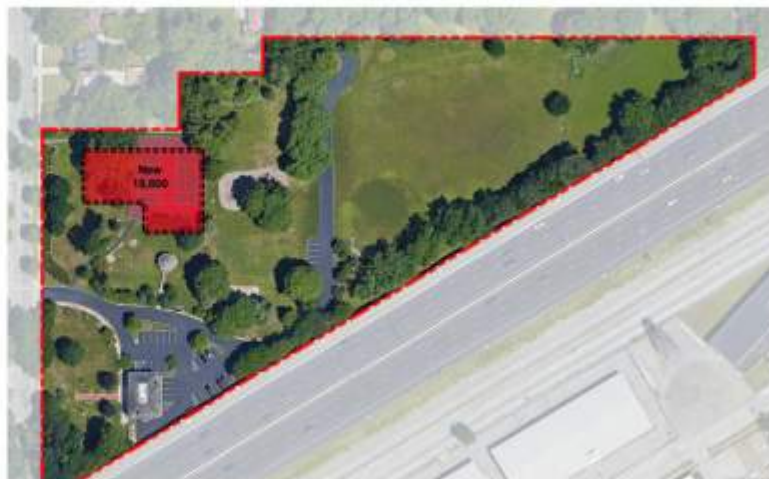
Concept 3D - Hybrid (2 Sites)

Rec to remain at Community Center

Village Admin and Police at Village Hall Site - New Construction

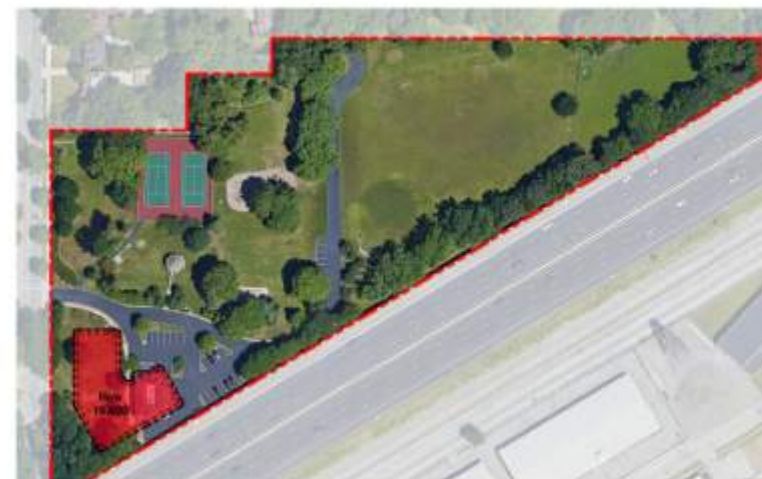
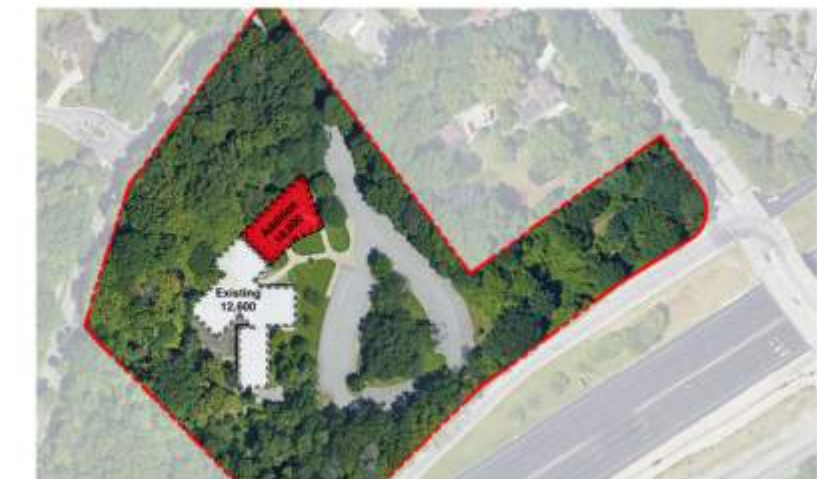
Concept 3C - Hybrid (2 Sites)

Village Admin and Police at Village Hall Site - New Construction

Rec at Bratenahl Center - Renovation + Addition

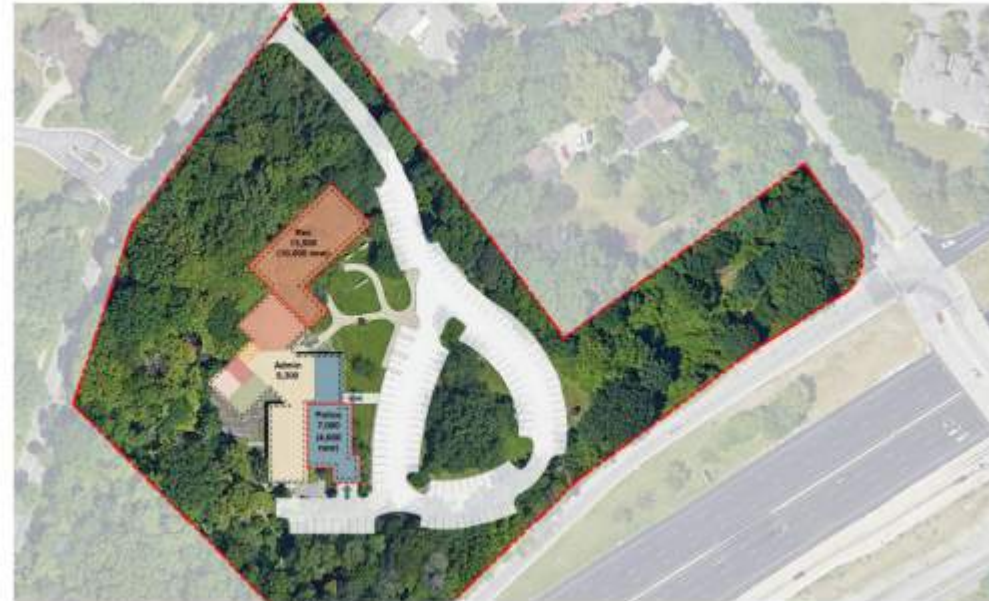
**Concept 1A.1 - Campus Center (1 Site)**

All services located at Bratenahl Center - Renovation + Addition

**Concept 1A.1: Opinion of Probable Project Cost: \$10.5M - 14.8M**  
**Millage = 6 Mills - 8 Mills**

- Most expensive remaining option
- Potential conflicts will all users on one site
- Removes Police presence from Village Hall Site
- Potential issues with site water management
- Have to tie into existing architecture

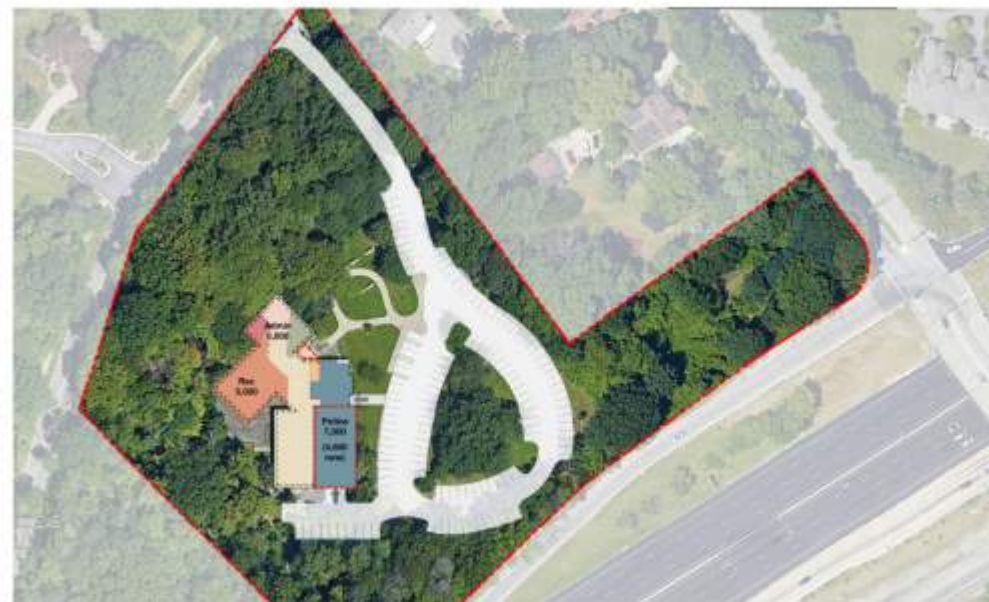
**Concept 1A.2 - Campus Center (1 Site)**

All services located at Bratenahl Center - Renovation + Addition

**Concept 1A.2: Opinion of Probable Project Cost: \$6M - 8.5M**  
**Millage = 4 Mills - 5 Mills**

- Potential conflicts will all users on one site
- Removes Police presence from Village Hall Site
- Potential issues with site water management
- Have to tie into existing architecture
- Does not provide all desired programing elements for all departments

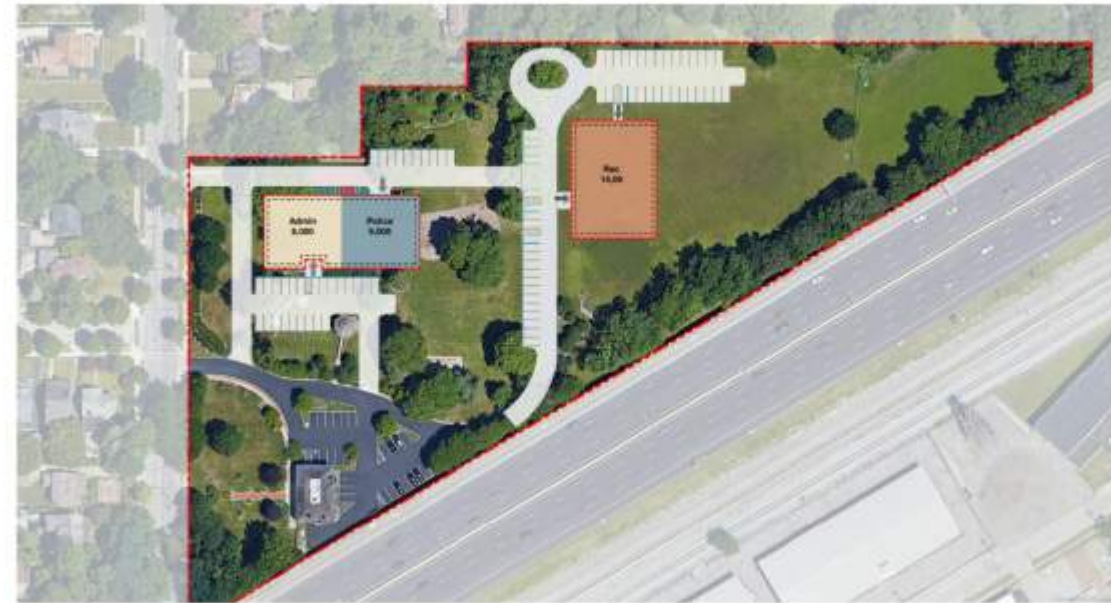
Concept 1B.1 - Campus Center (1 Site)

All services located at Village Hall Site - New Construction, 2 Buildings

Concept 1B.1: Opinion of Probable Project Cost: \$10M - 14.5M  
Millage = 6 Mills - 8 Mills

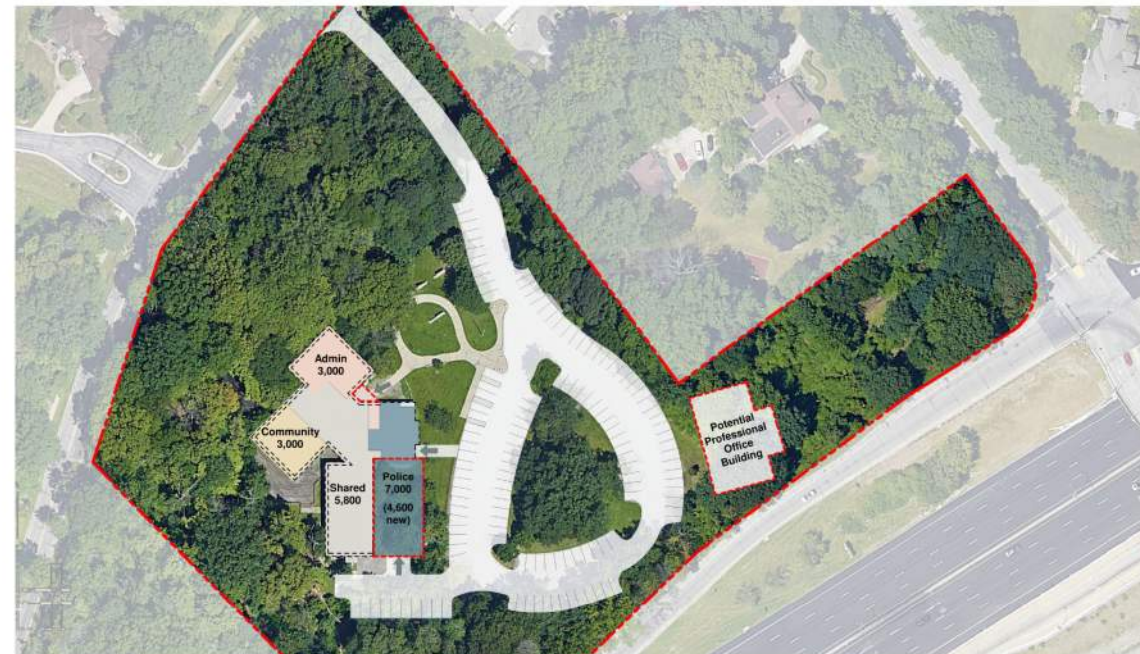
NEW POLICE STATION WITH RENOVATION FOR ADMIN OFFICES & COMMUNITY SUPPORT SPACES

18,800 SF | OPINION OF PROBABLE PROJECT COST \$6,000,000 - \$8,500,000 | MILLAGE = 5 MILLS

- Potential conflicts will all users on one site
- Removes Police presence from Village Hall Site
- Potential issues with site water management.
- Have to tie into existing architecture
- Does not provide all desired programing elements for all departments.

Recommendation 1: Opinion of Probable Project Cost: \$6M - 8.5M  
Millage = 5 Mills

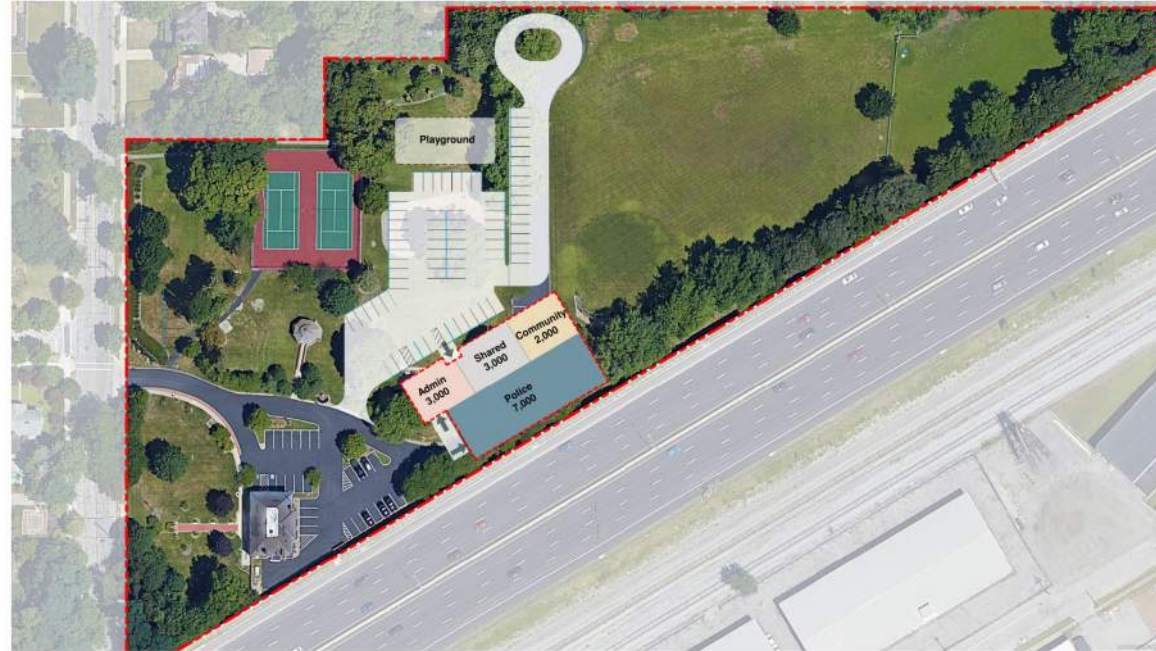
NEW POLICE STATION WITH ADMIN OFFICES & COMMUNITY SUPPORT SPACES

15,000 SF | OPINION OF PROBABLE PROJECT COST \$7,000,000 - \$10,000,000 | MILLAGE = 6 MILLS

Concept 2A: Opinion of Probable Project Cost: \$7M - 10M  
Millage = 6 Mills

- One site entry/exit point could pose a challenge with site circulation
- Loss of existing green space
- Exceeds goal of 5 Mills or less

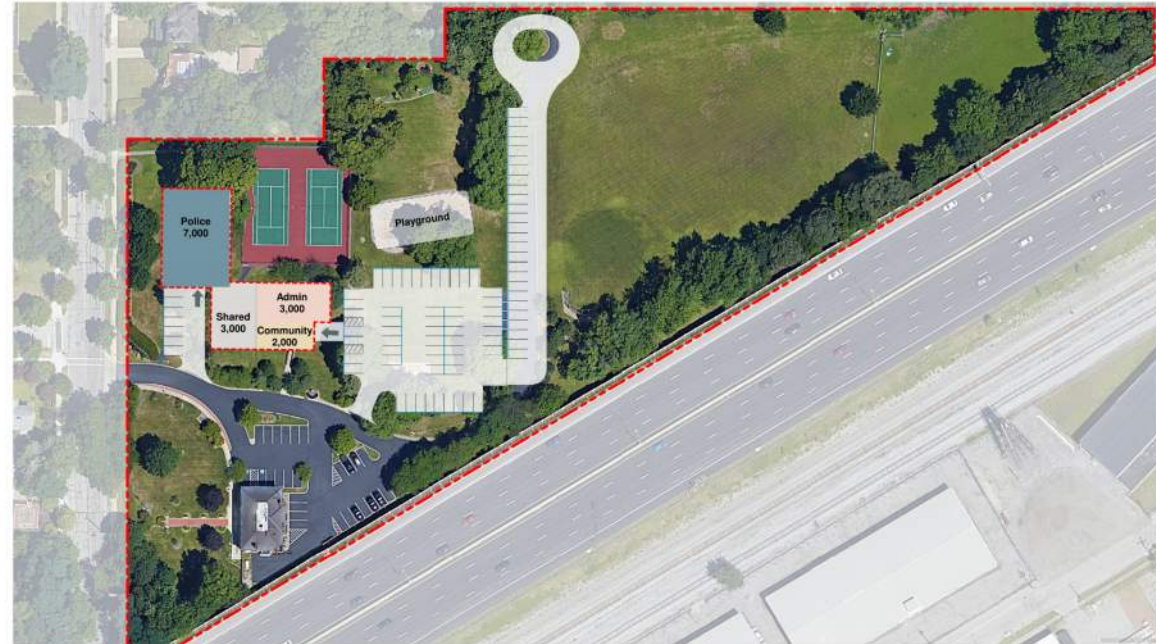
NEW POLICE STATION WITH ADMIN OFFICES & COMMUNITY SUPPORT SPACES

15,000 SF | OPINION OF PROBABLE PROJECT COST \$7,000,000 - \$10,000,000 | MILLAGE = 6 MILLS

Recommendation 2B: Opinion of Probable Project Cost: \$7M - 10M  
Millage = 6 Mills

- One site entry/exit point could pose a challenge with site circulation
- Loss of existing gazebo
- Exceeds goal of 5 Mills or less
