VILLAGE OF BRATENAH  
VILLAGE CENTER  
FEASIBILITY STUDY

## 2022 Bratenahl Condition Assessments

### Bratenahl Center – Facade Observations & Recommendations

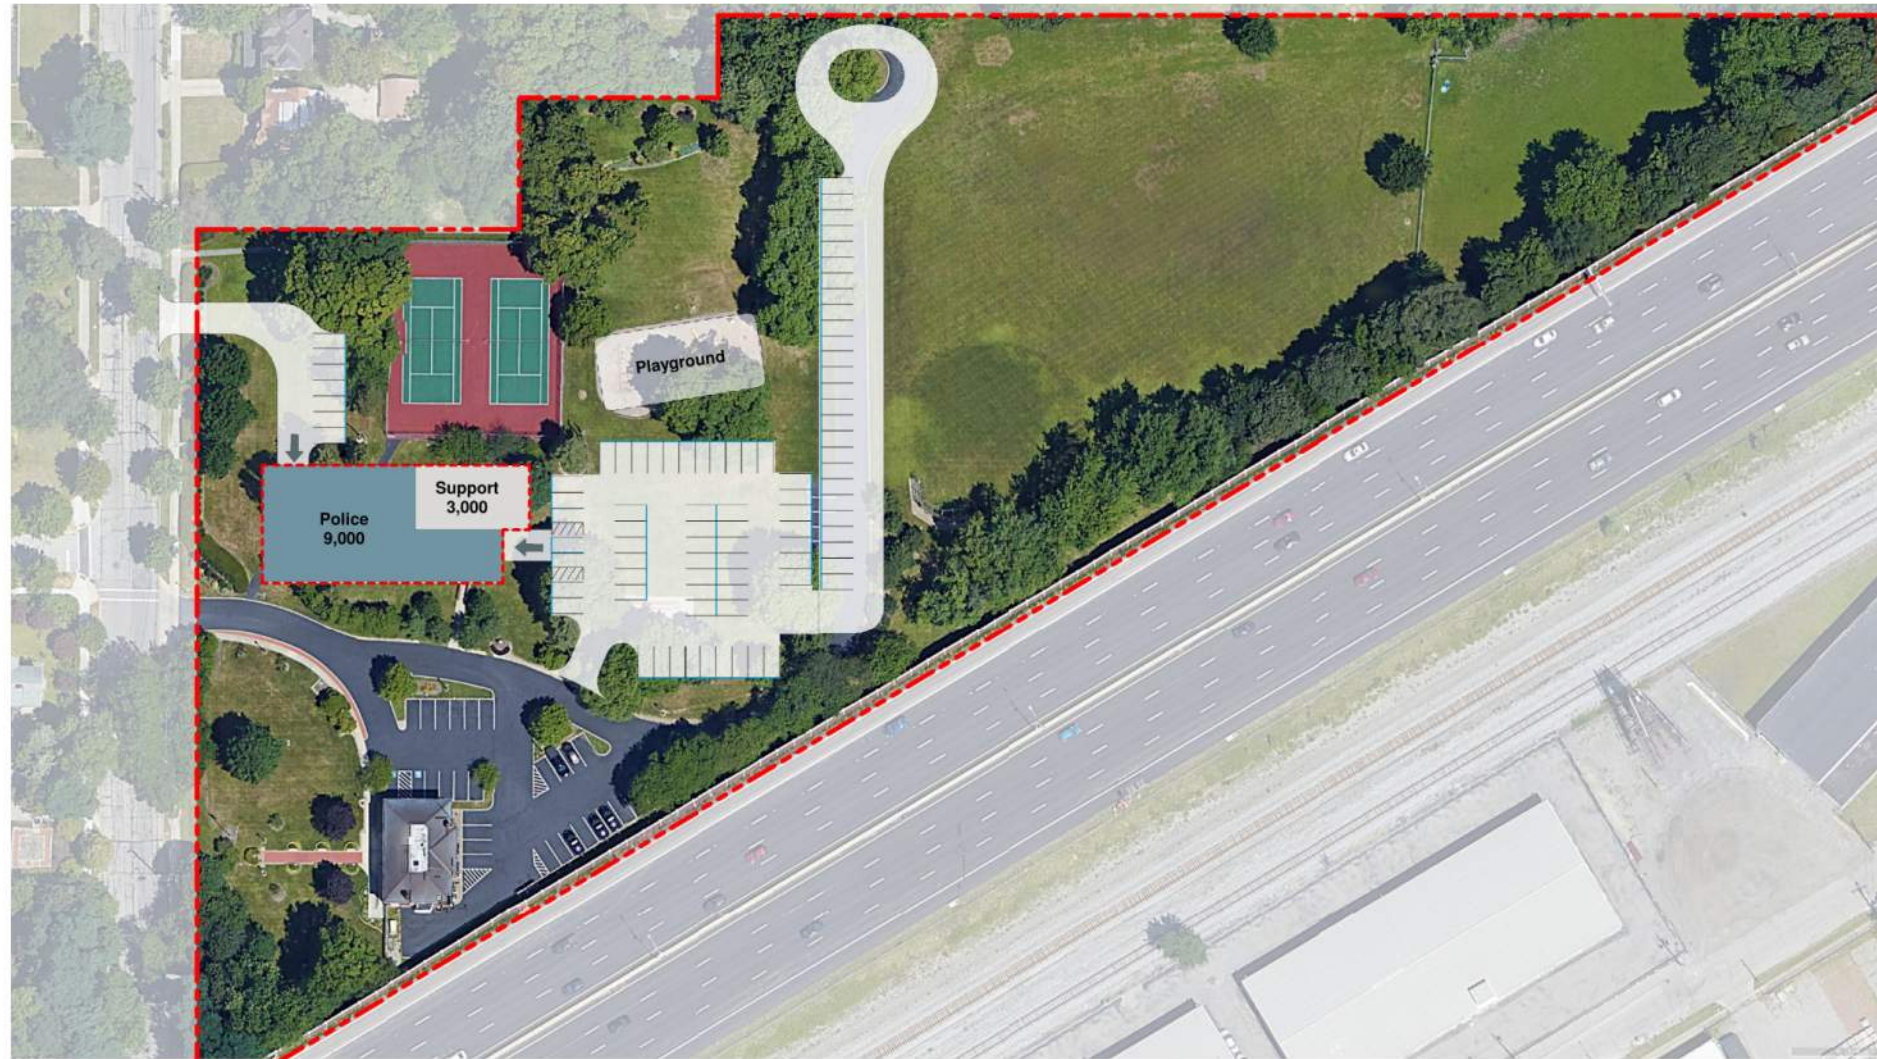
NEW POLICE STATION WITH SUPPORT SPACE

12,000 SF | OPINION OF PROBABLE PROJECT COST \$6,000,000 - \$8,000,000 | MILLAGE = 5 MILLS

**Final Recommendation: Opinion of Probable Project Cost: \$6M - 8M  
Millage = 5 Mills**

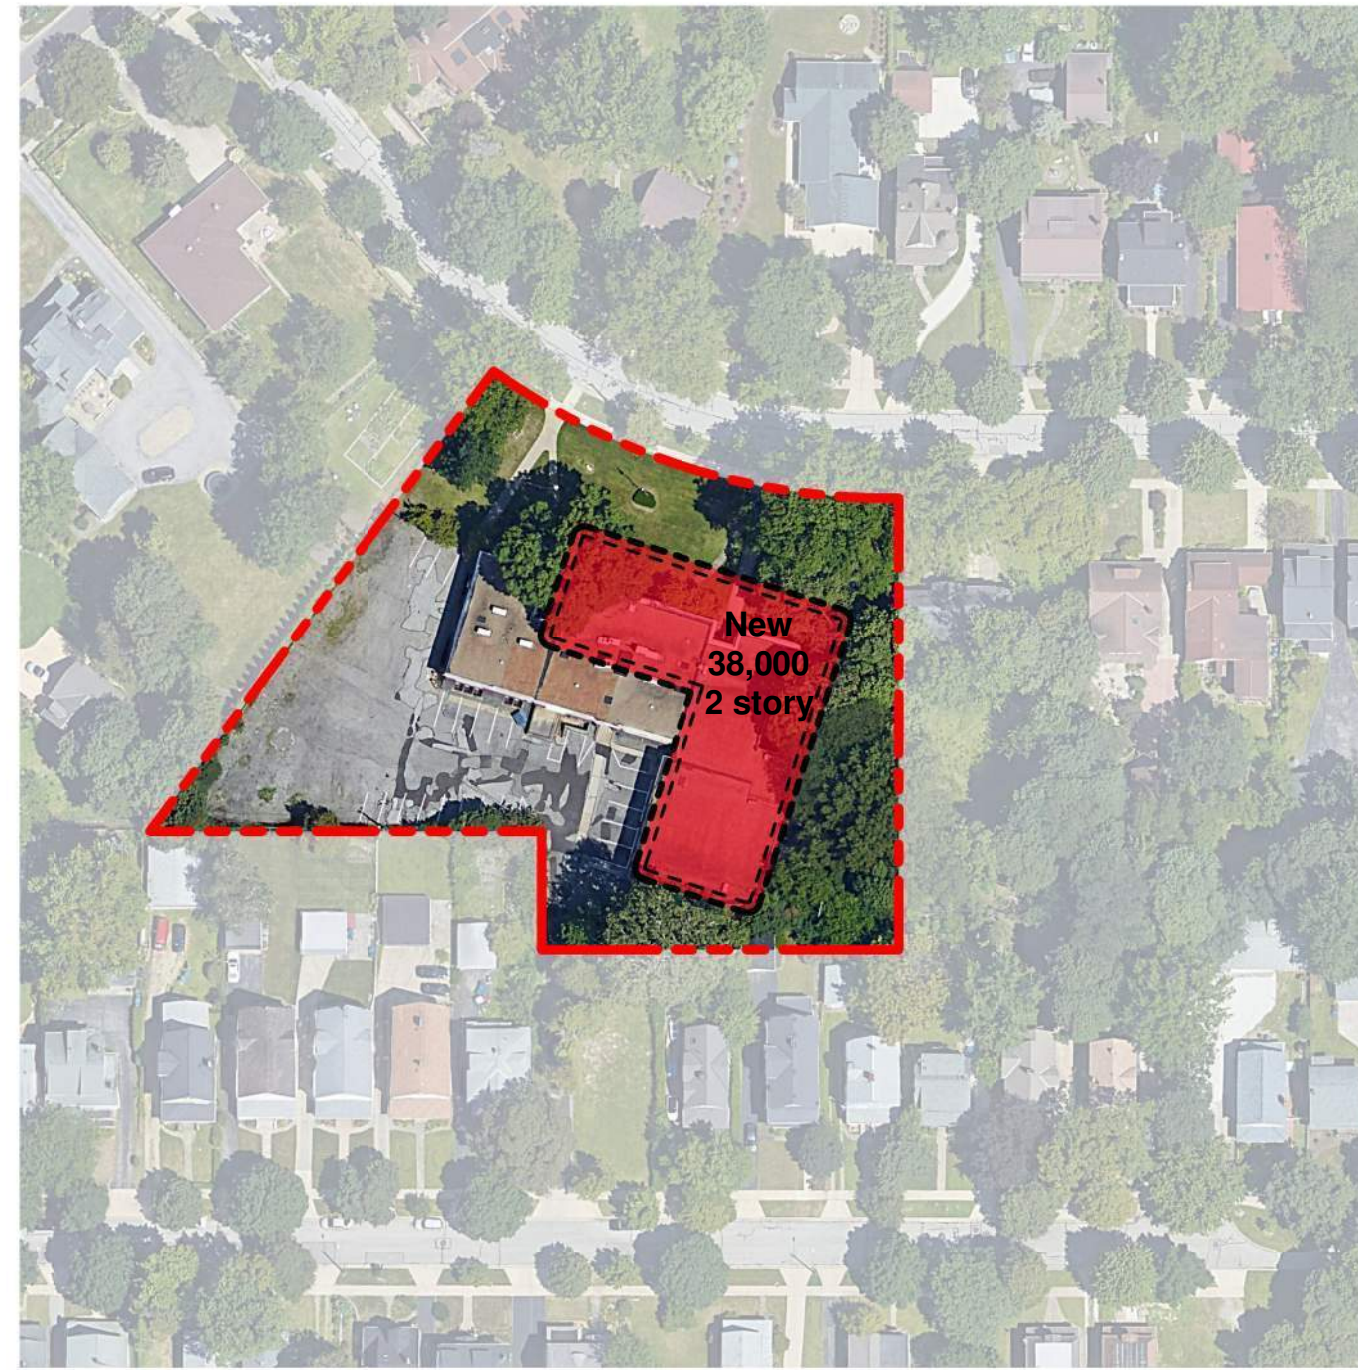
**1C** Concept 1C - Community Center  
1" = 100'-0"

**Concept 1C - Community Center**

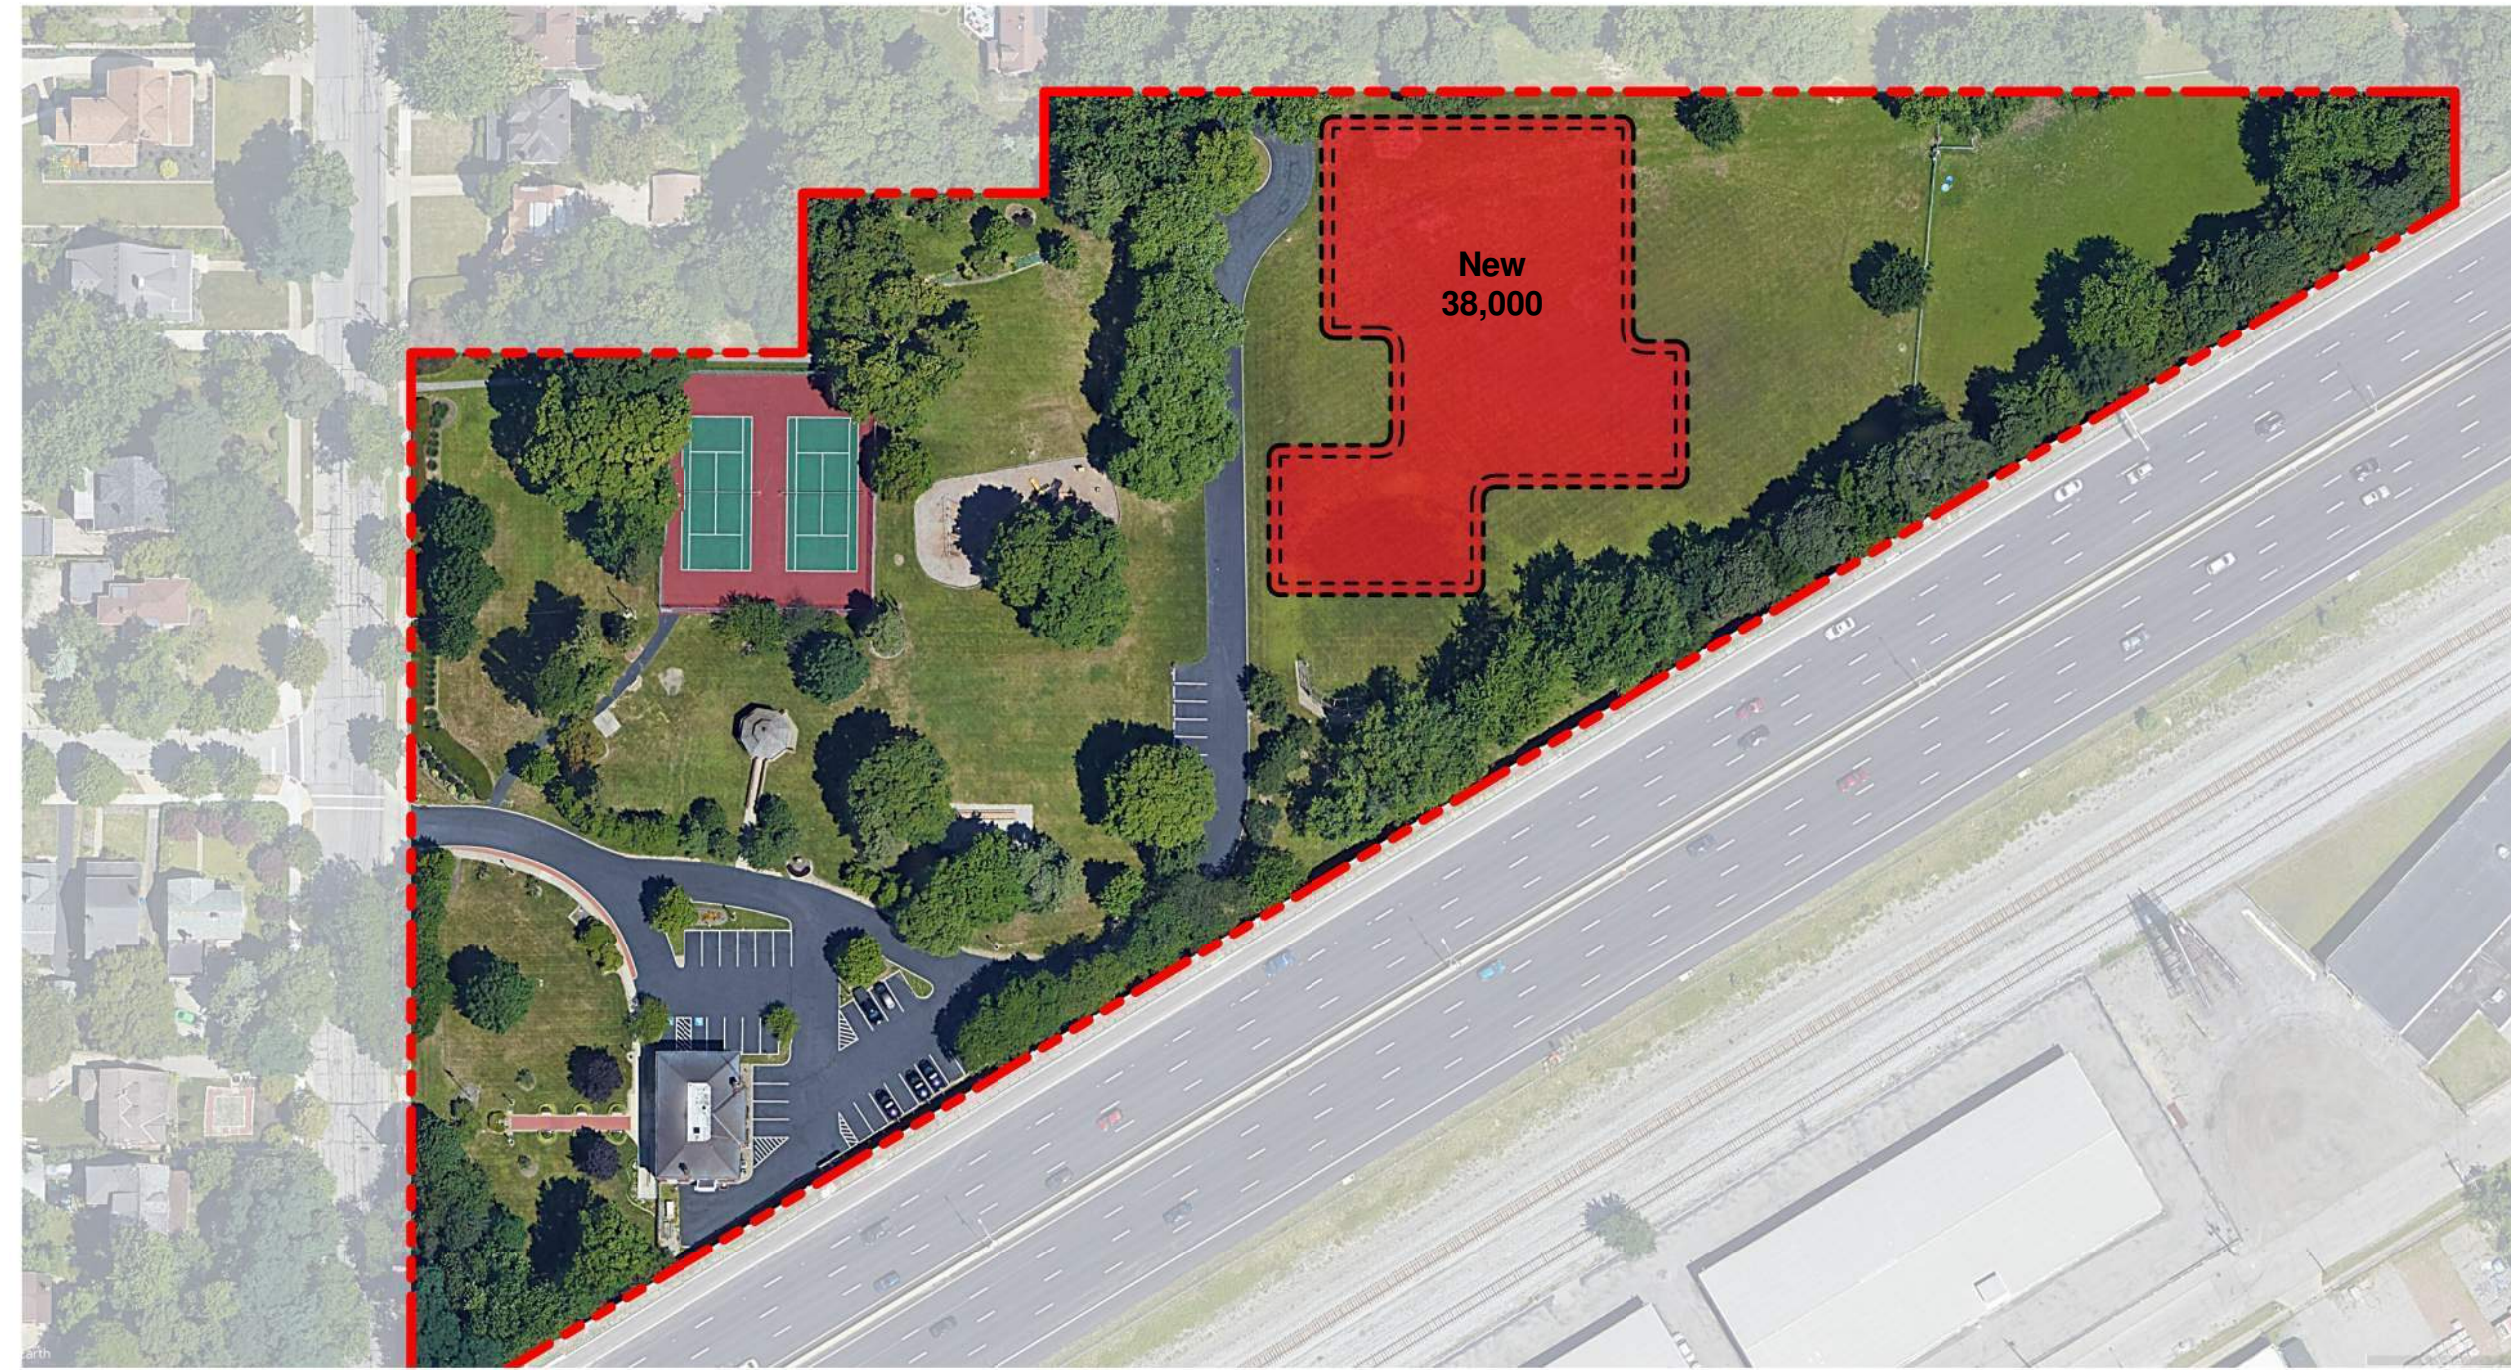
**1B** Concept 1B - Village Hall  
1" = 100'-0"

**Concept 1B - Village Hall**

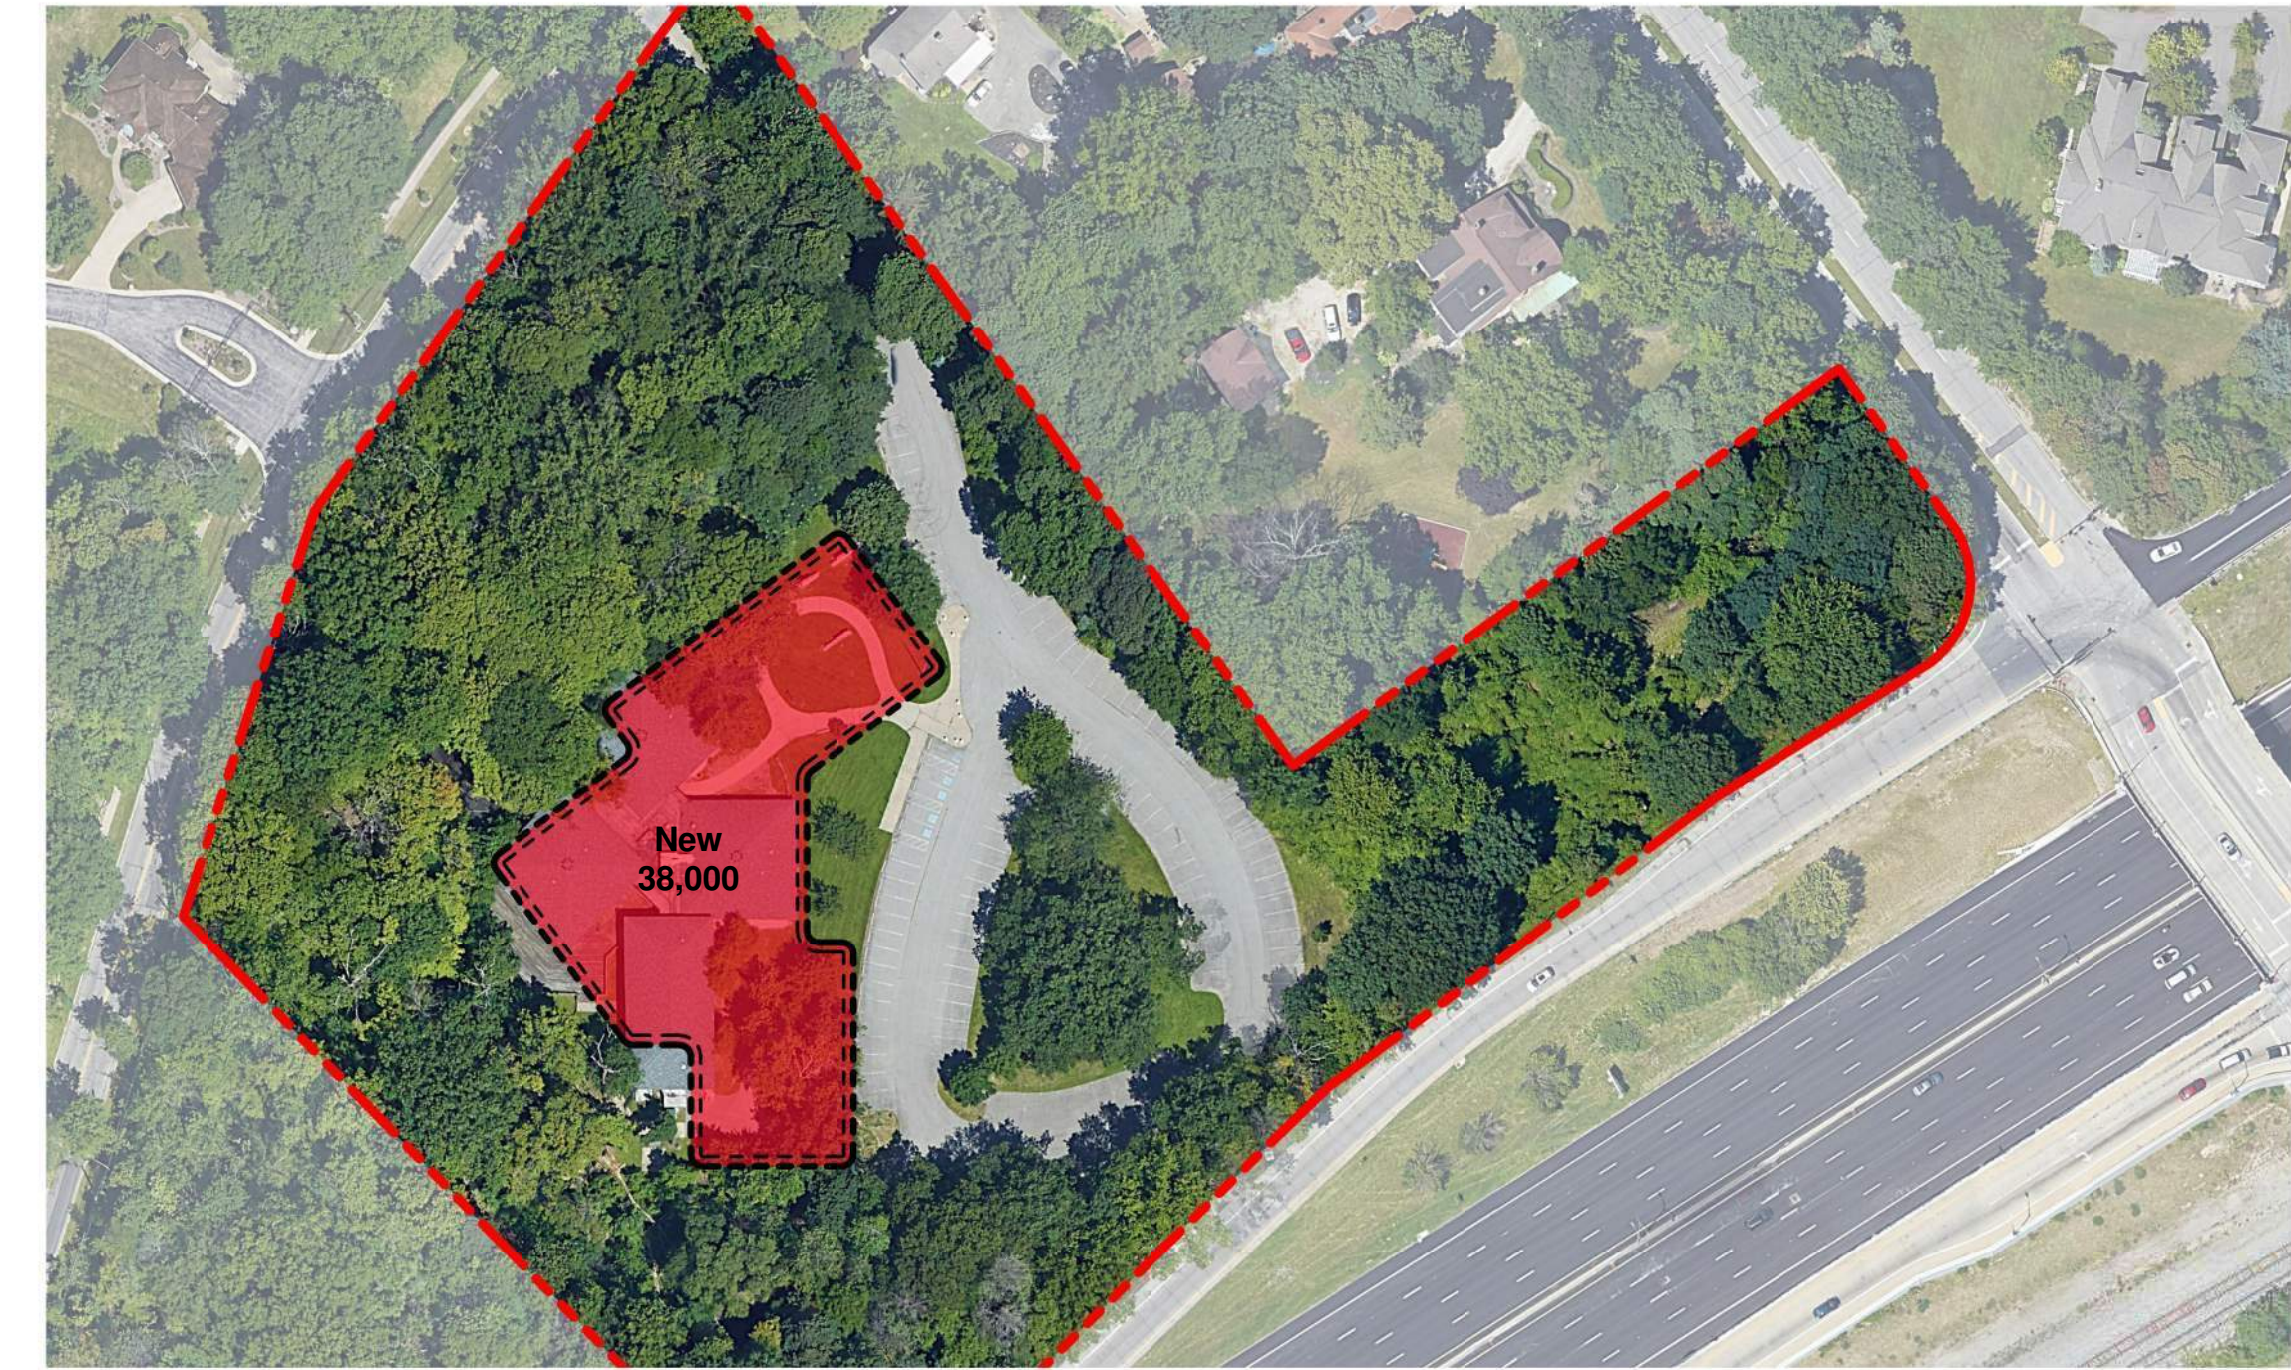
**1A** Concept 1A - Bratenahl Center  
1" = 100'-0"

**Concept 1A - Bratenahl Center**

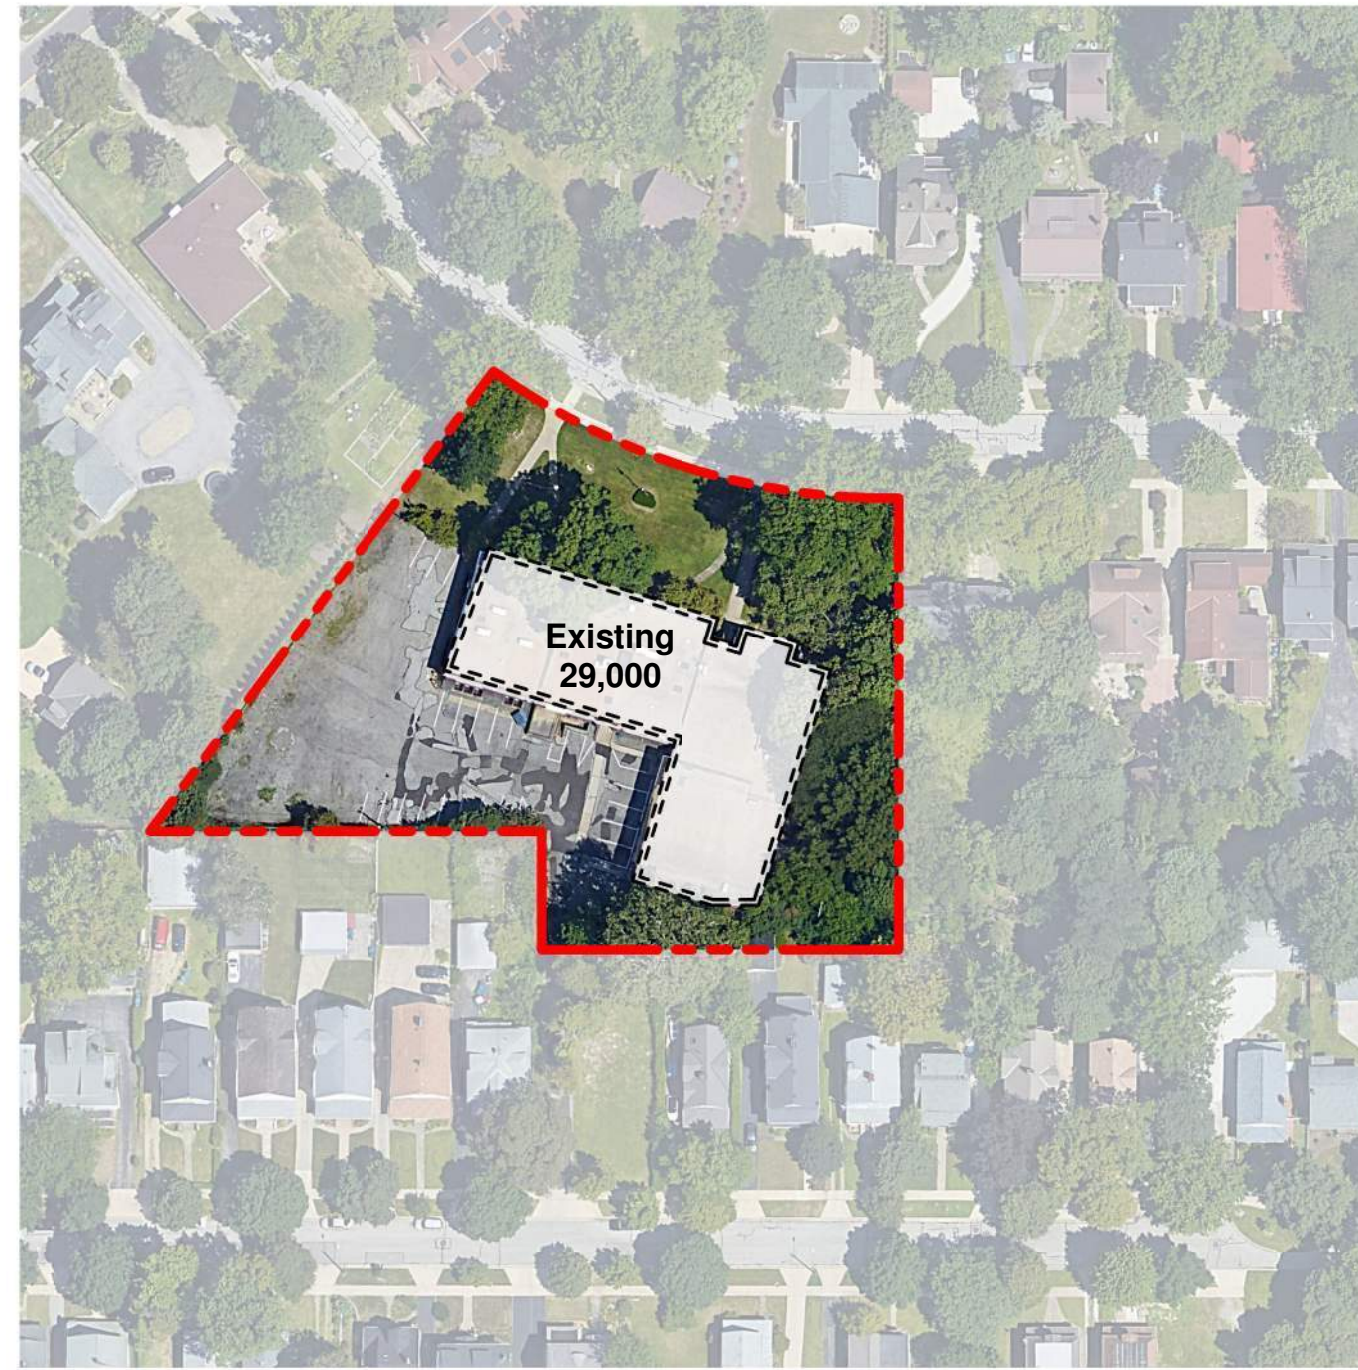
2A.3 Concept 2A - Community Center  
1" = 100'-0"

**Concept 2A - Rec at Community Center, Police at Village Hall and Admin at Bratenahl Center**

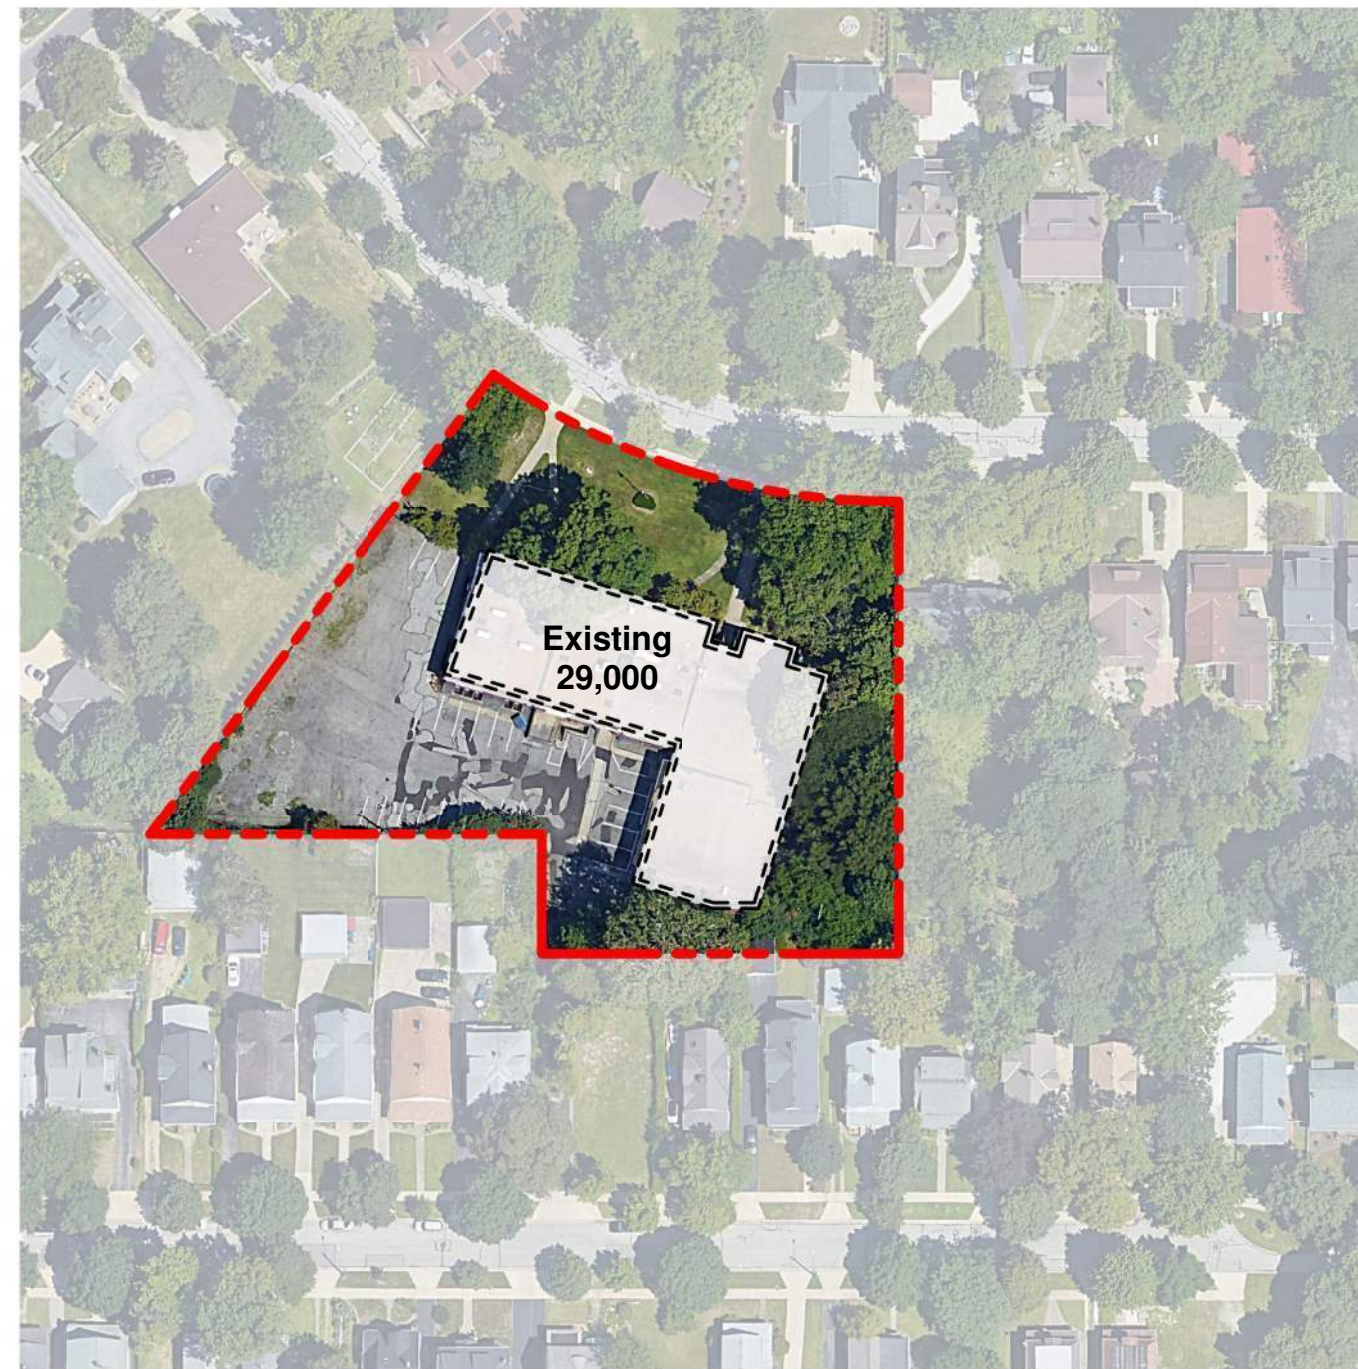
2 Concept 2B - Community Center  
1" = 100'-0"

**Concept 2B - Rec at Community Center, Police at Bratenahl Center and Admin at Village Hall**

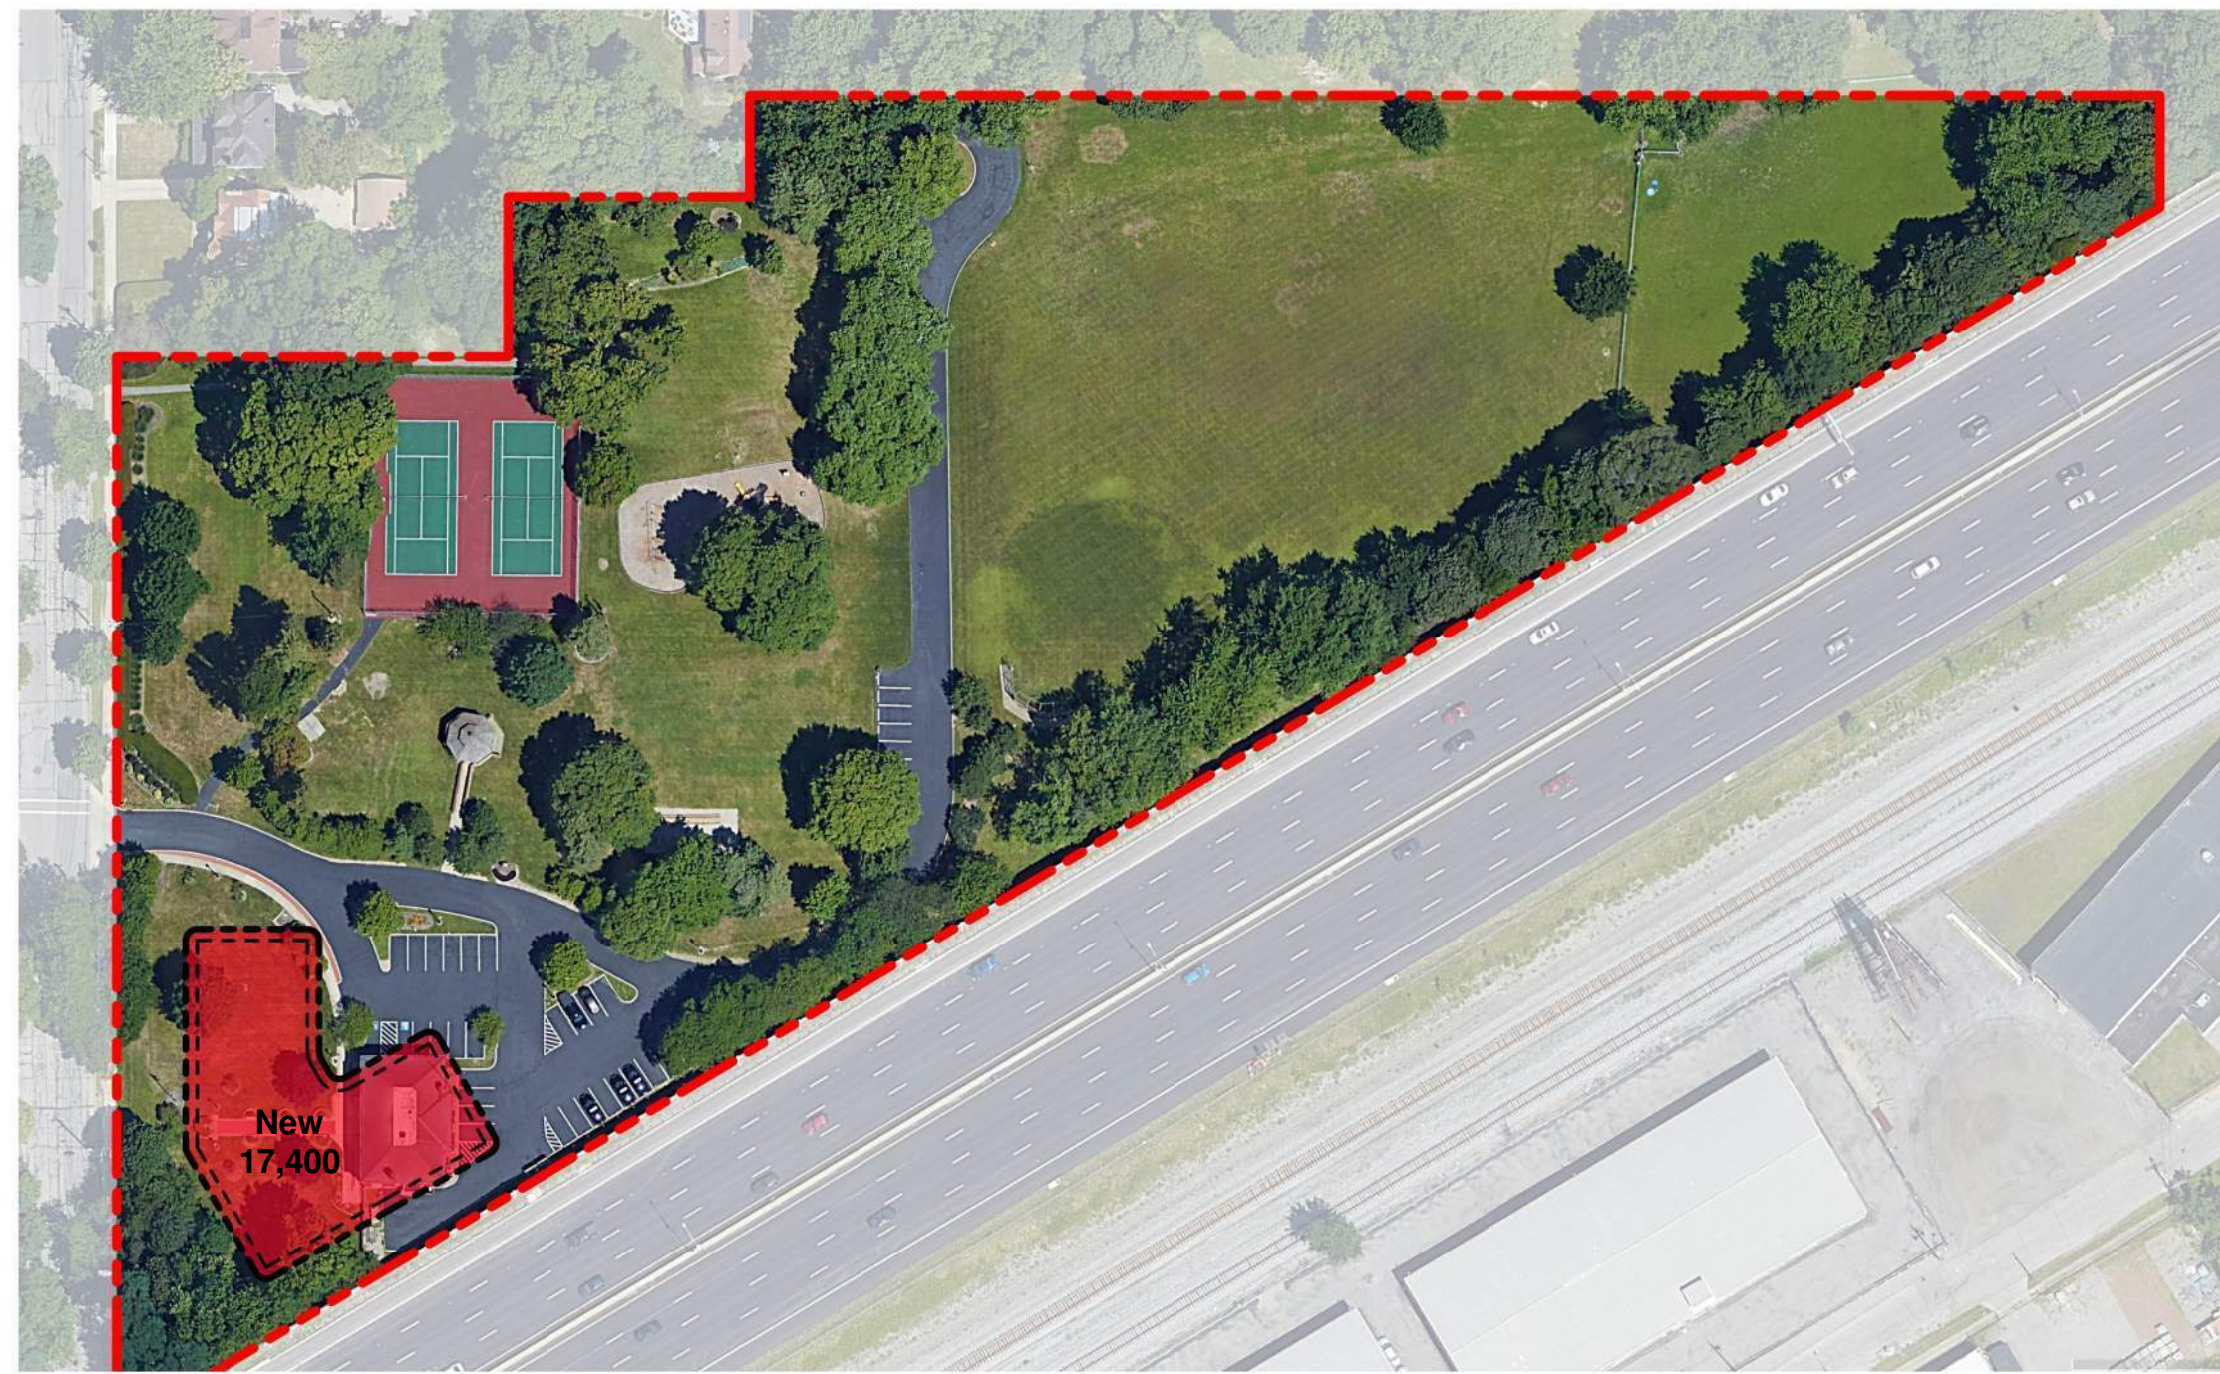
3C.1 Concept 3C - Village Hall  
1" = 100'-0"

**Concept 3C - Rec at Bratenahl Center, Police/Admin at Village Hall**

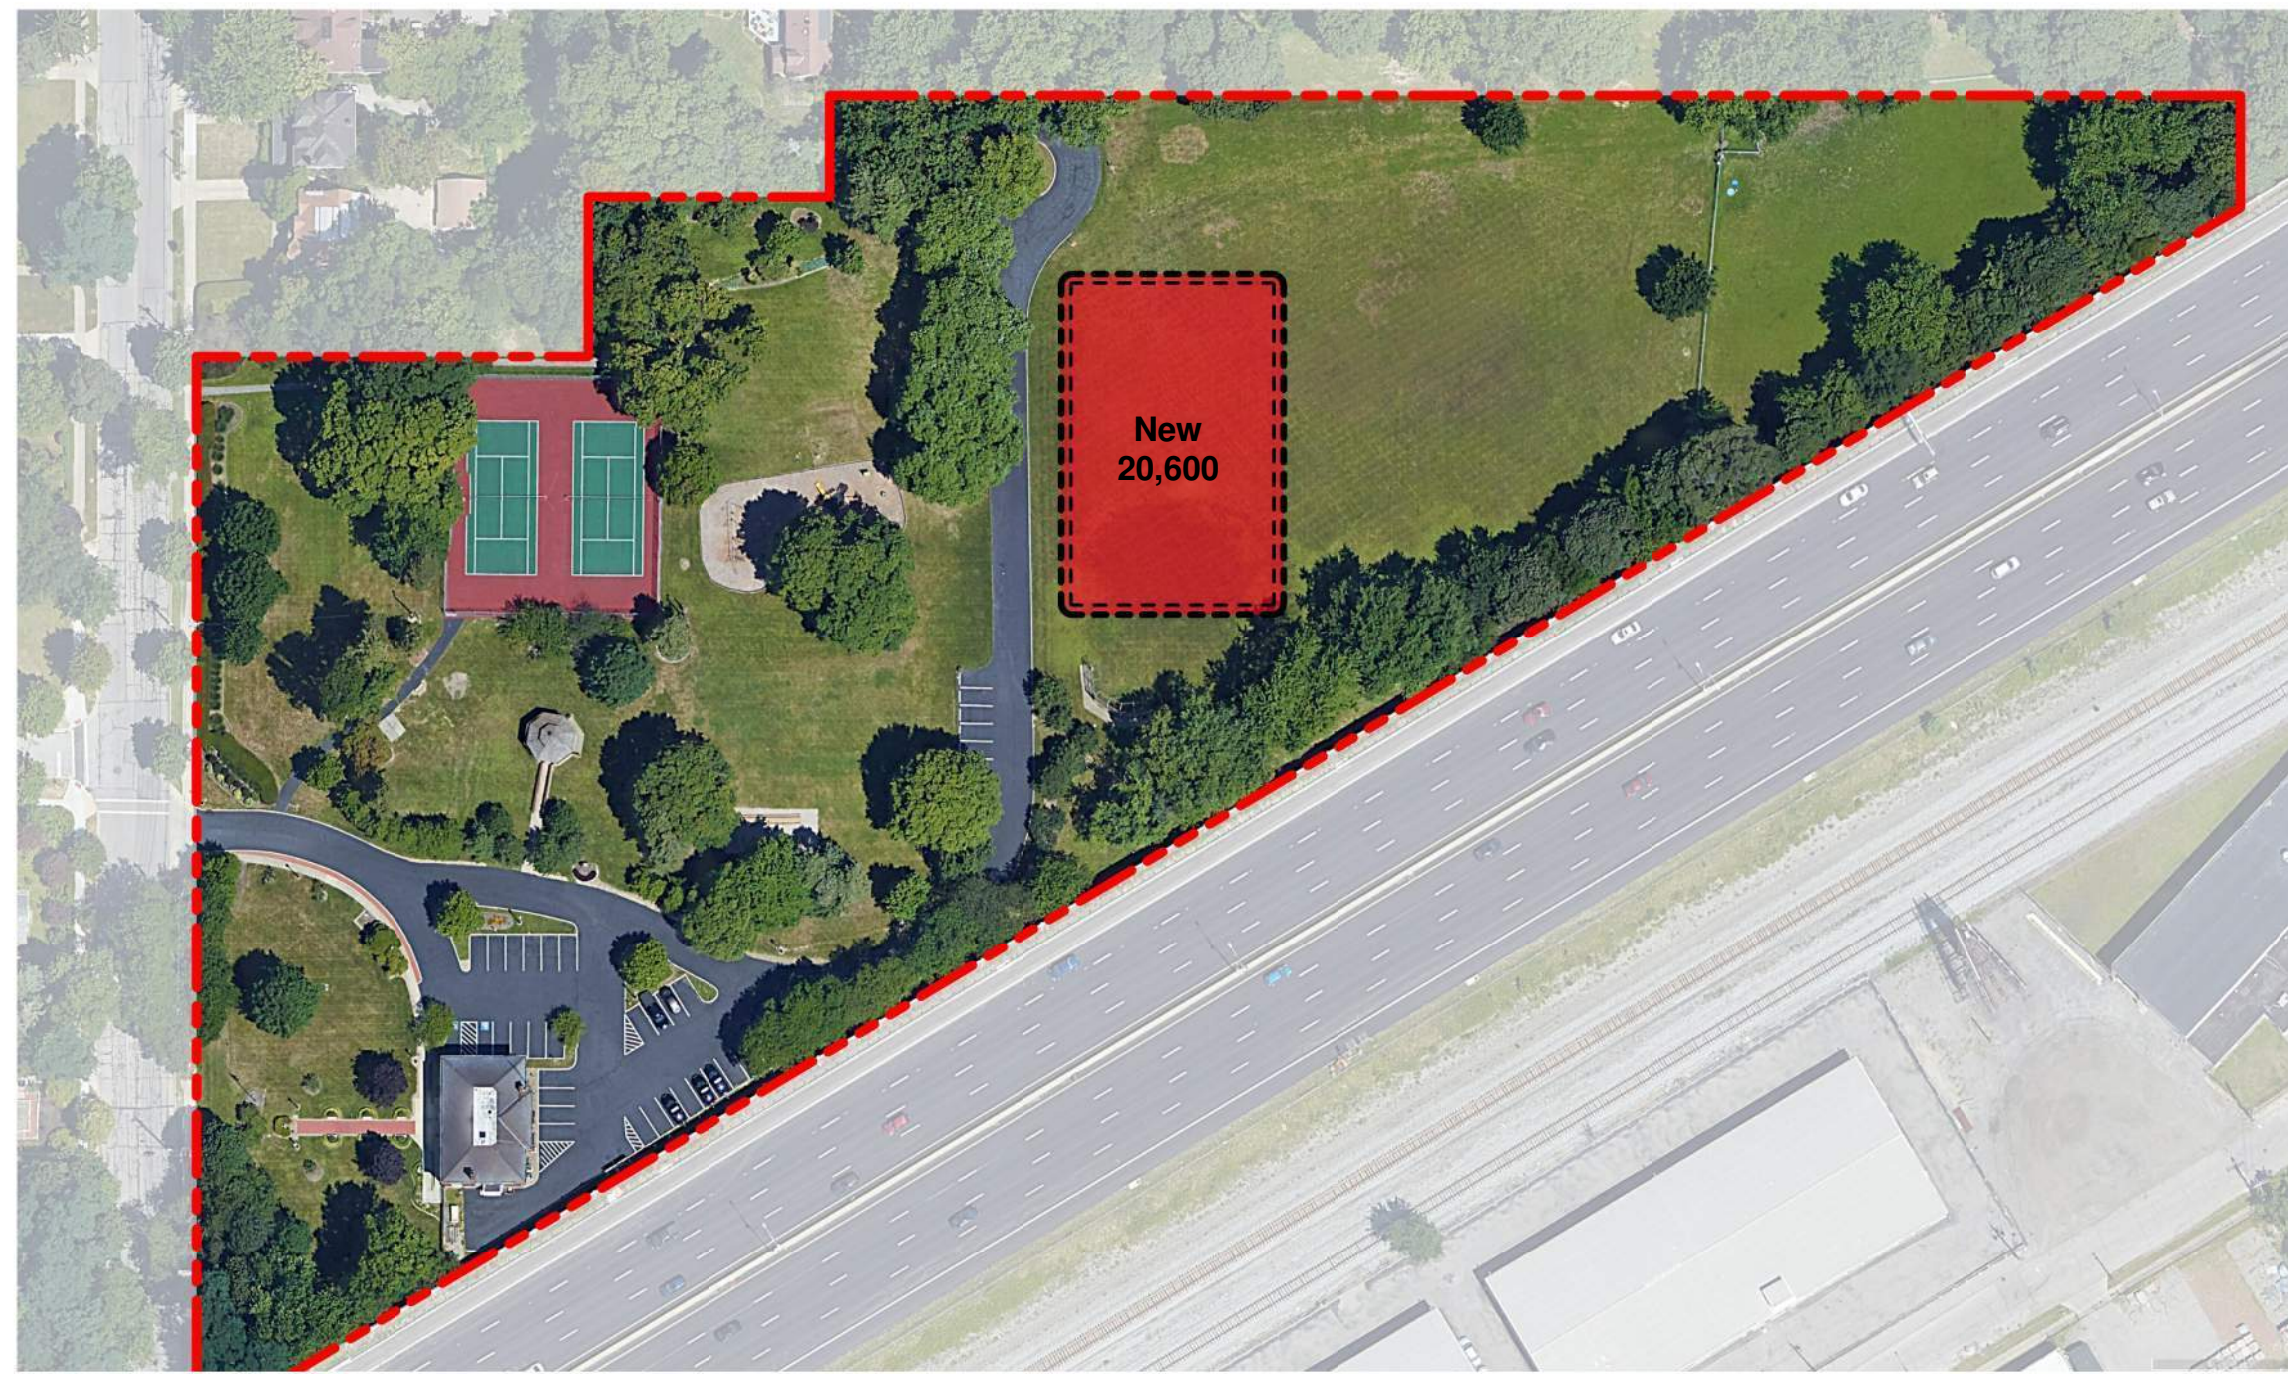
3B.1 Concept 3B - Village Hall  
1" = 100'-0"

**Concept 3B - Rec at Village Hall, Police/Admin at Bratenahl Center**

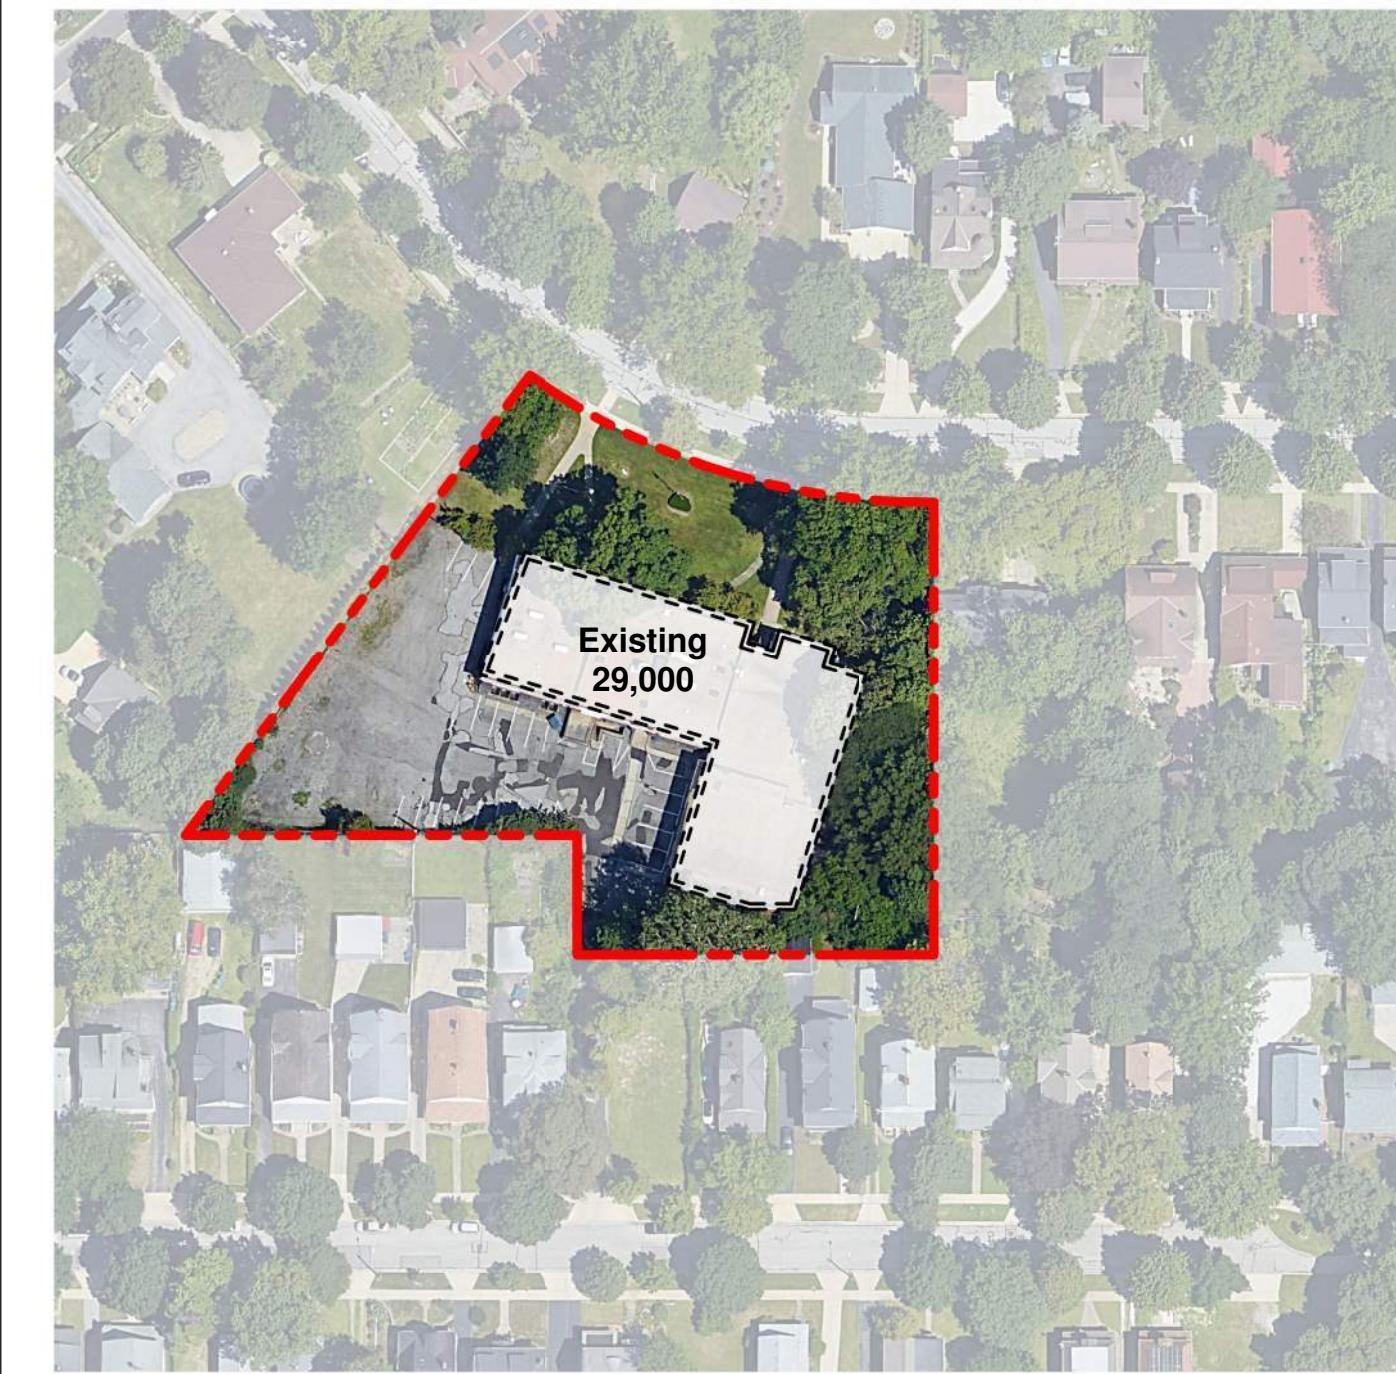
3A.1 Concept 3A - Community Center  
1" = 100'-0"

**Concept 3A - Rec at Community Center, Police/Admin at Bratenahl Center**
