VILLAGE OF BRATENAH  
VILLAGE CENTER  
FEASIBILITY STUDY

## 2022 Bratenahl Condition Assessments

### Bratenahl Center – Facade Observations & Recommendations

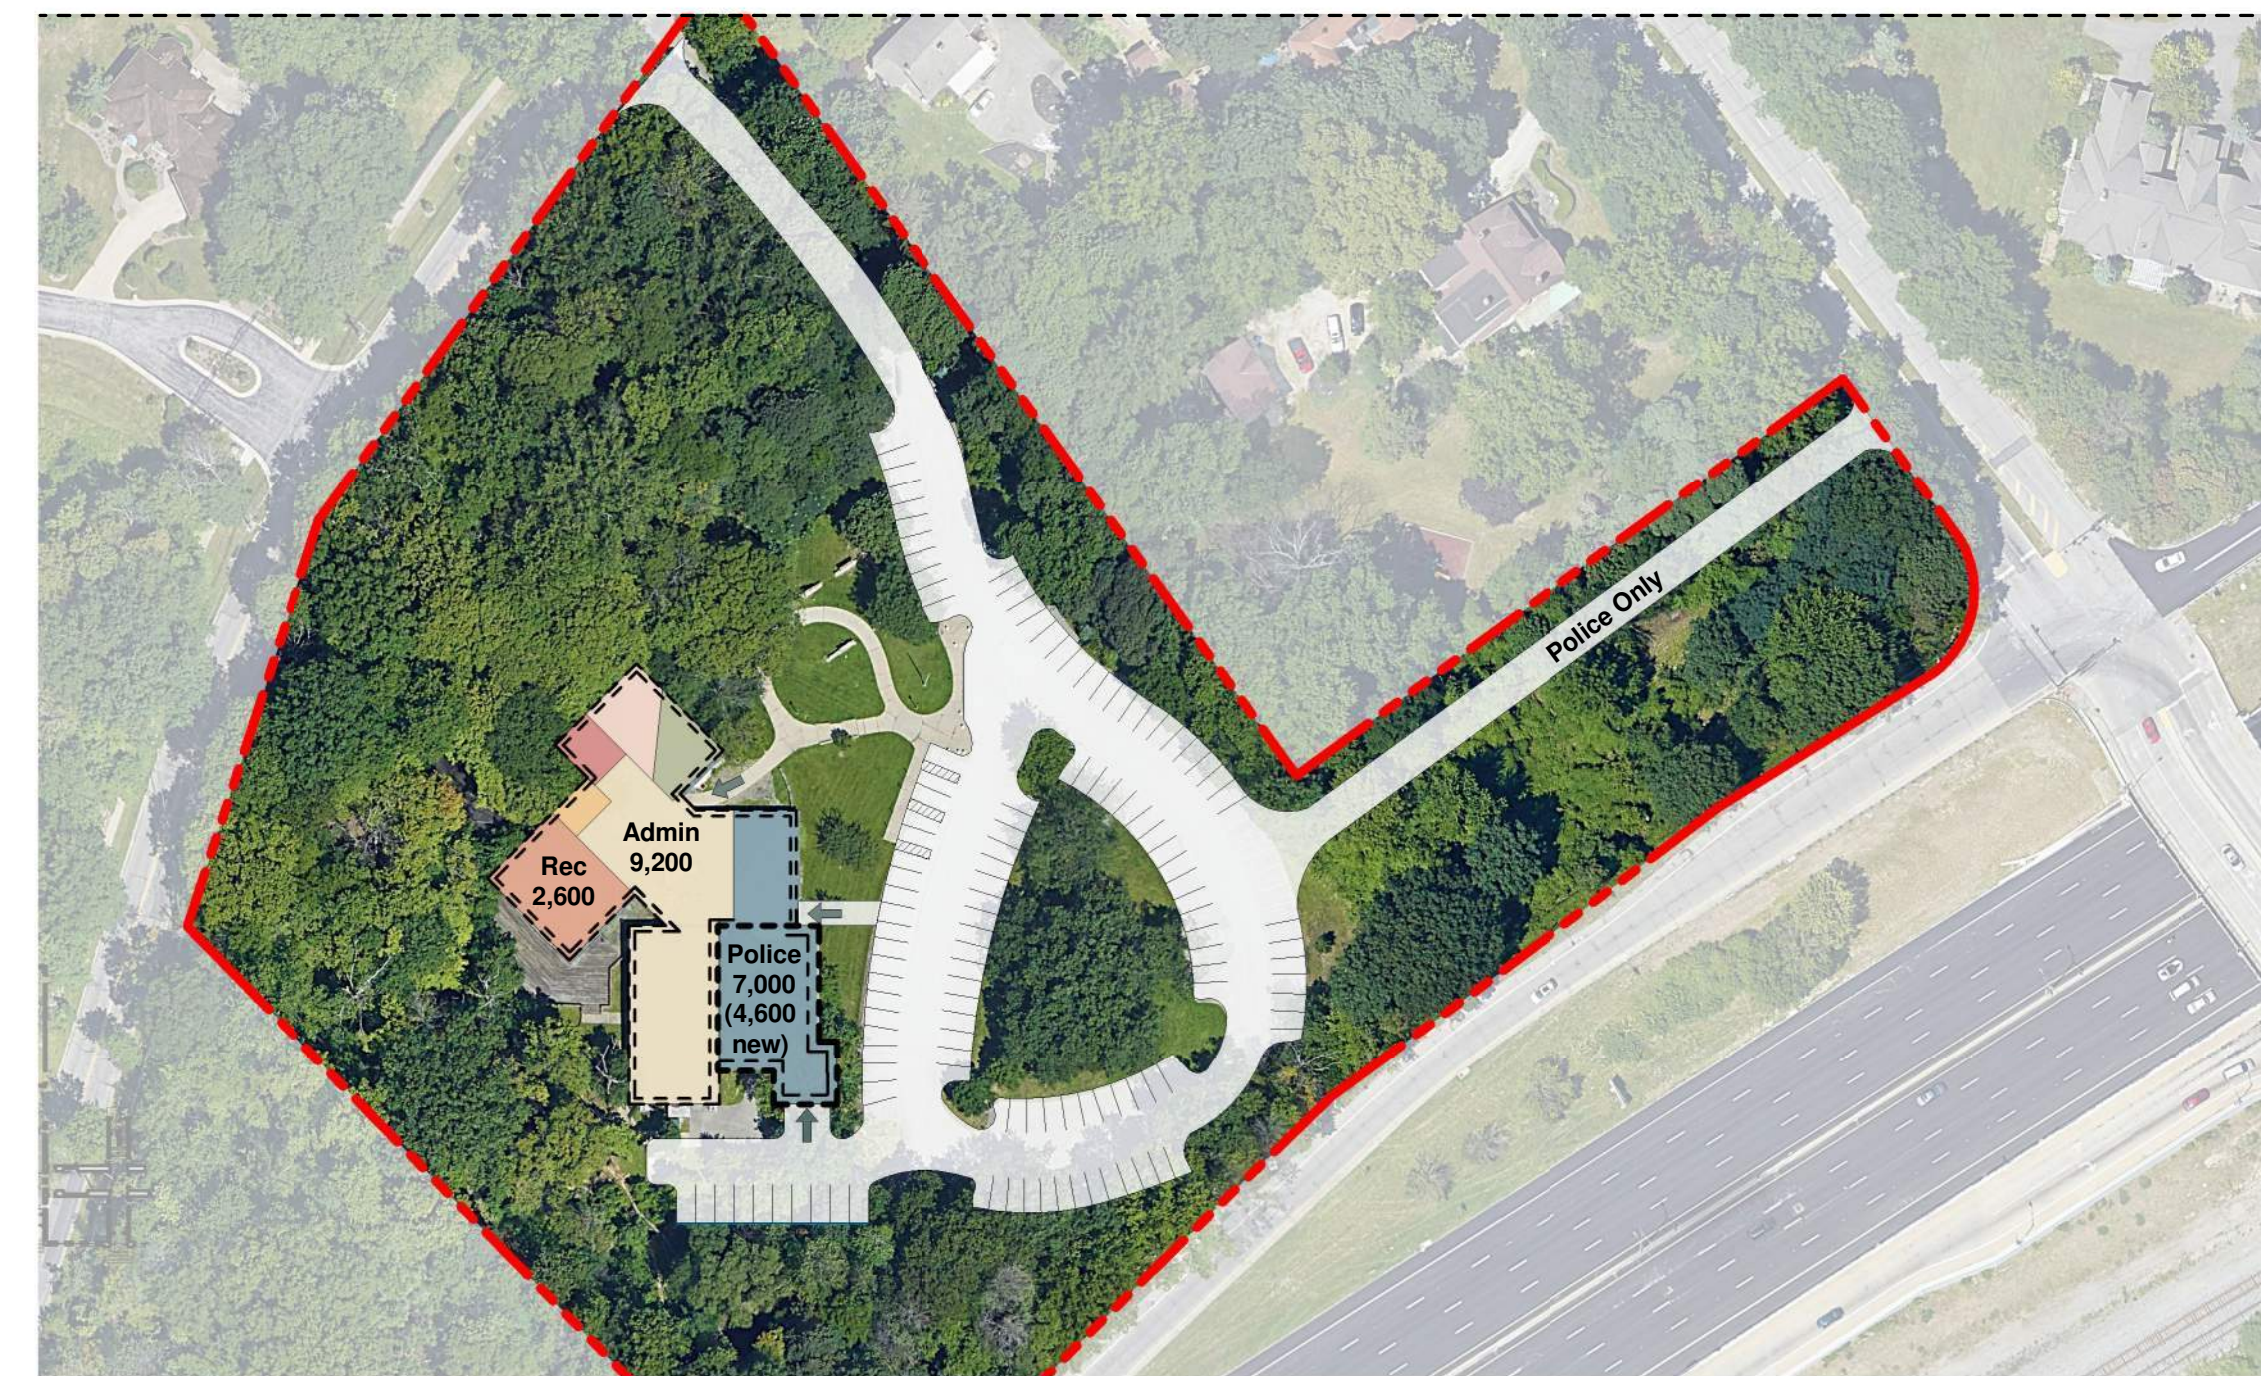
Concept 1A.2 - Campus Center (1 Site)

All services located at Bratenahl Center - Renovation + Addition

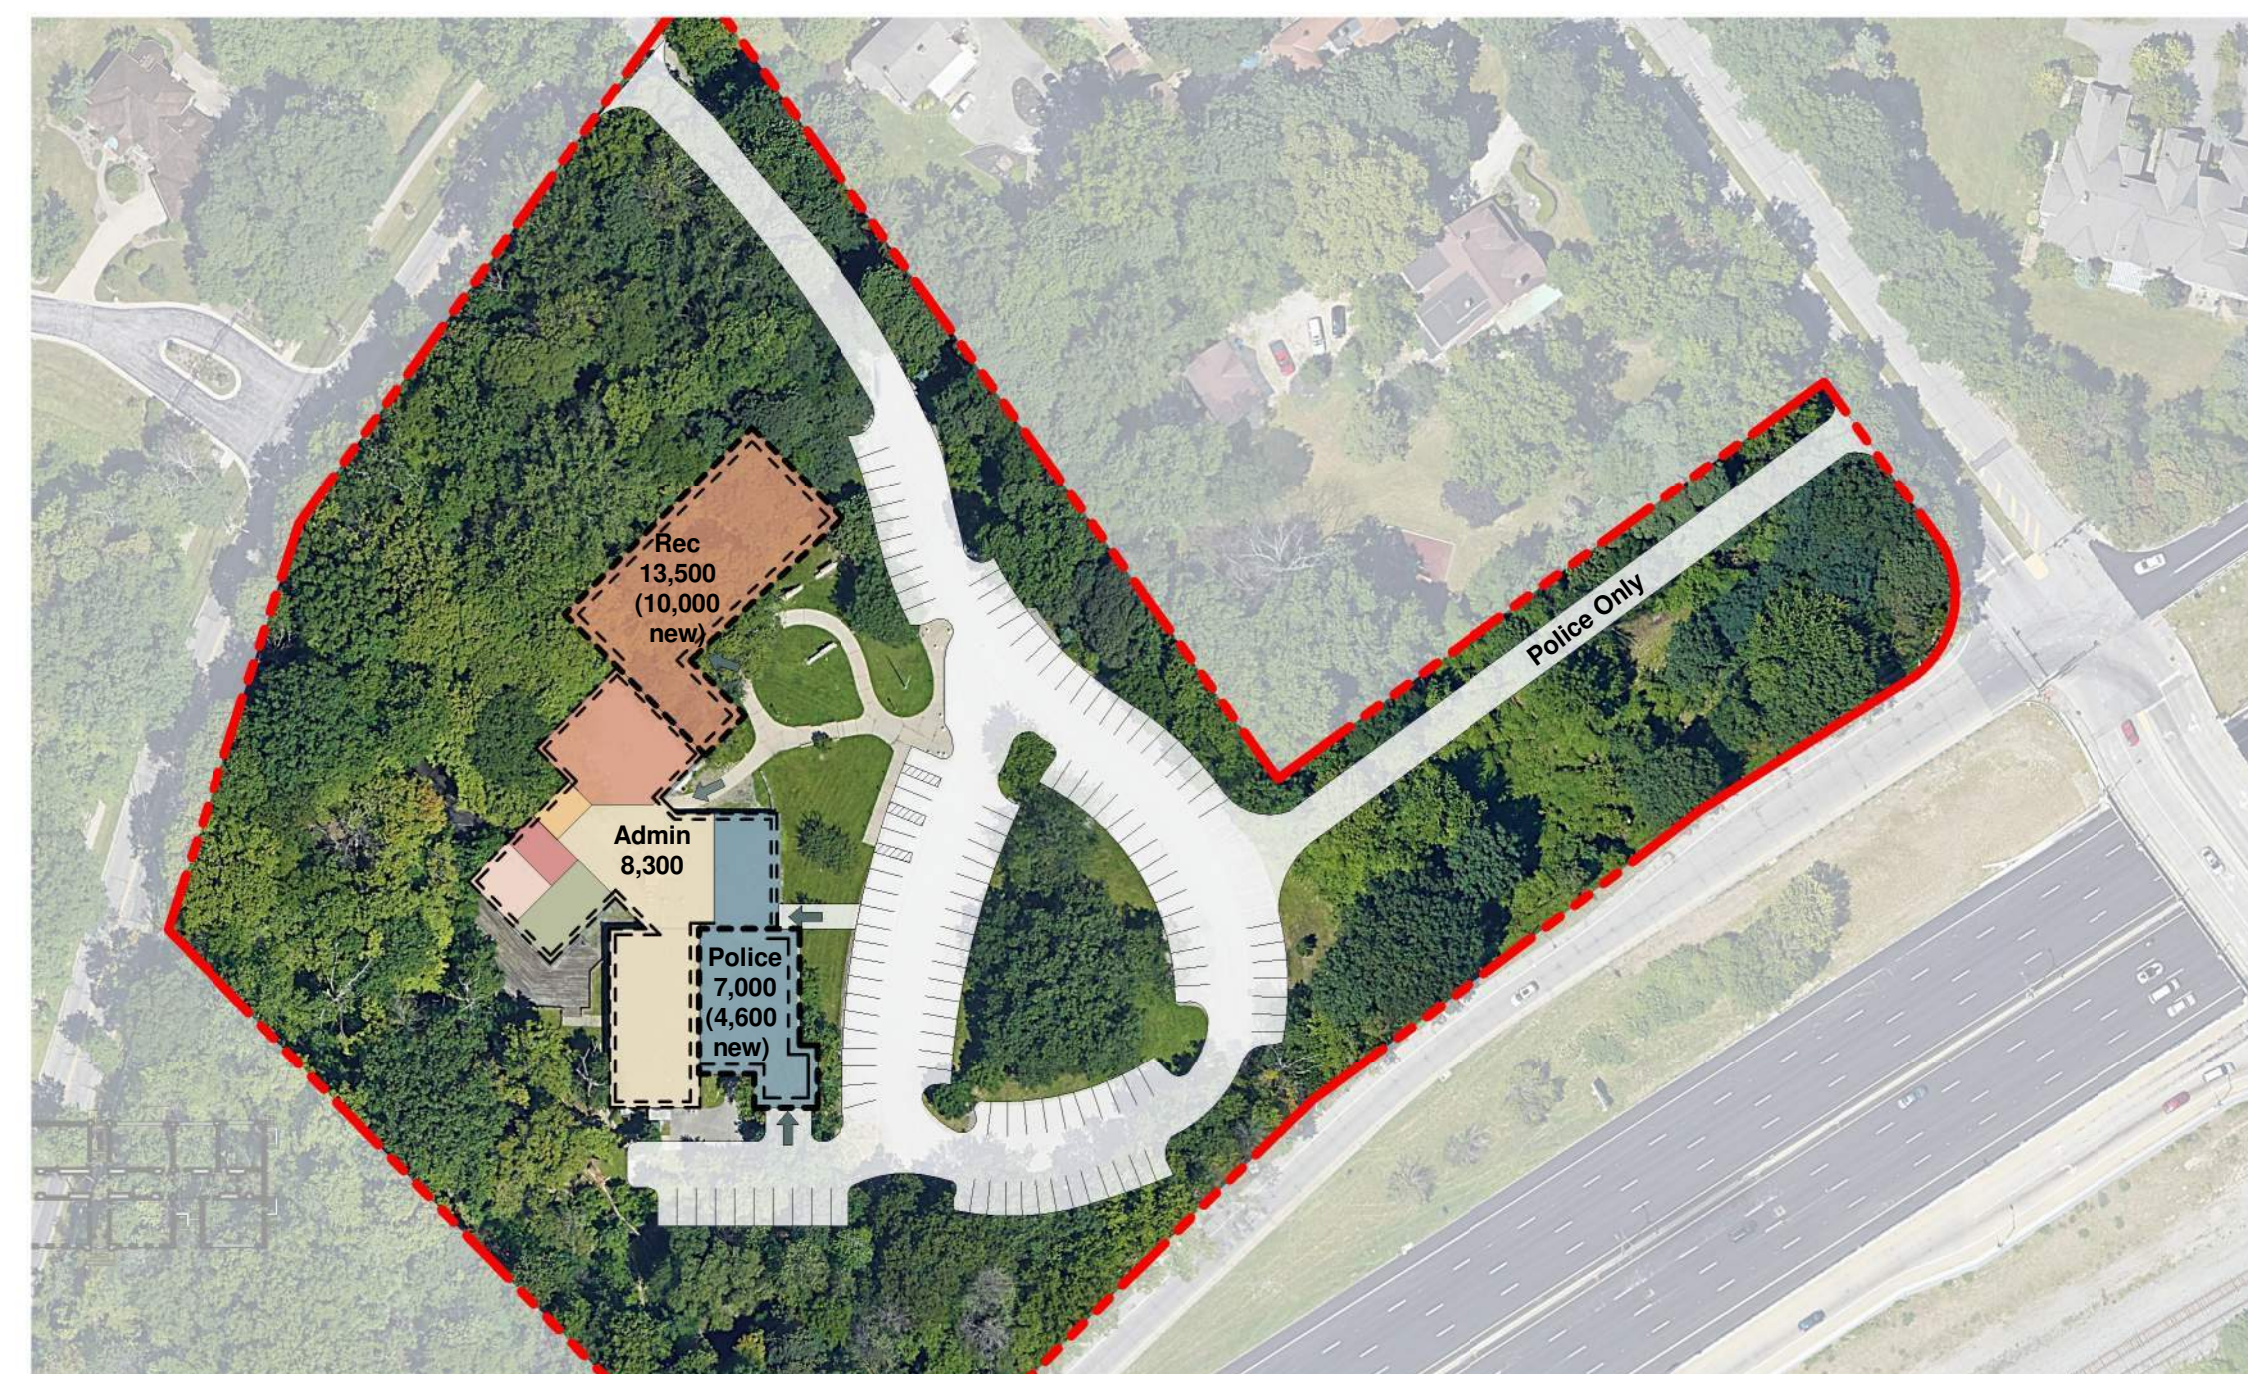
**Concept 1A.1 - Campus Center (1 Site)**

**All services located at Bratenahl Center - Renovation + Addition**

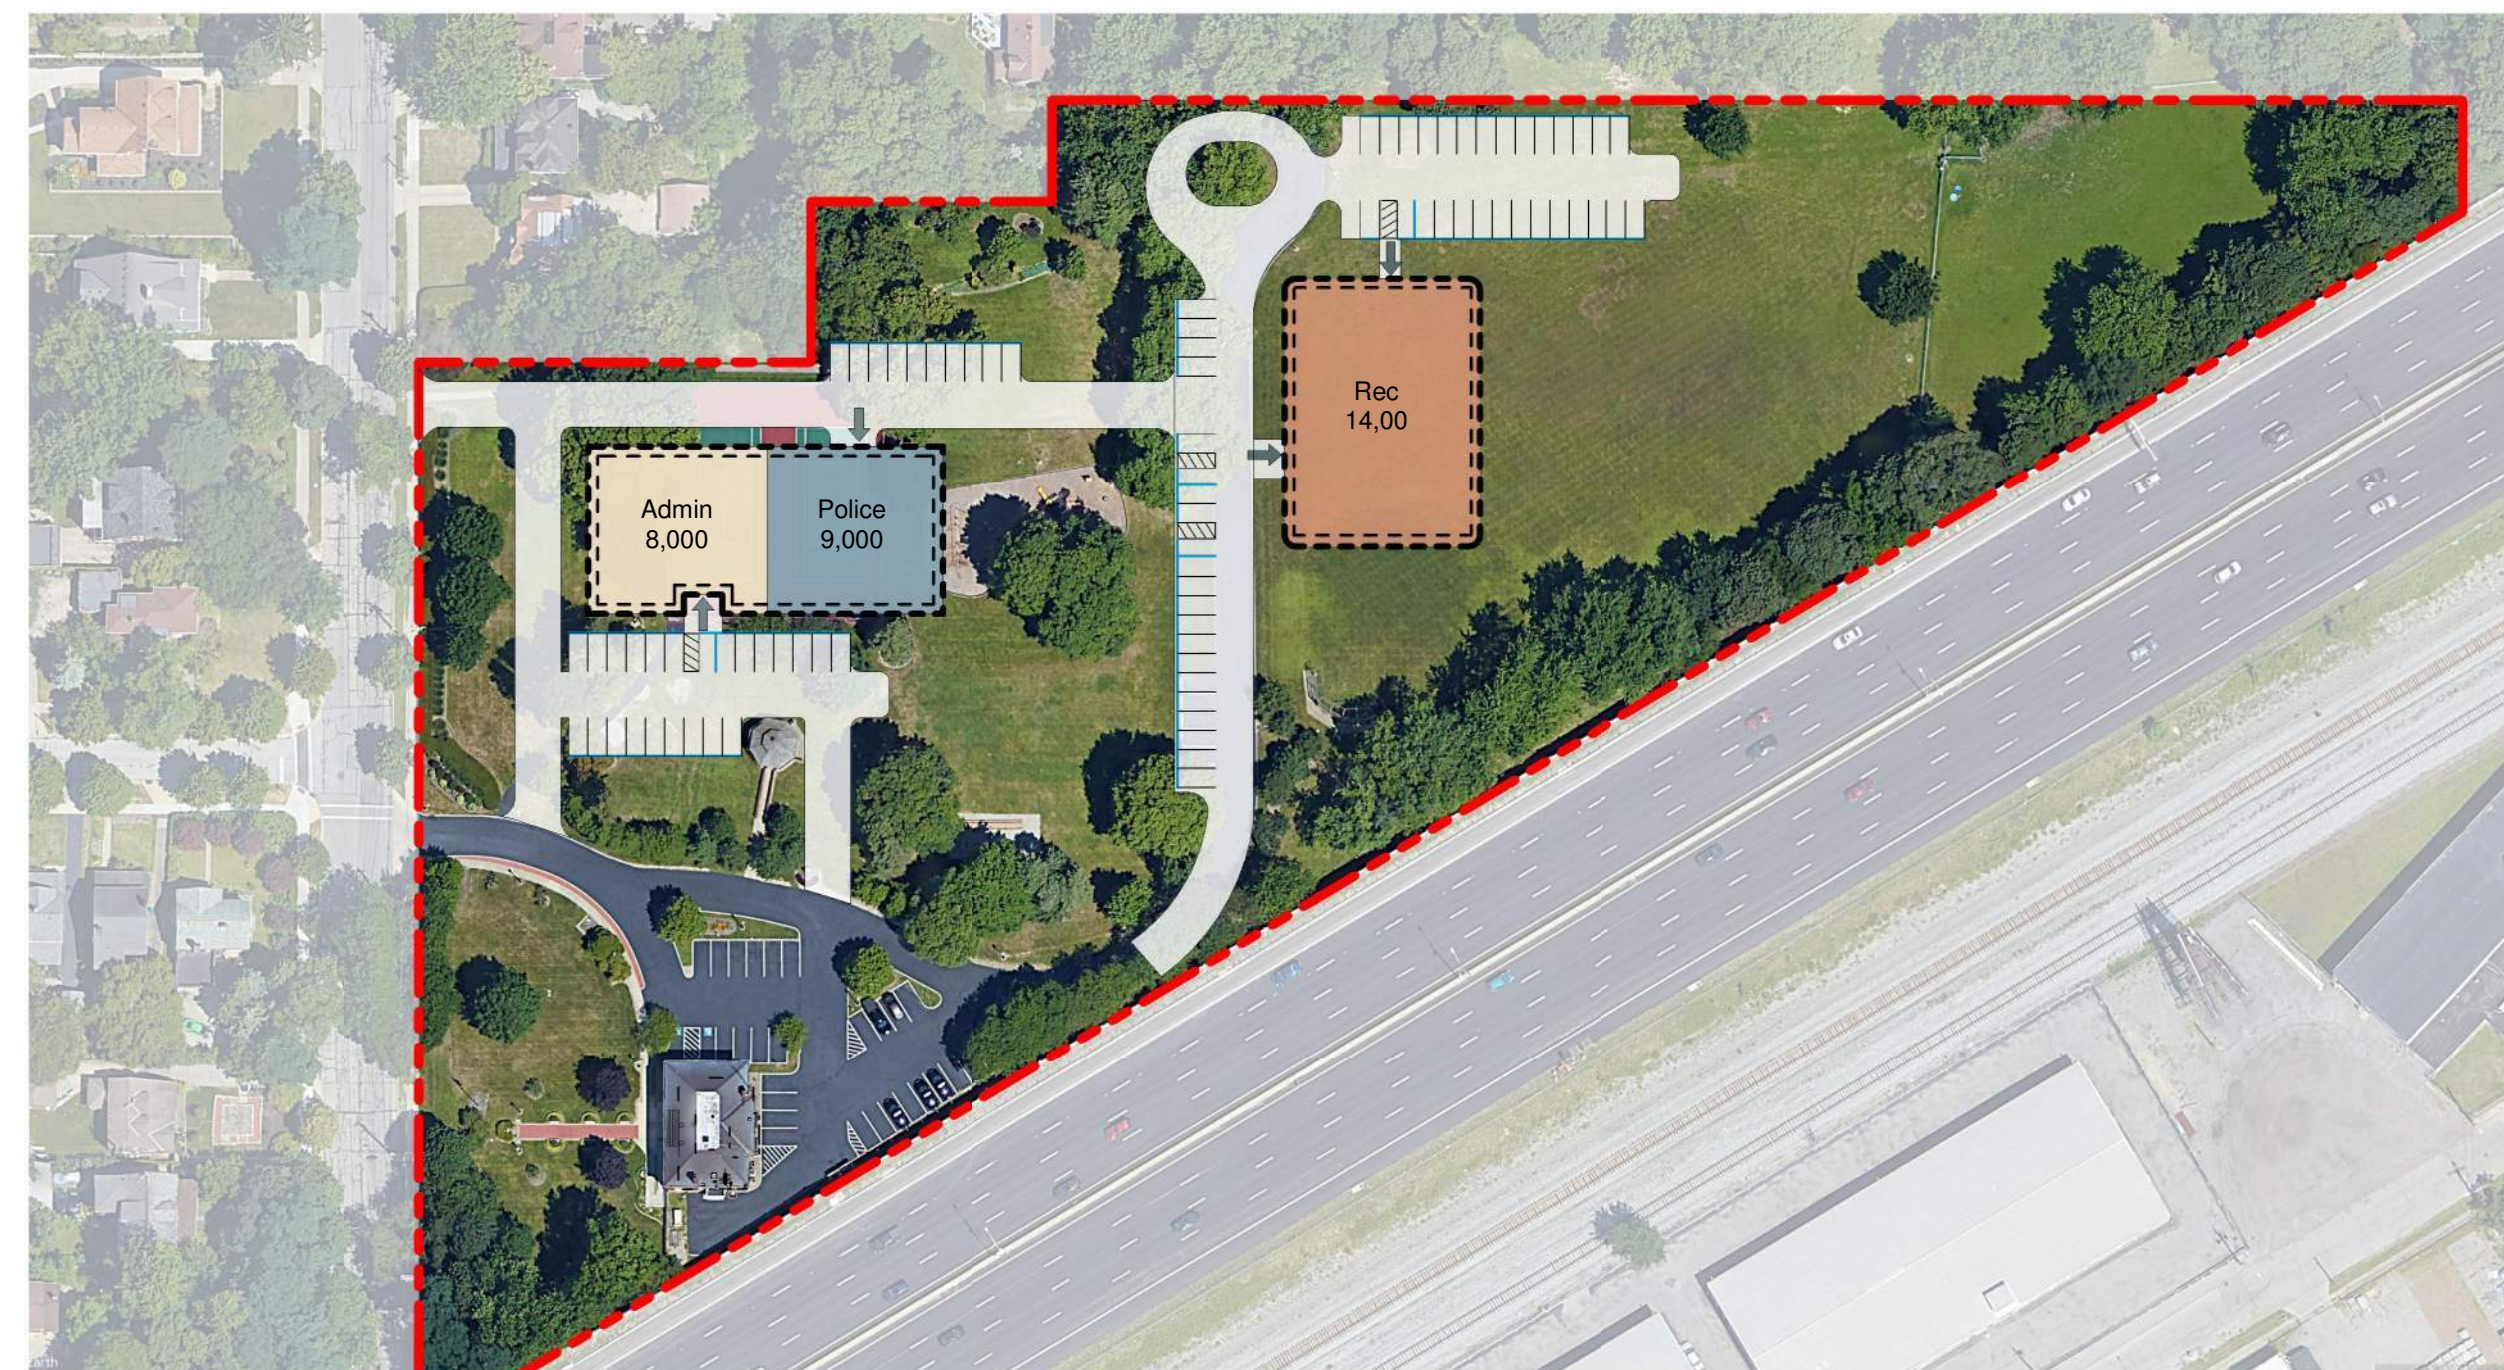
**Concept 1B.1 - Campus Center (1 Site)**

**All services located at Village Hall Site - New Construction, 2 Buildings**

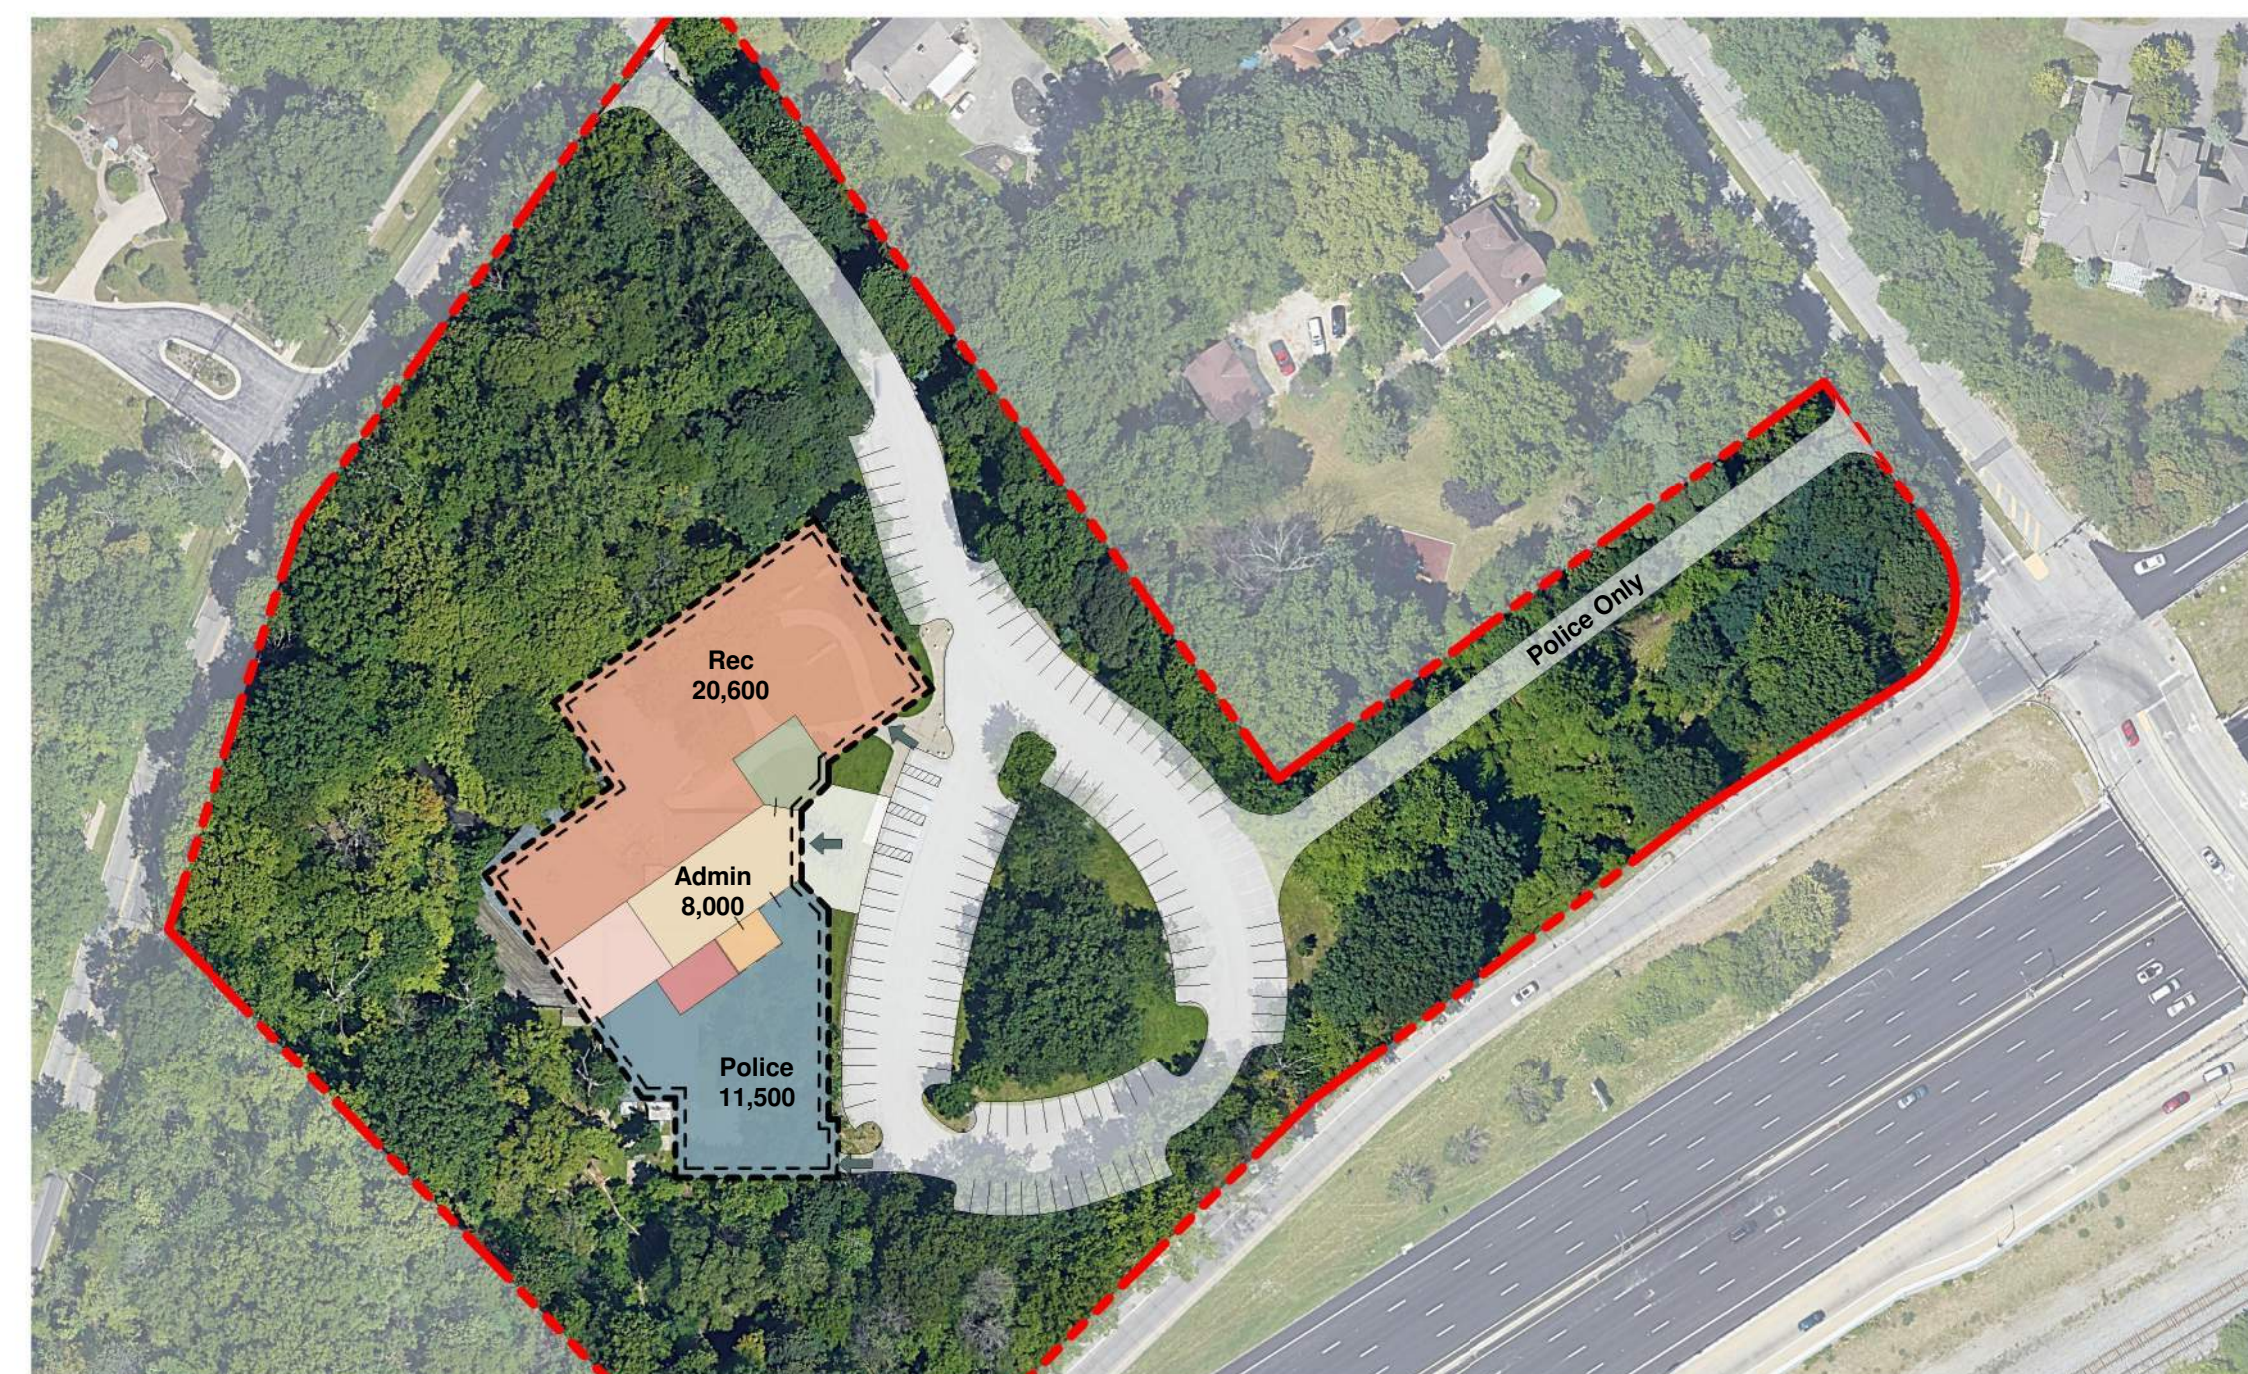
**Concept 1A - Campus Center (1 Site)**

**All services located at Bratenahl Center - New Construction**

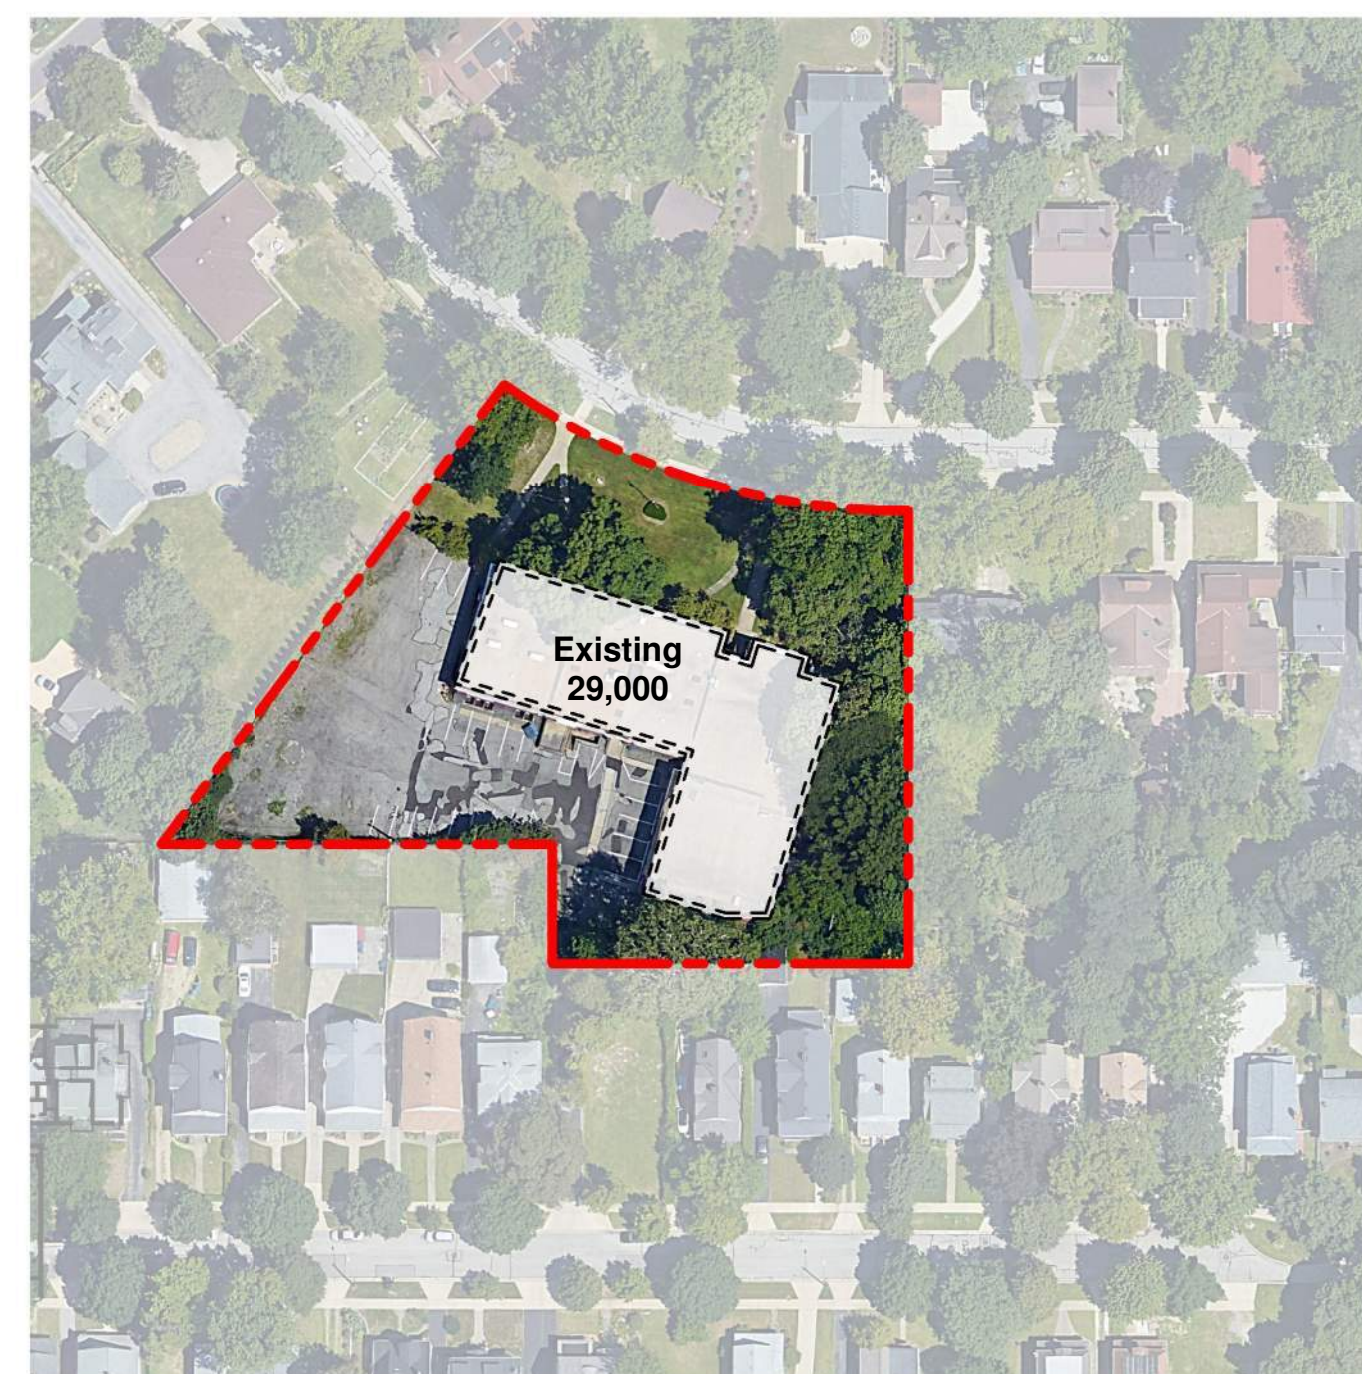
**Concept 3A - Hybrid (2 Sites)**

**Rec to remain at Community Center**

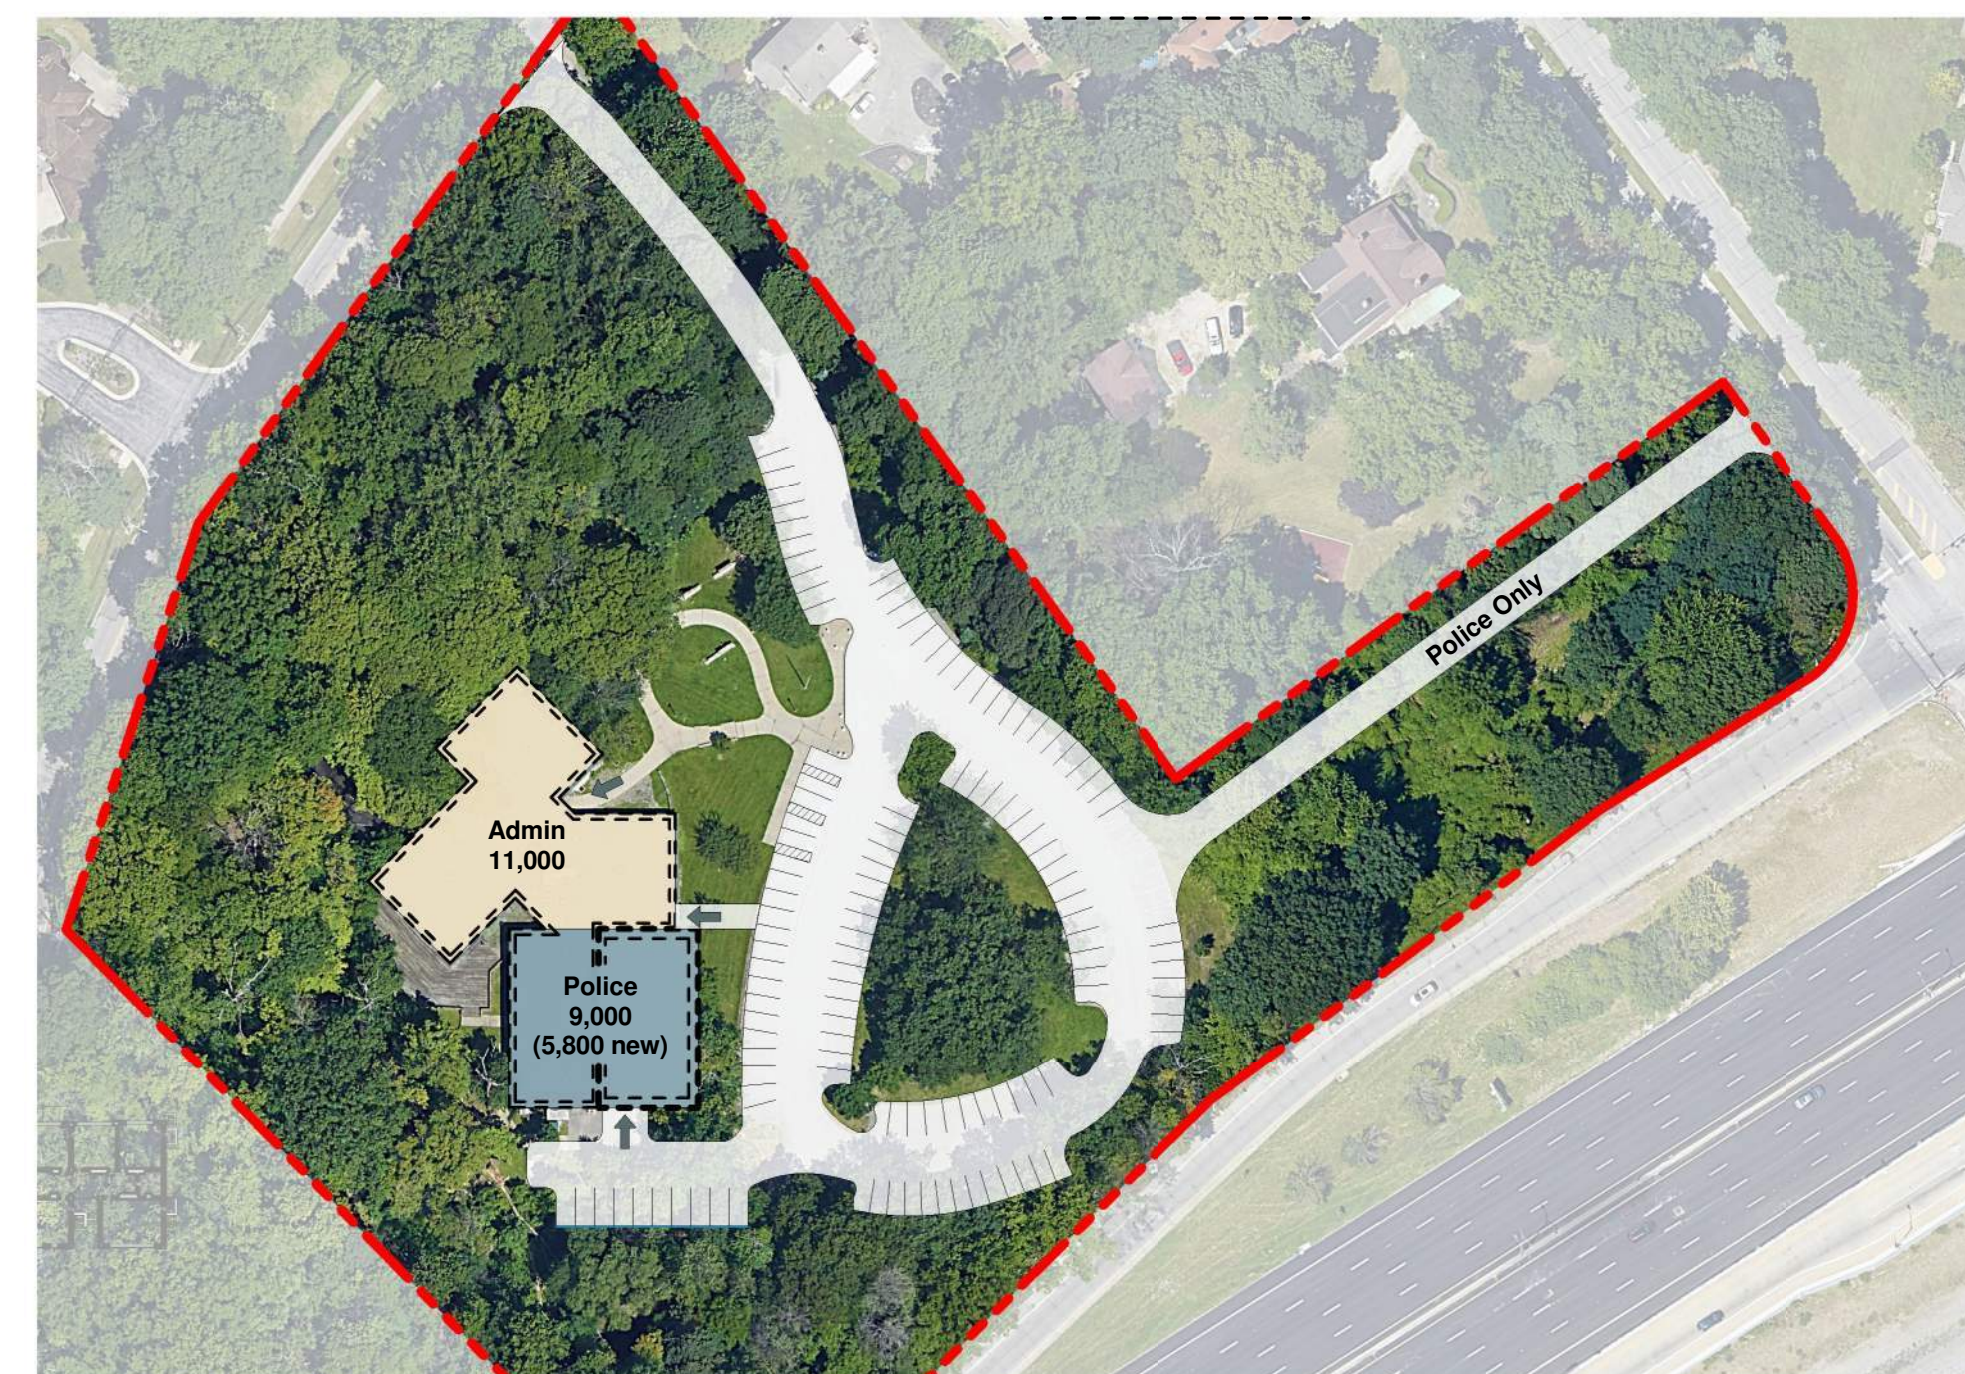
**Village Admin and Police at Bratenahl Center - Renovation + Addition**

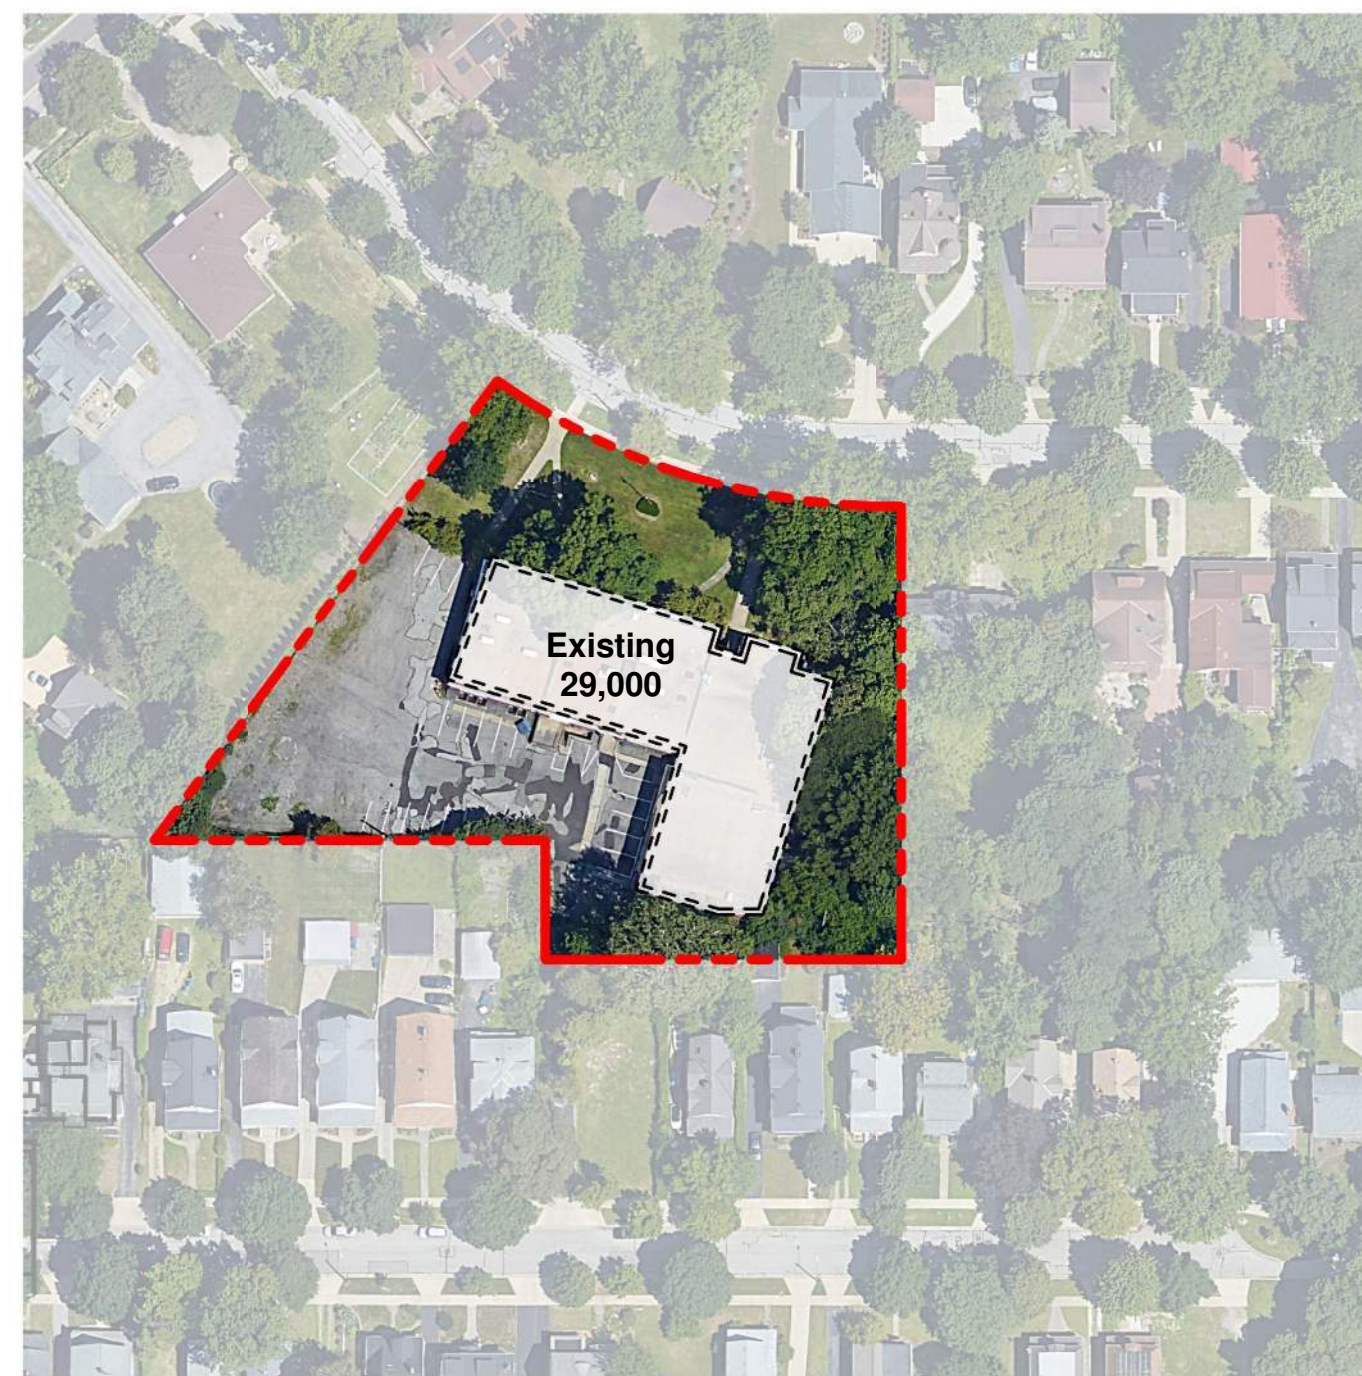
**Concept 3A.1 - Hybrid (2 Sites)**

**Rec to remain at Community Center**

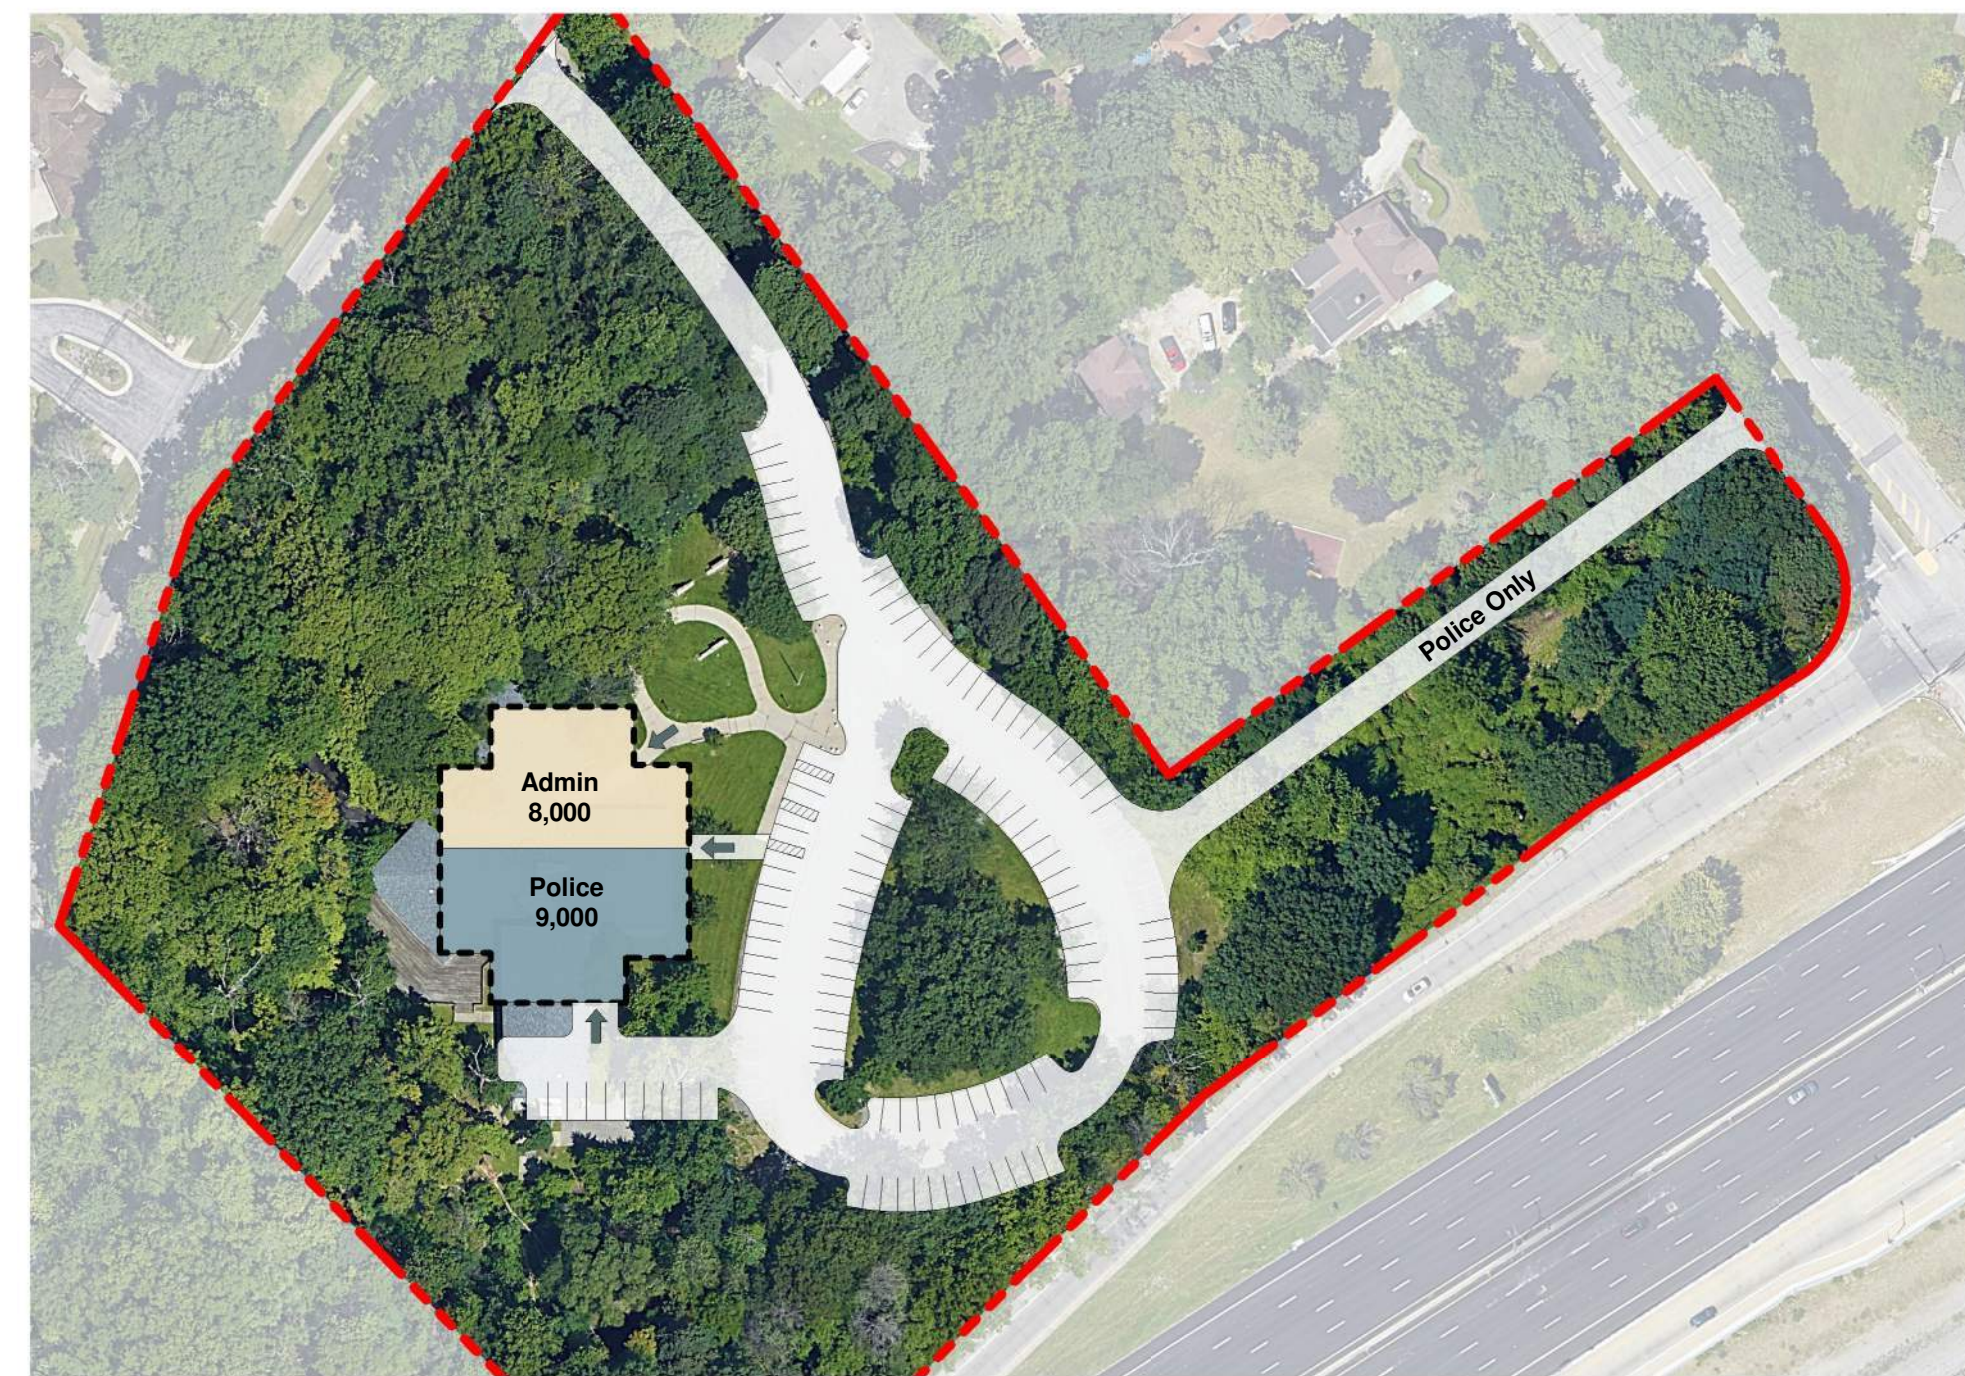
**Village Admin and Police at Bratenahl Center - New Construction**
