VILLAGE OF BRATENAH  
VILLAGE CENTER  
FEASIBILITY STUDY

## 2022 Bratenahl Condition Assessments

### Bratenahl Center – Facade Observations & Recommendations

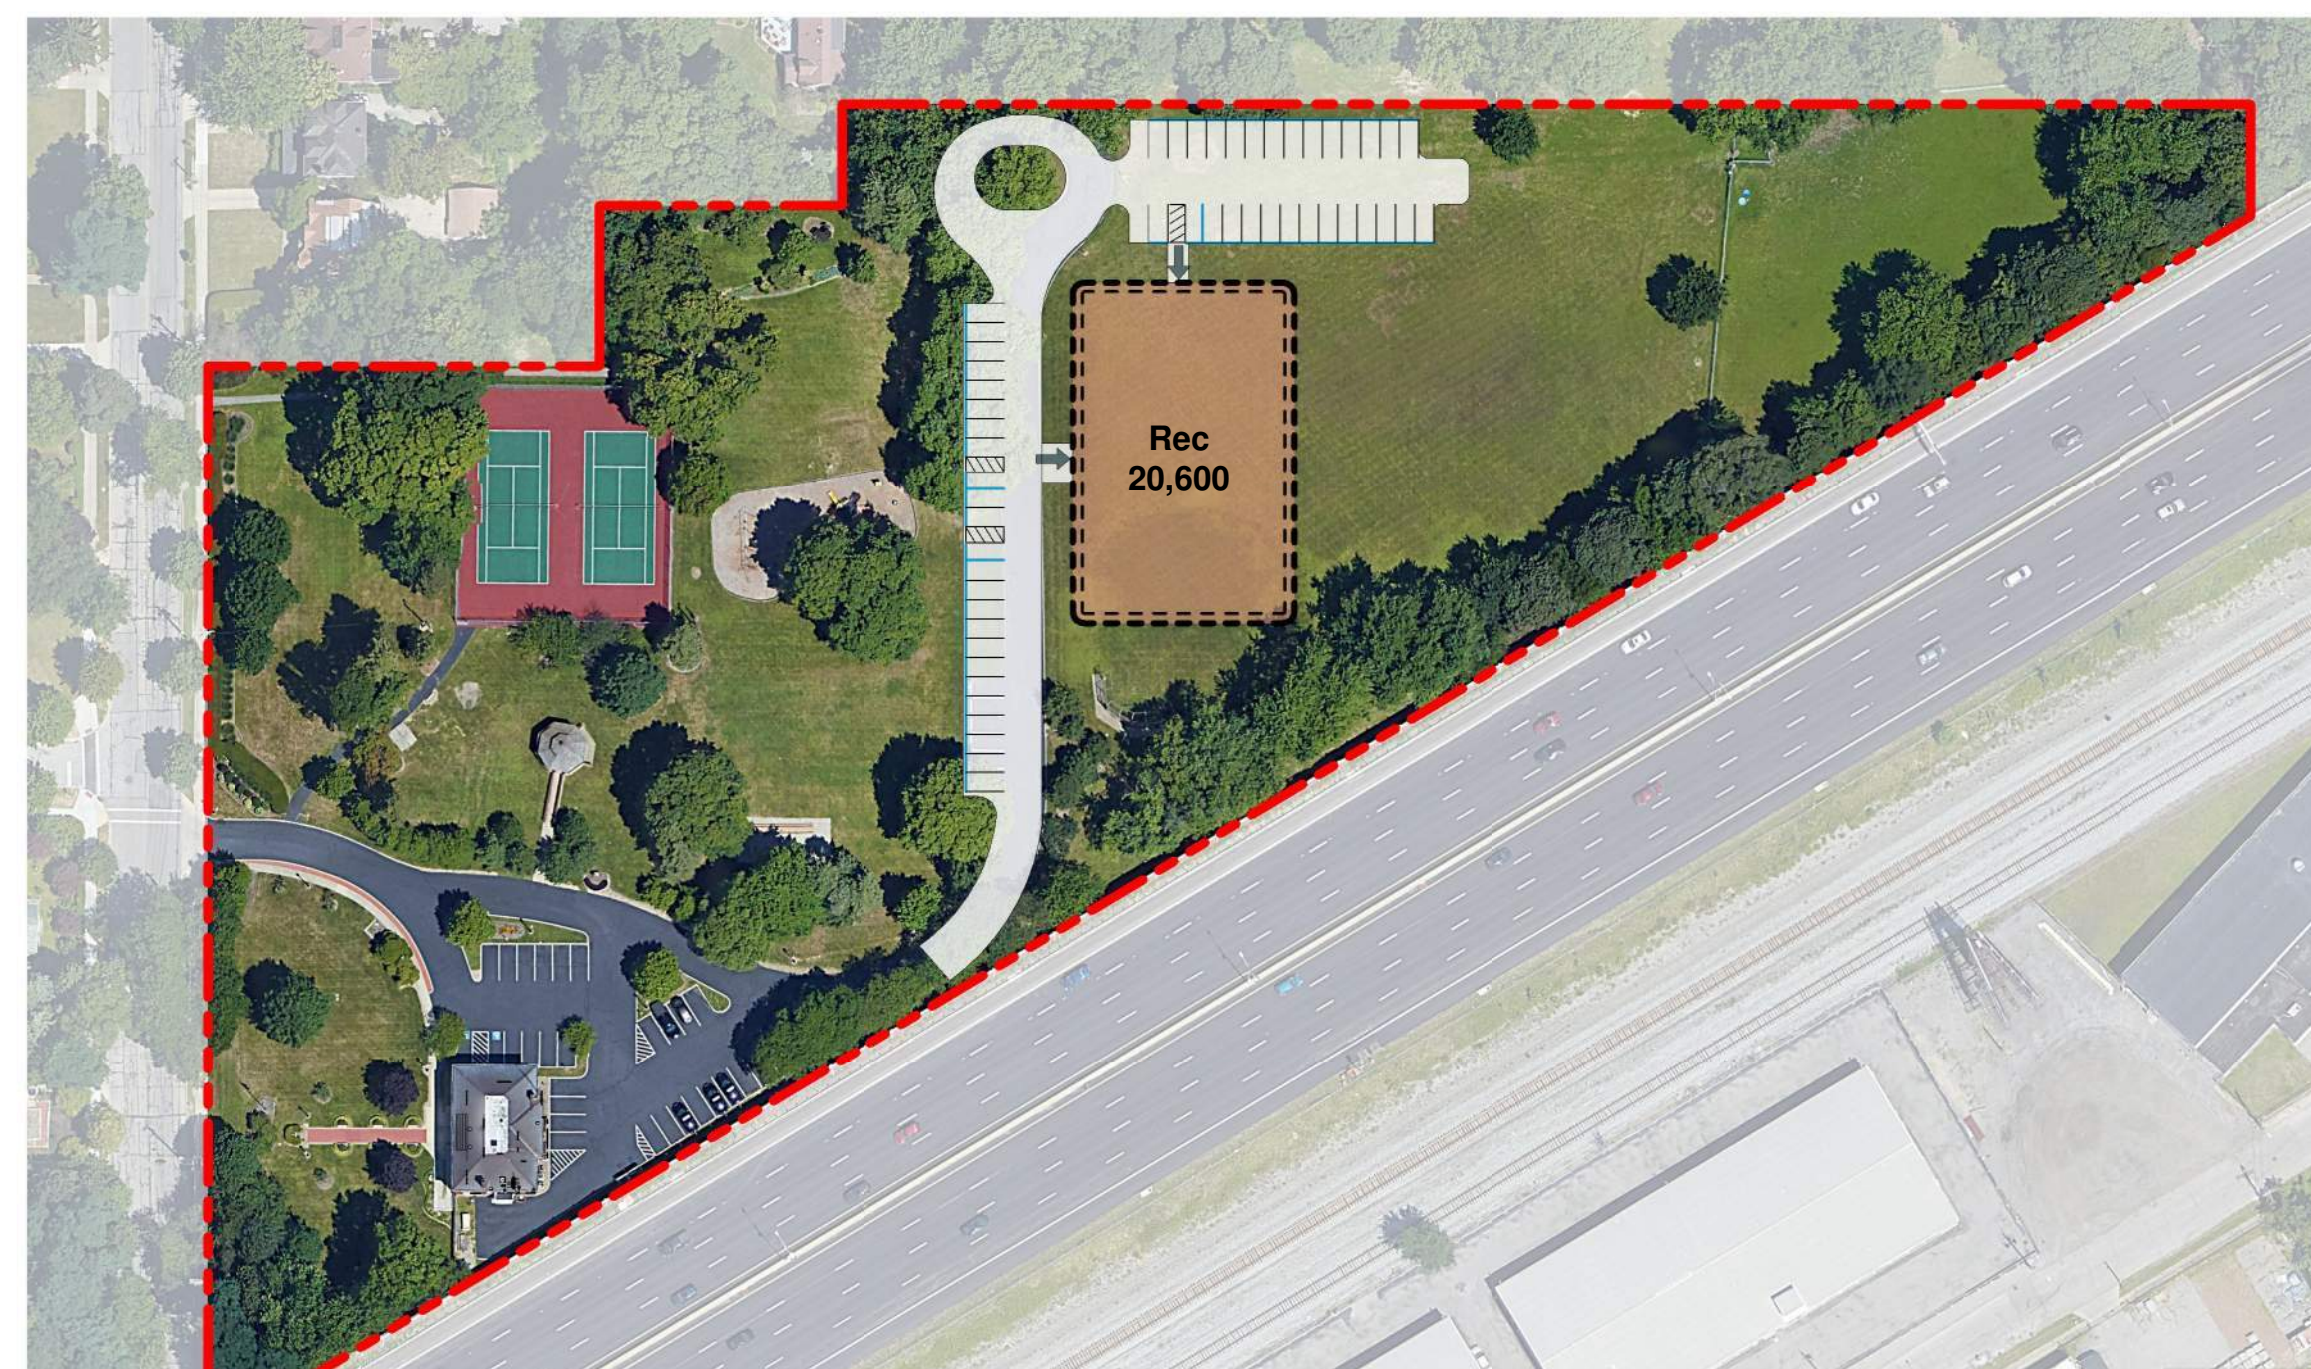
**Concept 3B.1 - Hybrid (2 Sites)**

**Rec at Village Hall Site - New Construction**

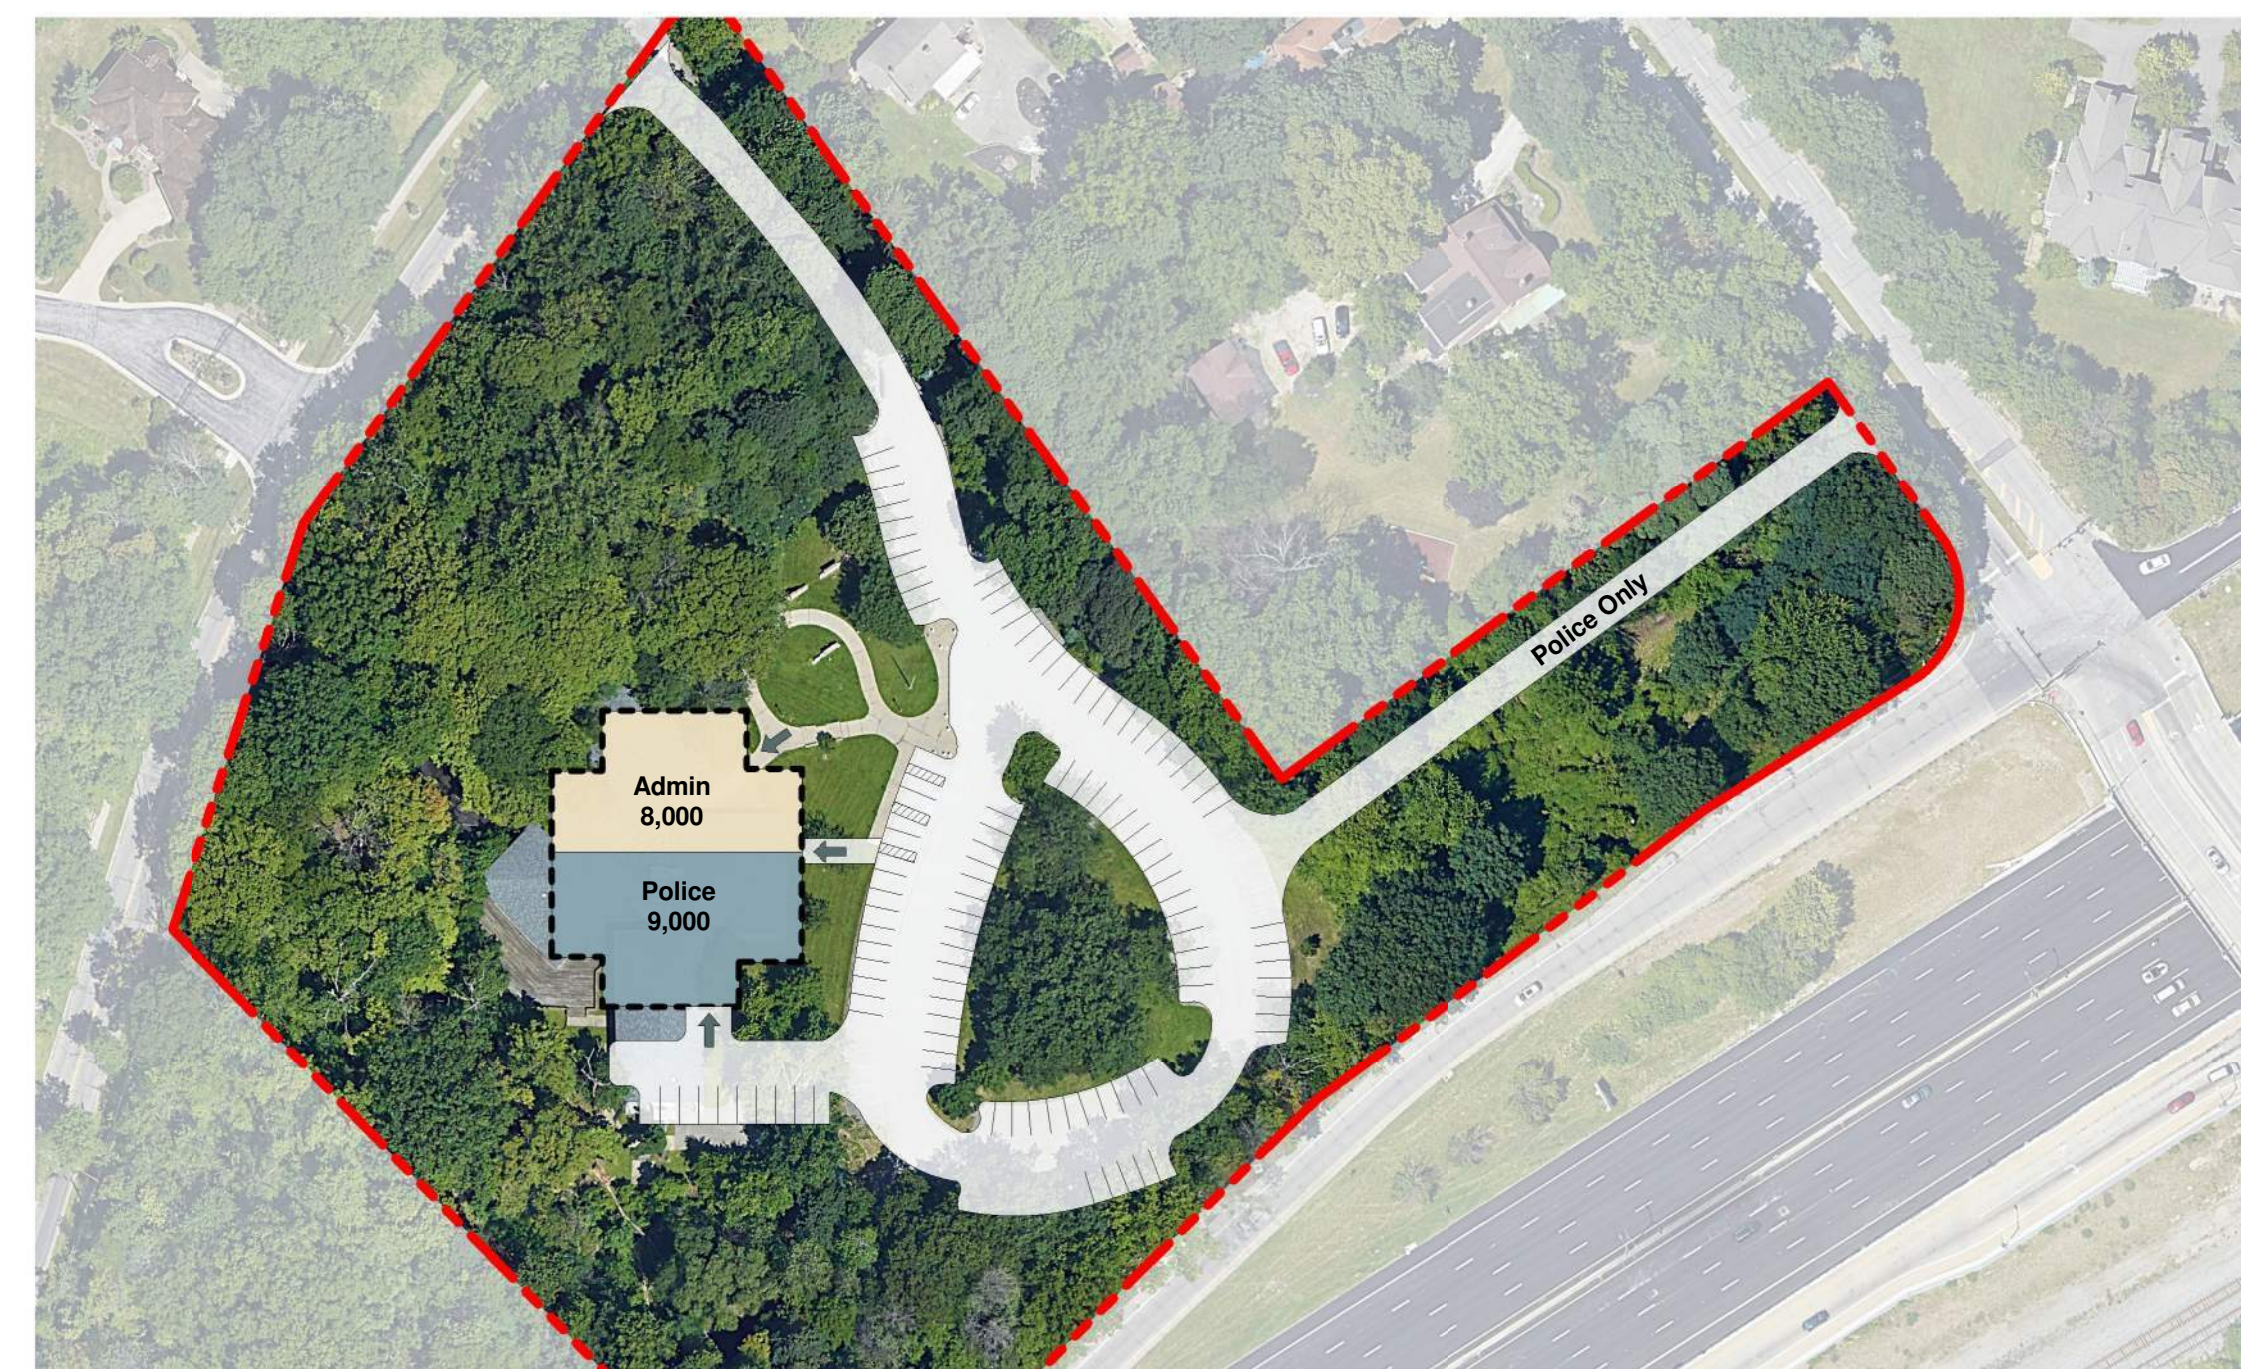
**Village Admin and Police at Bratenahl Center - Renovation + Addition**

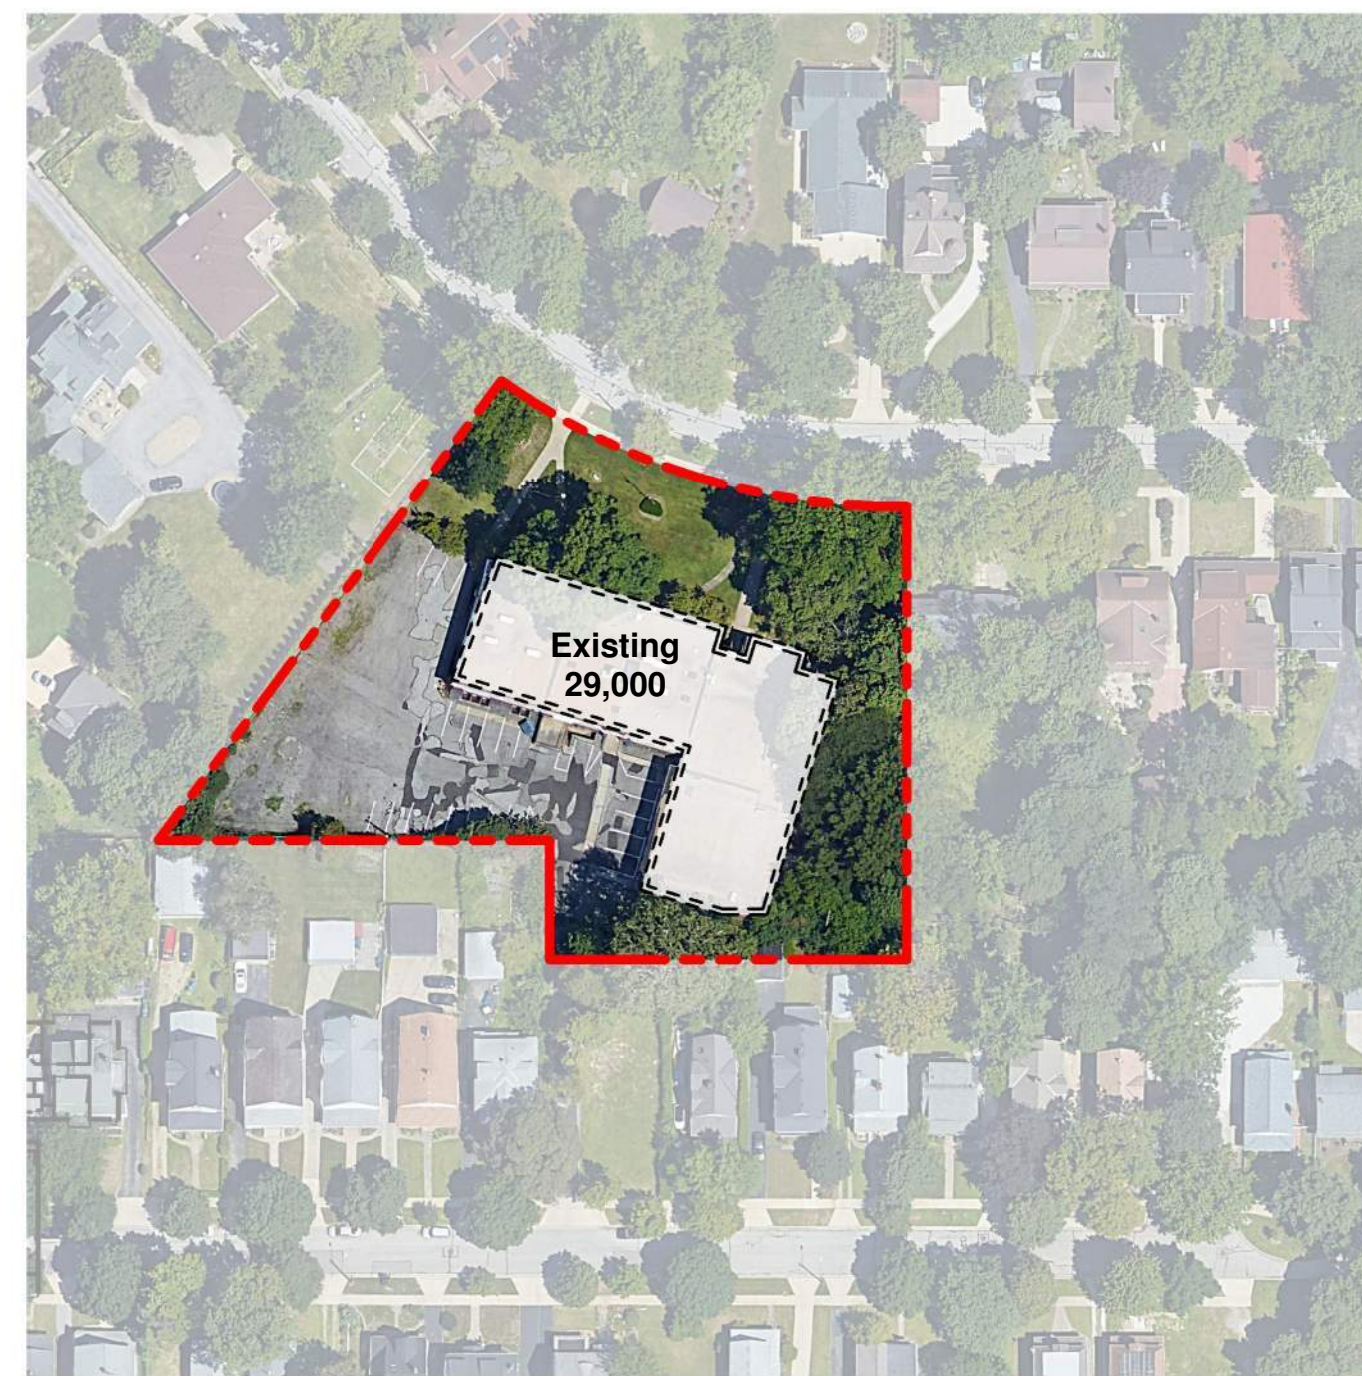
**Concept 3D - Hybrid (2 Sites)**

**Rec to remain at Community Center**
