VILLAGE OF BRATENAHL
VILLAGE CENTER
FEASIBILITY STUDY

2022 Bratenahl Condition Assessments

Bratenahl Center – Facade Observations & Recommendations

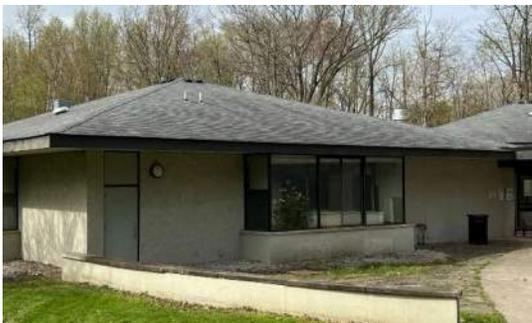
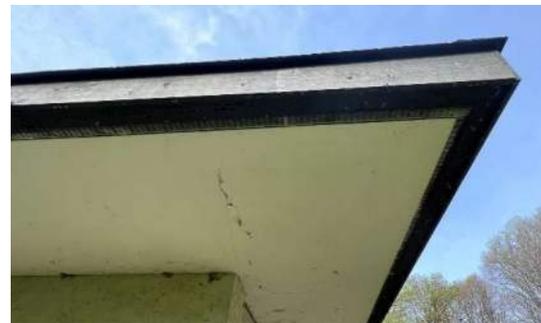
1. Asphalt Shingled Roofs: The roof consists of high-sloped hipped asphalt shingled roofs that were observed to be in overall fair condition. The shingles extend approximately 2-inches past the edge of the roof; we did not observe a drip edge, gutters, or downspouts. A sheet metal diverter is installed at the base of the roof over the main entrance to direct the water to the adjacent hipped roofs to drain off their edges. The roofs are vented with 2-inch-wide continuous soffit vents as the intake, and two box vents at the top of each hip as the exhaust.

We recommend removal and replacement of the asphalt shingle roof. During replacement, we recommend installation of a drip edge to facilitate shedding of water off the fascia and, although it will alter the aesthetics of the building, potential installation of gutters and downspouts to drain the water. Additionally, we recommend performing calculations to confirm that the roof ventilation is sufficient.

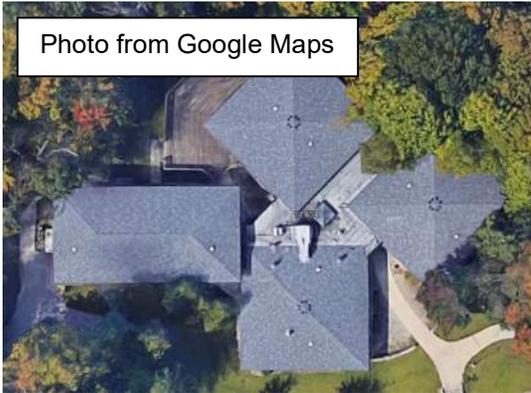
2. Low-Sloped Membrane Roof: The footprint of the building consists of four rotated rectangular sections, with hipped roofs, with a central connection. The roof of the central section consists of a low-sloped roof membrane. The original design drawings indicate a built-up roof with gravel ballast. We were unable to review the roof membrane, but from satellite photographs it appears to consist of an SBS modified bitumen roof membrane. A scupper is located on the northwest elevation for drainage directly off the roof; a drip edge or downspout are not provided.

We recommend review of the low-sloped membrane roof for replacement. It is our understanding that leaks are occurring into the interior of the building within the low-sloped roof.

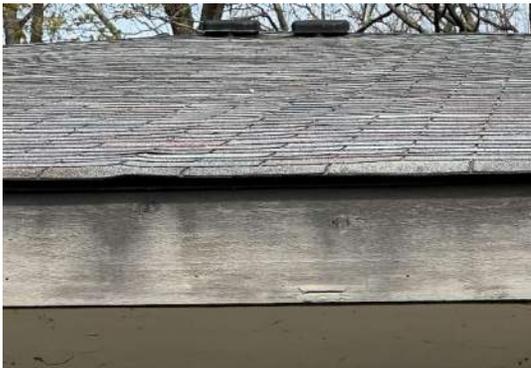
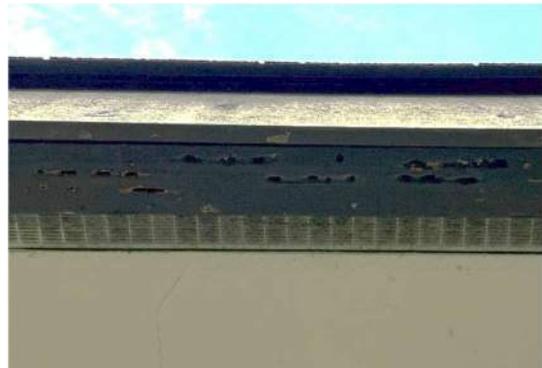
3. Wood Fascia: A 1x12 stained wood fascia is located at the base of the roof around the perimeter of the building at both the hipped roofs and the central low-sloped roof. The fascia was observed to have weathered and the stain has cracked, blistered, and peeled at isolated locations. Additionally, bugs have burrowed holes within the wood fascia at isolated locations around the perimeter of the building.

We recommend removal and replacement of any isolated portions of deteriorated and damaged wood, application of an epoxy hardener where it is soft, and cleaning and staining the wood fascia to extend its service life.

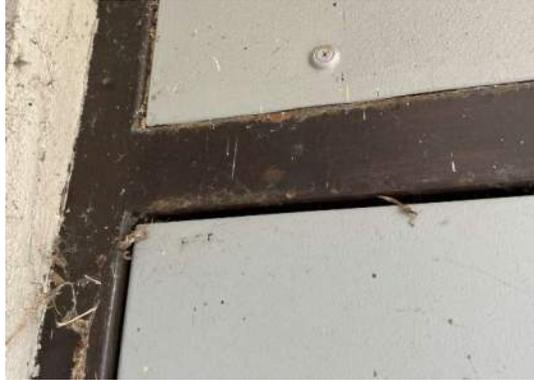
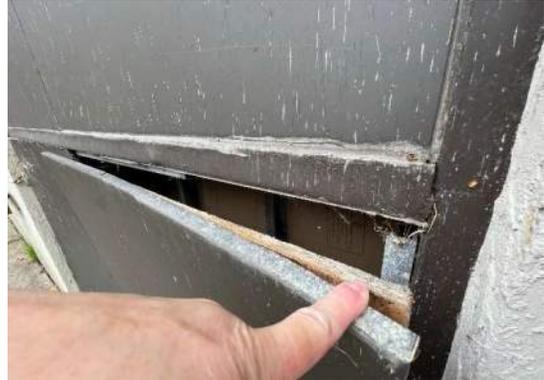
- f. Metal Doors: The doors consist of painted metal doors and frames. The frames, which extend to the soffit, are infilled with sheet metal panels installed as transoms over the doors and as wall panels at additional infilled door locations. The metal doors, frames, and metal panels are in overall good condition, with outward displacement of the metal panels observed at isolated locations. The paint has weathered and has cracked, blistered, and peeled at isolated locations. We observed surface corrosion of the exposed metal, as well as of the exposed door hinges.

The door frames were installed tight to the stucco walls. The urethane joint sealant at the perimeter of the frames was observed to be thin in profile, to have hardened, and to be typically concealed by paint.

We recommend cleaning and painting the metal doors, frames, and sheet metal infill panels, as well as removal and replacement of the joint sealant with silicone at the perimeter of the frames.

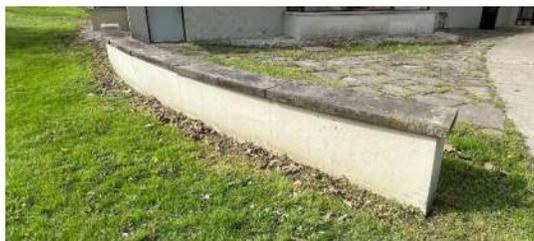
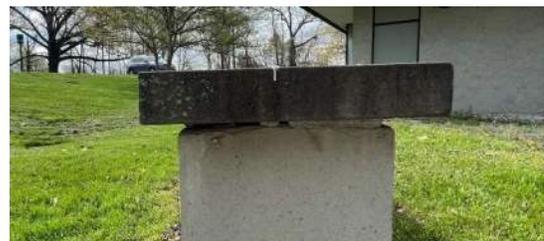
- b. Exterior Barrier Walls: Exterior barrier walls are located at the main entry, one each side of the sidewalk. The walls are constructed of concrete masonry, coated with exterior stucco, with cast stone copings. The mortar joints within the copings were observed to have cracked, lost bond, contain voids, or to be missing at various locations, and isolated coping units have displaced, providing direct paths for moisture penetration into the barrier wall. Through-wall flashing was not observed below the copings.

We recommend the following repairs within the exterior barrier walls:

- Removal and reinstallation of the cast stone copings to allow for installation of sheet metal through-wall flashing. We recommend reinstallation of the copings in full mortar head and bed joints, with head joints raked back to allow for the installation of backer rod and silicone joint sealant.

- Removal of loose material and patching the stucco at cracks, delaminations, and spalls.
- Installation of reveals/control joints within the stucco.
- Removal of the stucco at the base of the barrier walls for installation of new sheet metal flashing/weep screed. (Industry standards recommend maintaining the base of the stucco 4-inches minimum above grade, requiring installation of a waterproof membrane at the base of the concrete masonry backup.)

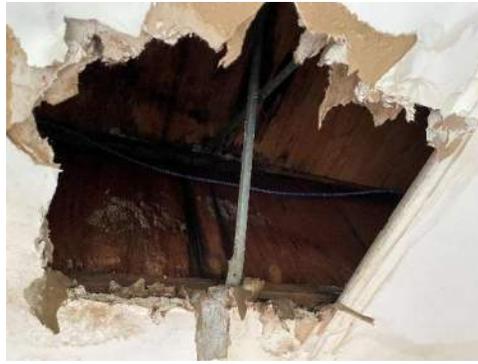
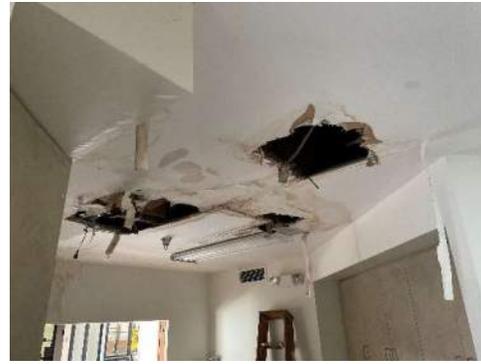
- a. Extensive roof leaks exist at the flat roof above the entrance lobby and kitchen area. The roof structure in this area was observed to be wood I-joists. The moisture from the roof leaks has saturated the wood. Wood I-joists typically have plywood webs. Moisture can decrease the strength of the webs.

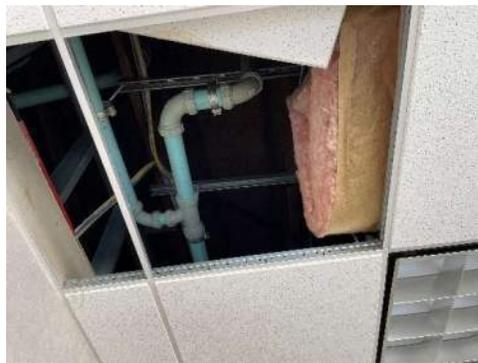
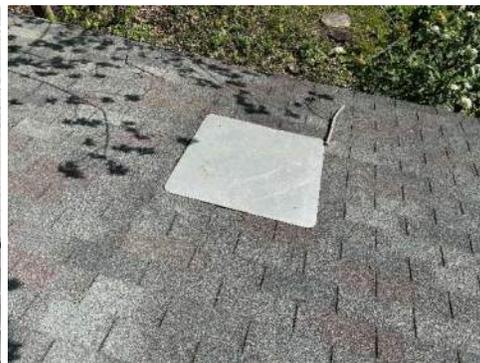
- b. Several roof leaks were observed throughout the areas of the building with wood trusses and plywood roof sheathing. Roof sheathing observed to be moisture stained.

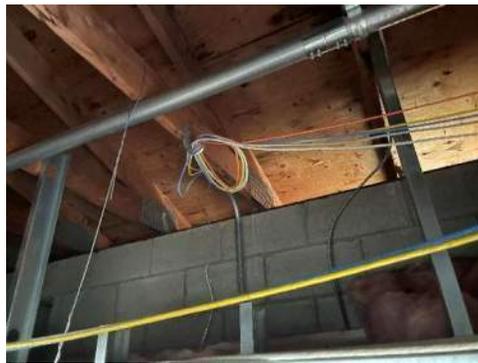
- c. Wood trusses with little to no moisture staining. Roof leaks typically occurred away from the truss bearing.

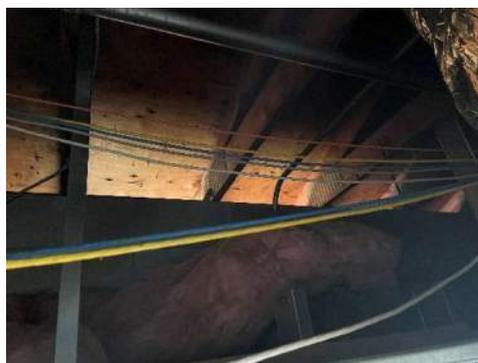
- d. At one location on the north side of the building a hole through the roof sheathing was observed. The hole in the roof sheathing is above the perimeter soffit.

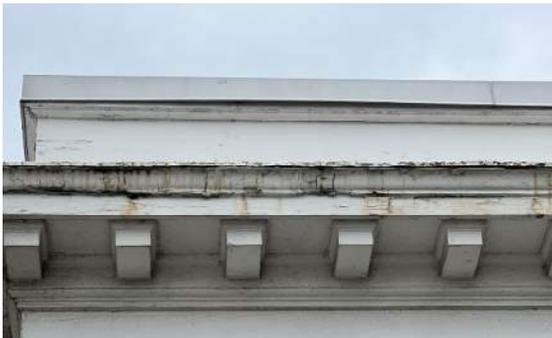
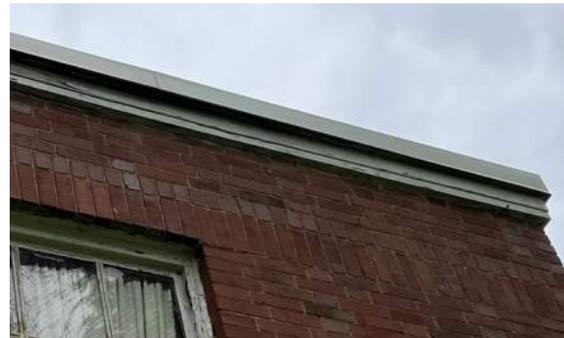
1. Sheet Metal Copings: Sheet metal copings cap the top of the exterior walls around the perimeter of the building. A drip edge is provided within the coping to facilitate shedding of water way from the vertical face of the wall. Concealed splices are provided between adjacent sections of sheet metal within the coping. It appears that the cleats that secure the coping to the exterior wall are widely spaced as the vertical face of the coping was observed to displace inward and outward.

We recommend removal and replacement of the sheet metal copings. The copings should be secured to the exterior wall with cleats that are 4-inches wide, minimum, and spaced 12-inches on center, maximum, or are continuous around the perimeter of the roof.

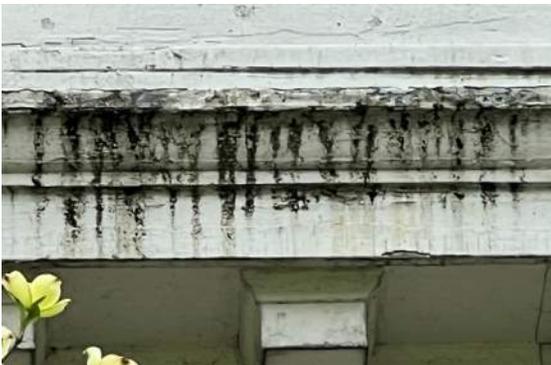
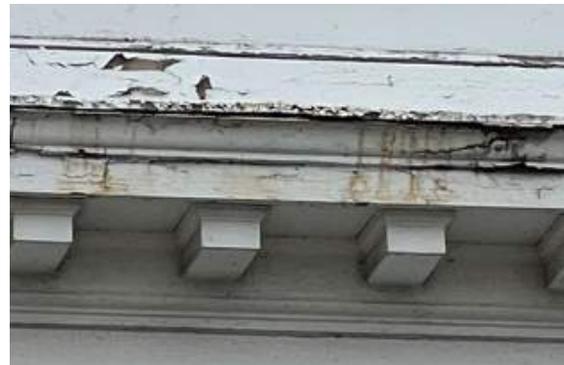
3. Cornice Cap: The top of the projecting cornice is capped by sheet metal. The sheet metal is bent downward at the edge of the cornice; however, we did not observe a drip edge. We observed blistered and peeling paint, moisture staining, and deterioration of the wood directly below the cap. The sheet metal was previously coated/painted; however, the coating is blistered and peeling. We observed surface corrosion of the metal as well as corrosion stains on the wood below.

We recommend removal and replacement of the existing cornice cap with new sheet metal with a baked Kynar coating that matches the color of the cornice. Industry standards recommend providing a hemmed drip edge, bent 1/2-inch away from the face of the wall, to facilitate shedding of water away from the wall.

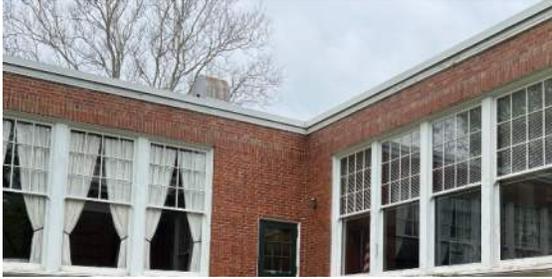
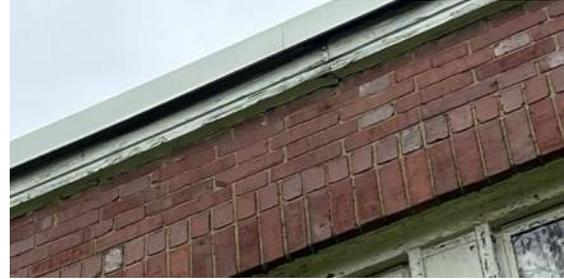
4. Wood Fascia: A painted wood fascia is located at the top of the wall around the perimeter of the east addition. The paint was observed to have cracked, blistered, and peeled at isolated locations.

We recommend removal and replacement of any isolated portions of deteriorated and rotted wood, application of an epoxy hardener where it is soft, and cleaning and painting the wood fascia to extend its service life.

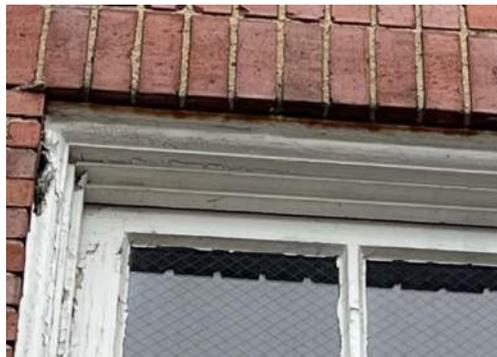
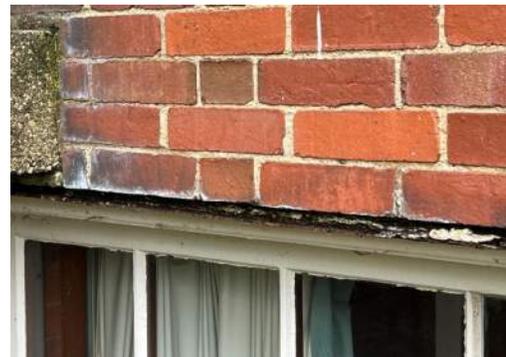
- c. Lintels: Painted steel lintels are installed over masonry openings (windows, doors, and louvers) to support the masonry above. Due to the age of the building and the addition, through-wall flashing was not installed at the lintels. Surface corrosion of the steel was typically observed while evidence of the development of pack rust was observed at isolated locations.

We recommend removal and replacement of the steel lintels that have developed pack rust, experienced section loss, or have severely deflected, with new with new galvanized steel lintels. In conjunction with the lintel replacement, we recommend installation of new stainless-steel sheet metal through-wall flashing to protect the embedded steel.

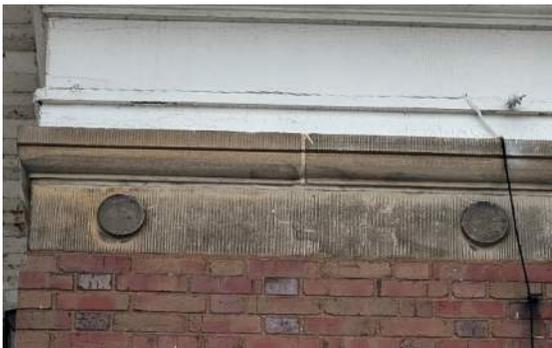
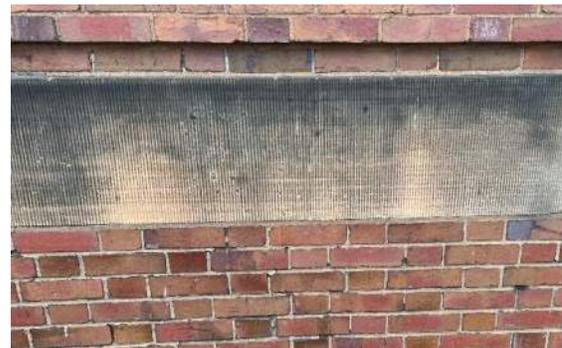
6. Sandstone: Sandstone is installed within the exterior masonry walls as accent bands at the top, as a water table, and at the base of the exterior walls of the original building, as pilaster caps within the gymnasium, as well as at windowsills throughout the building. Moisture and atmospheric staining were observed at throughout the sandstone. Biological growth was observed at isolated locations due to moisture accumulation within the stone.

We recommend cleaning the stone masonry and applying a clear water repellent sealer after completion of masonry repairs to minimize moisture penetration and freeze-thaw deterioration of the sandstone and to extend its service life.

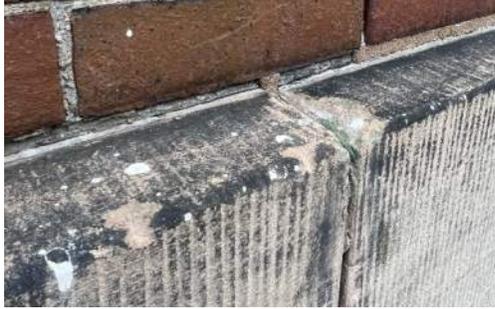
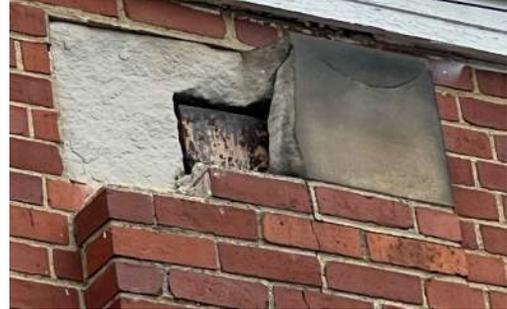
- a. Cracks, Delaminations & Spalls: Hairline cracks, delaminations, and spalls were observed within the sandstone at isolated locations, particularly within areas of moisture accumulation. (A delamination is a separation within the stone. When a delaminated portion breaks away, it is a spall.)

We recommend routing the cracks, removal of loose material at delaminations and spalls, and patching the stone with a stone repair mortar to minimize the penetration of moisture and continued freeze-thaw deterioration of the masonry. We recommend removal and replacement of stone units that have significantly lost section.

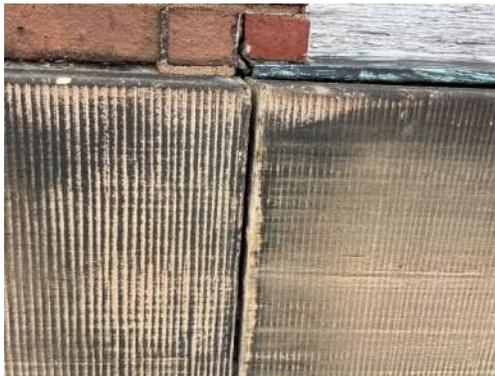
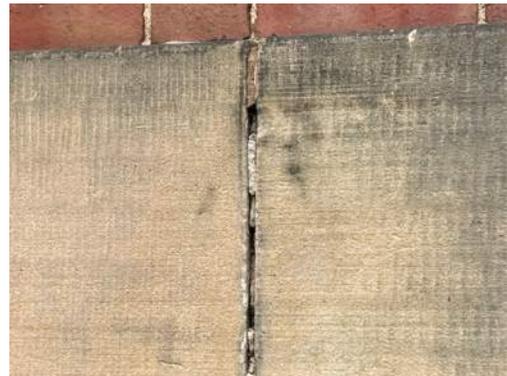
- b. Mortar: The mortar within the stone masonry was observed to be in overall poor condition. The mortar, which was struck flush with the face of the stone, is friable and has typically cracked, lost bond, or is missing at various locations.

We recommend repointing the mortar 100 percent within the sandstone to minimize moisture penetration and freeze-thaw deterioration of the stone.

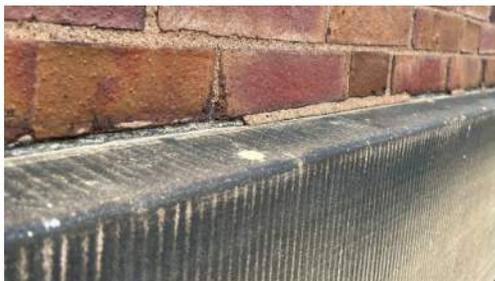
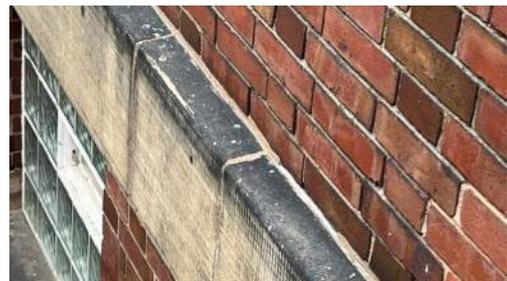
- c. Projecting Stone Water Table: The stone masonry projects out from the exterior face of the wall at the water table. The mortar bed joint between the exterior wall and the top of the projecting masonry, which is susceptible to moisture accumulation and freeze-thaw deterioration, has been previously repointed. However, the repointed mortar was observed to have cracked, lost bond, and to be missing at isolated locations.

We recommend, after repointing the mortar bed joint between the stone masonry and the projecting stone, the installation of a cove joint of silicone sealant to minimize moisture penetration into the joint. We recommend installing silicone joint sealant, which has a 20-year anticipated service life, versus 5 to 7 years for urethane.

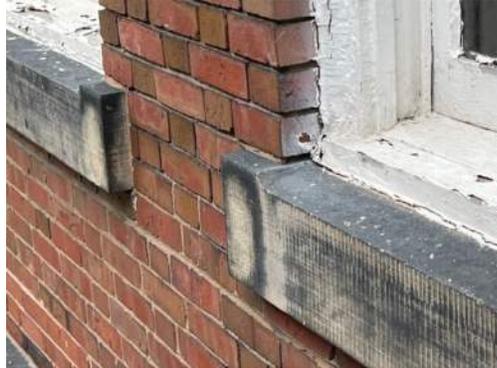
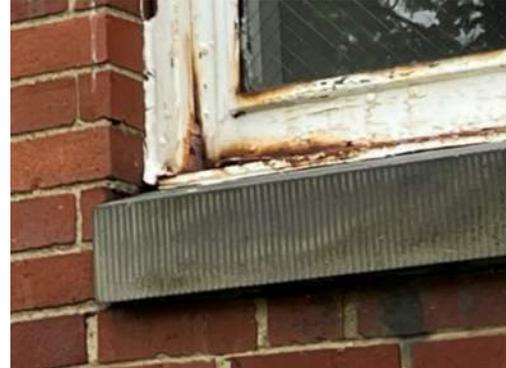
- d. Stone Sills: The windowsills throughout the building are sandstone. The bed joint at sills that extend into the brick jambs, and the mortar head joints at the ends of sills of equal width to the masonry openings, are susceptible to moisture penetration and freeze-thaw deterioration.

We recommend, after repointing the mortar bed joints between the stone masonry and the projecting stone sills as well as the vertical/head joints between the sills and the adjacent brick jambs, the installation of a cove joint of silicone sealant to minimize moisture penetration into the joint.

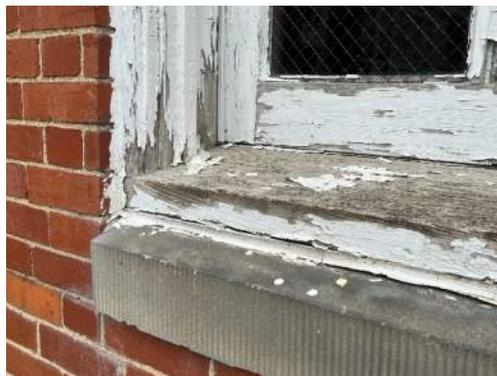
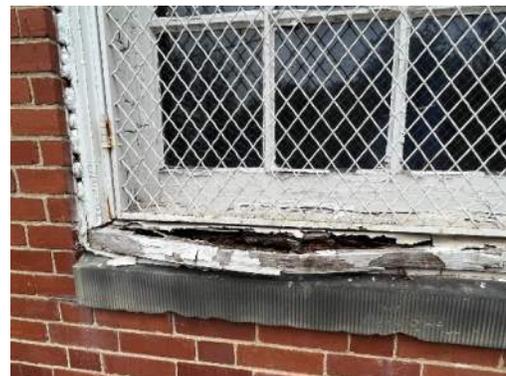
- a. Wood Framed Windows: The windows within the Bratenahl Community Center typically consist of the original painted wood windows. The paint was observed to have cracked, blistered, and peeled, exposing bare wood. The perimeter joint sealant, which consists of urethane, has hardened, cracked, and lost bond to at isolated locations.

We recommend removal and replacement of the wood framed windows with new thermally broken windows that would improve the energy efficiency of the building. If budget constraints do not allow replacement, we recommend the following. At exposed portions of the wood window frames, we recommend repair of any damaged wood, or application of an epoxy hardener where it is soft, and cleaning and painting the window frames. We recommend removal and replacement of the perimeter joint sealant with silicone.

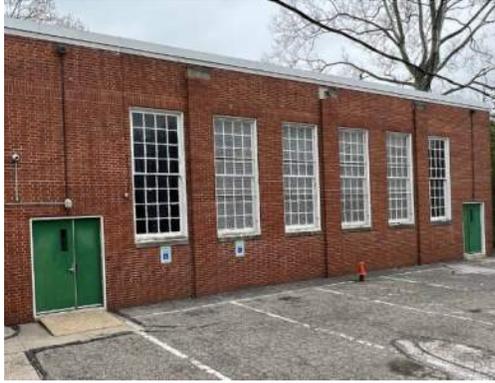
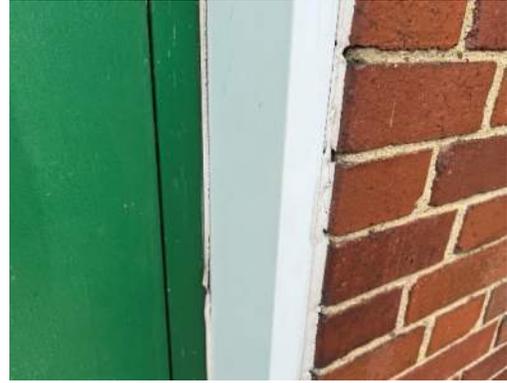
- f. Metal Doors: The doors on the west elevation of the gym consist of painted metal doors and frames. The metal doors are in overall good condition; however, the paint has weathered. It appears that metal trim was installed over an existing frame. Joint sealant is installed at the metal-to-metal joint at the perimeter of the frame and at the metal-to-brick joint at the perimeter of the trim. The urethane was observed to have hardened, cracked, and to have lost bond at isolated locations.

We recommend cleaning and painting the metal doors, as well as removal and replacement of the joint sealant with silicone at the perimeter of the frames and the perimeter of the trim.

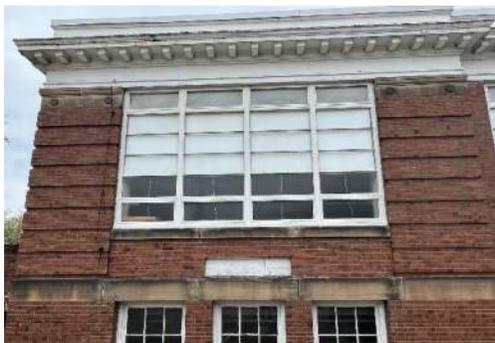
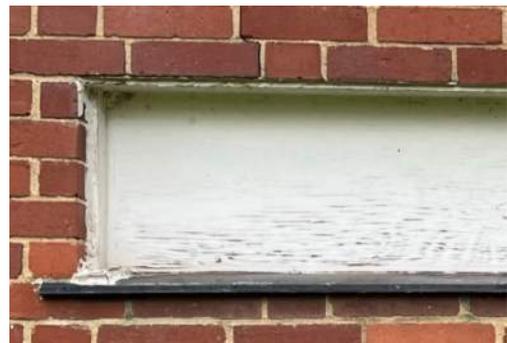
- g. Plywood Infill: Painted plywood infill was observed at locations of former louvers or vents within the exterior walls. The paint was observed to have weathered, cracked, blistered, and peeled, exposing bare wood. Joint sealant is installed at the perimeter of the wood infill; however, the urethane was observed to be thin in profile and to have hardened and cracked.

The sill within the former louver/vent openings consists of copper sheet metal. The sheet metal is hemmed (turned under) but lacks a drip edge to break the capillary action of water draining off its surface. The copper extends out the face of the wall within the brick masonry; however, at louver/vent openings located directly over the water table, the outer edge of the sheet metal is located on top of the stone.

We recommend removal of the plywood infill and copper sheet metal sills and infill with clay brick masonry. If budget constraints do not permit infill with new brick, we recommend cleaning and painting the infill, replacement of the perimeter sealant with silicone, as well as installation of silicone joint sealant below the copper sheet metal to the brick or along the edge of the copper to the sandstone water table.

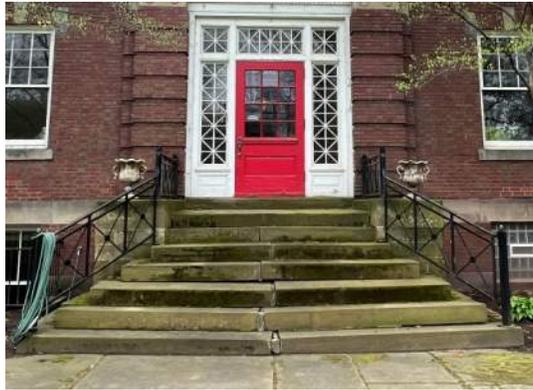
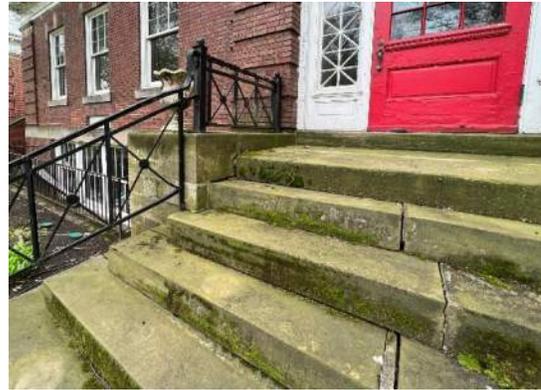
- a. Main Entry Stair: Stone stairs lead to the main entry doors at the west façade. The mortar head and bed joints within the stone treads were observed to have cracked, lost bond and to contain voids at isolated locations; settlement of the treads at the center of the stair has resulted in opening of the head joints. Stone barrier walls are located on each side of the stair. The mortar joints within the barrier walls were observed to have cracked, lost bond, and to contain voids at isolated locations. Moisture accumulation has caused staining and development of biological growth throughout the treads and barrier walls. The railings consist of painted wrought iron with base plates anchored to the stone. We observed blistering and peeling of the paint, and surface corrosion, at isolated locations, particularly at the base of the posts.

We recommend the following repairs within the main entry stairs:

- Removal and resetting of the stone treads, with repair of the underlying structure as required.
- Stone patching at cracks and spalls within the stone with a repair mortar.
- Reinstallation of the treads with full mortar head and bed joints, with head joints raked back to allow for the installation of backer rod and silicone joint sealant.
- Installation of cove joint sealant at the stair treads and landings, with silicone. (Cove joints are the joints at the intersection of horizontal and vertical elements.)
- Mortar repointing within the stone barrier walls.
- Cleaning of the stone and application of clear water repellent.
- Cleaning and painting wrought iron railings and installation of cove joint sealant at the perimeter of the railing post base plates.

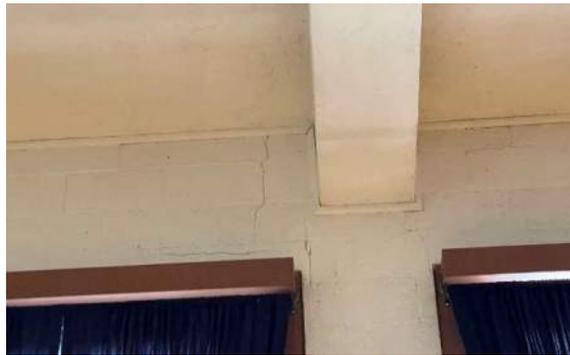
- b. Distress was observed at the roof structure bearing at one location on the north exterior wall of the gym.

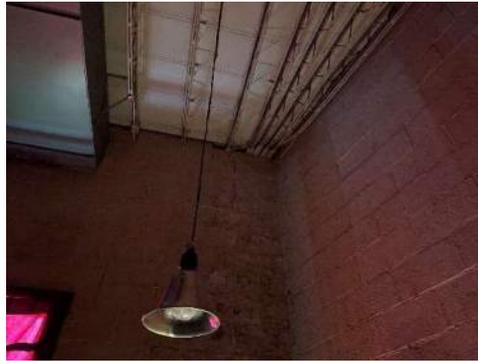
- d. In the southwest corner of the stage/gym building, moisture staining is present.

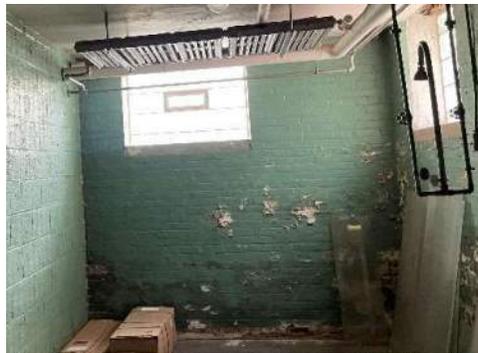
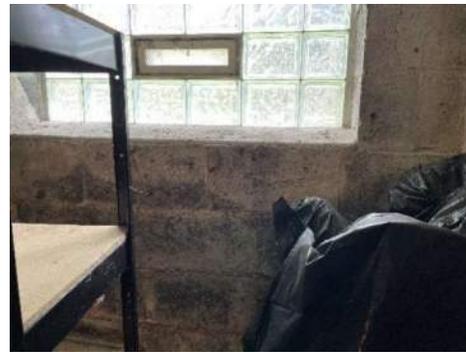
- e. Typically, the interior side of the basement walls was observed to be moisture stained showing high vapor drive into the building.

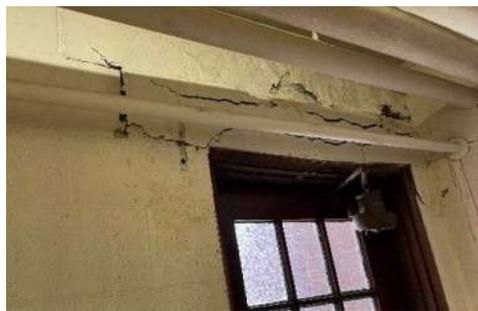
- f. At the exterior door on adjacent to the current men's locker room on the east side of the building to an area well, the concrete lintel is spalled.

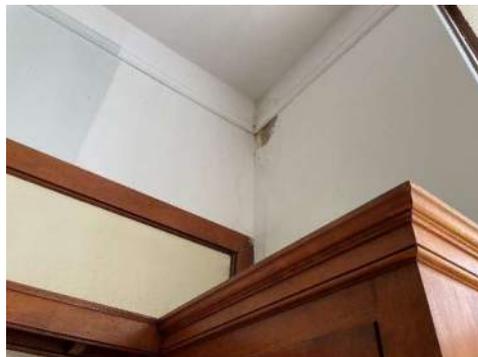
- g. Moisture damage was observed at the southeast corner of the Bratenahl room on the exterior wall.

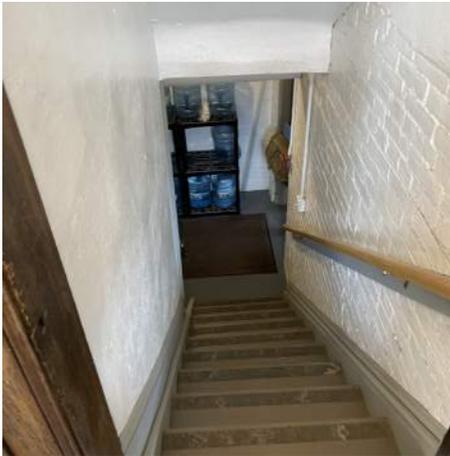
The existing stair is non-code compliant as it does not meet the minimum required width for an egress stair. Thus, both the basement and Level 2 are not provided with adequate emergency egress at this time.

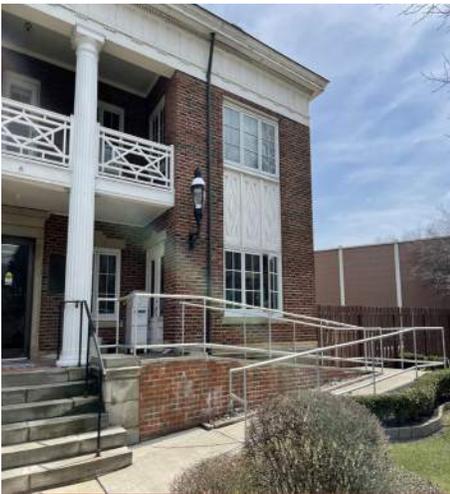
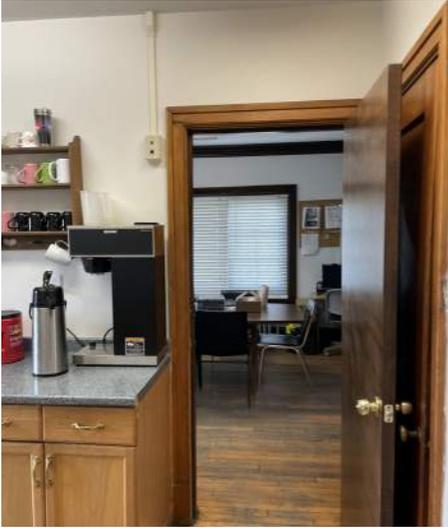
1. Several Door handles are non-compliant knob type and should be switched to a type not requiring tight grasping, pinching, or twisting of the wrist.
2. The internal stair located on the South Side of the building does not meet standards. The width is not adequate and handrails at internal stairs do not provide the proper extensions at top and bottom of stairs
